SERVICE BULLETIN

N° 139-663

ATA 30 - WIPER BLADE SPRAY NOZZLE REPLACEMENT

REPLACEMENT OF AW139 WIPER BLADE SPRAY NOZZLE
PN 3G3040V01151

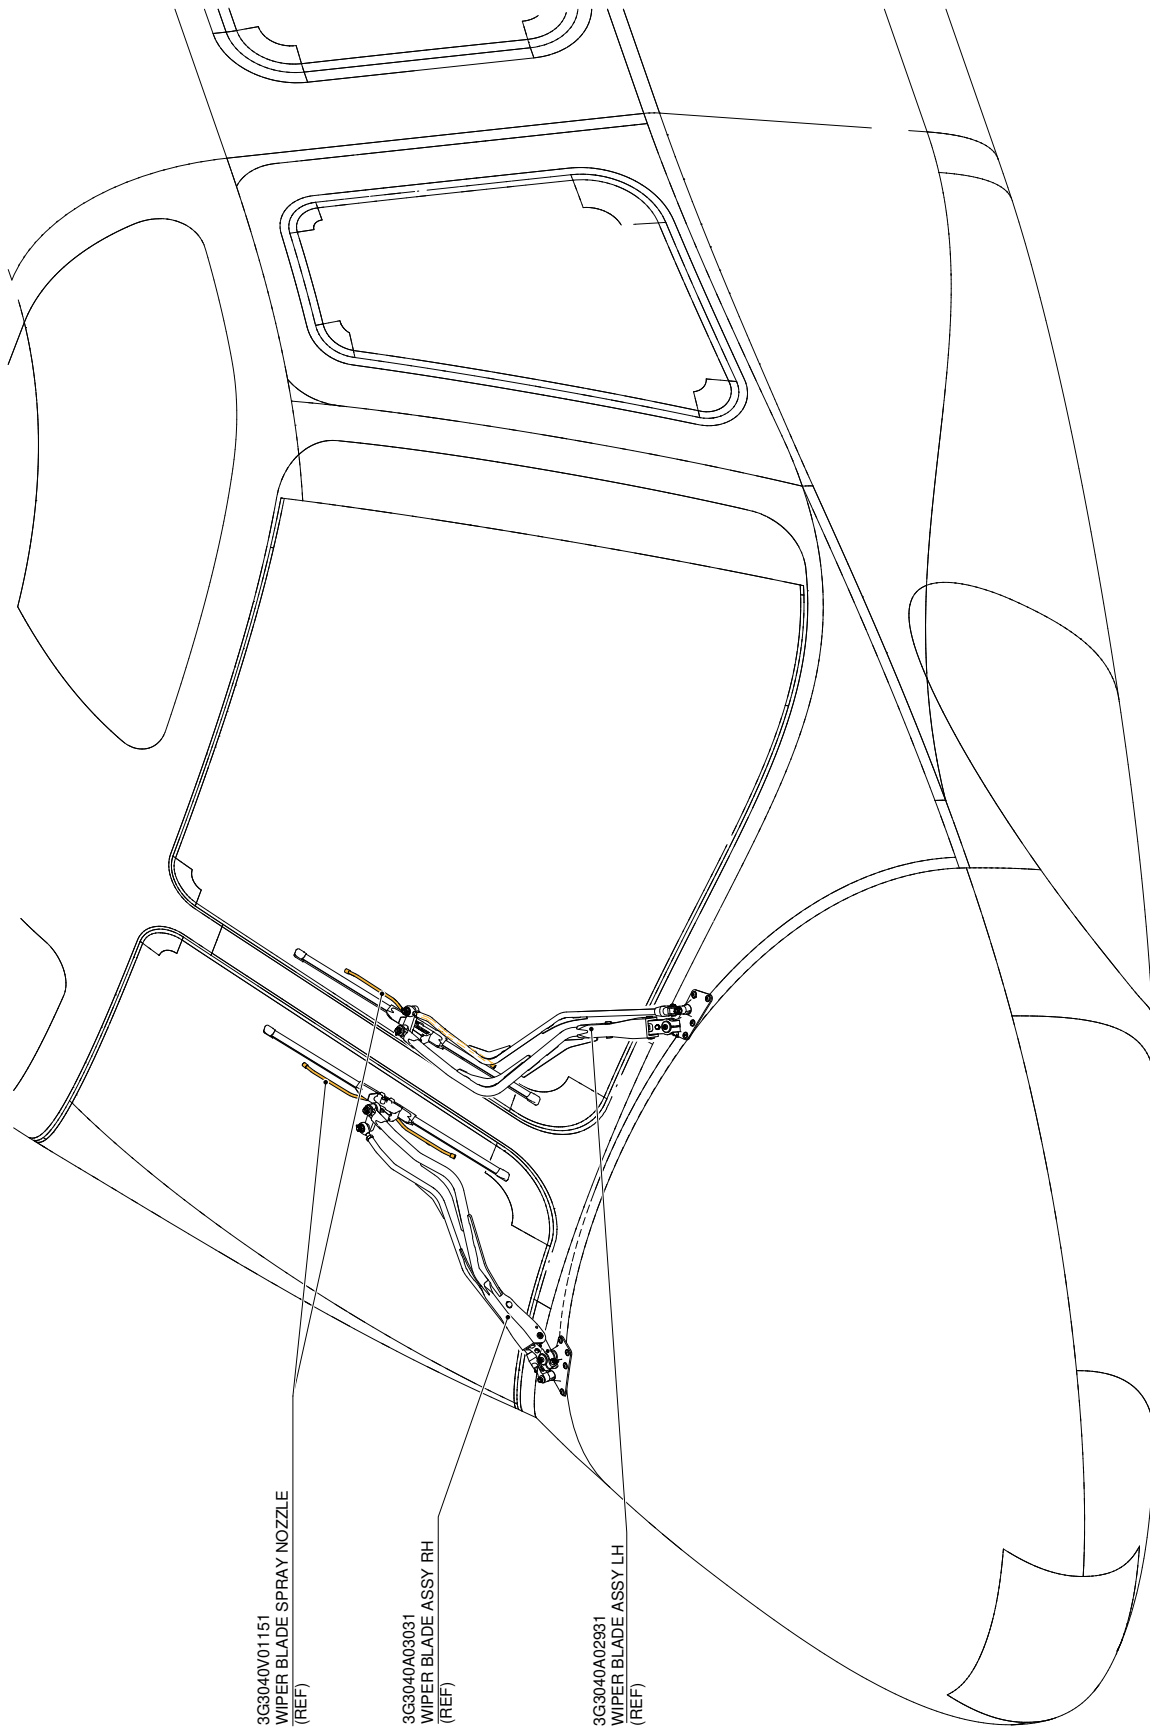
During investigations on the windshield washing, it has been discovered that wiper blade spray nozzles P/N 3G3040V01151 up to S/N 19090 resulted not within design requirements. Incomplete welding between the manifold and the two tubes attached, could result in improper functioning of the component. A new welding procedure based on laser-technology has been successfully applied to wiper blade spray nozzles P/N 3G3040V01151. The improved methodology offers higher quality standards, therefore, all components manufactured with the previous welding method have to be replaced.

1. In accordance with AMP DM 39-A-00-20-00-00A-120A-A, prepare the helicopter on ground for a safe maintenance. Disconnect the battery, all electrical power sources and/or the external power supply.
2. With reference to Figure 1, gain access to the wiper blades area of the helicopter.
3. With reference to Figure 1 and the example pictures in SB-85-479-001 in Annex A (page 7 of 7), check the serial number of each wiper blade spray nozzle(s) P/N 3G3040V01151. If the serial number is included in the effectivity of this Service Bulletin, take a picture of the component with visual evidence of the serial number and note the required information in the table of Figure 2. Discard and locally scrap the affected component(s).

4. With reference to Figure 1 and in accordance with Aerosystems Service Bulletin SB-85-479-001 in Annex A, perform the replacement of the affected wiper blade spray nozzle(s) installed on the wiper blade assy LH P/N 3G3040A02931 and/or RH P/N 3G3040A03031.

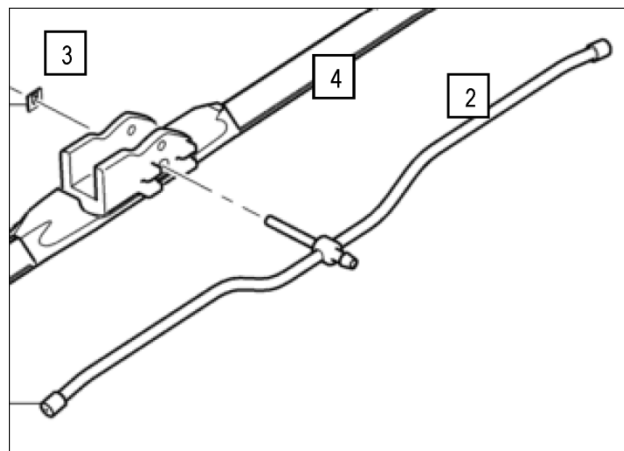
Figure 1

It has been notified that some AW139 wiper blade spray nozzles PN 3G3040V01151 have shown failures in service. The investigation has identified the reason in incomplete welding between the manifold and the two tubes attached, that may bring to the detachment of the latest.

- 1) Prepare the helicopter for a safe maintenance, disconnect any power supply, refer to AMP for applicable procedures.
- 2) Remove the rubber tube (1) connected to the Wiper Blade Spray Nozzles (2) PN 3G3040V01151 (Ref. Fig. 2)
- 3) Remove the Circlip (3) PN 85-142-02 by lifting the circlip tongue with a flat-headed screwdriver (Ref. Fig. 3 and 4).
- 4) Detach the Wiper Blade Spray Nozzles (2) PN 3G3040V01151 from the wiper blade (4) (ref. fig 1).
