SERVICE BULLETIN

N° 139-672

DATE: October 3, 2022

**ATA 29 - NUMBER 4 PUMP LINE INSTALLATION VISUAL INSPECTION AND
MODIFICATION**

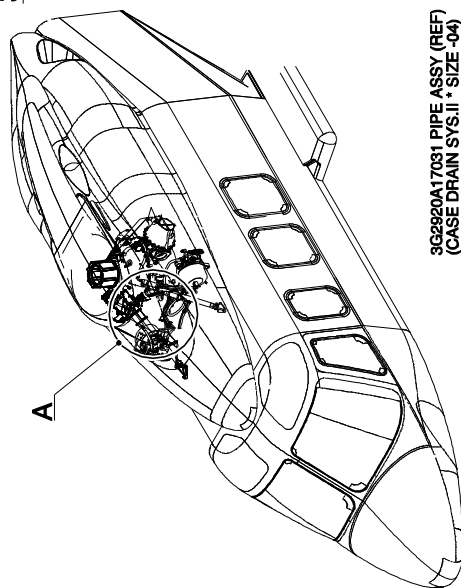
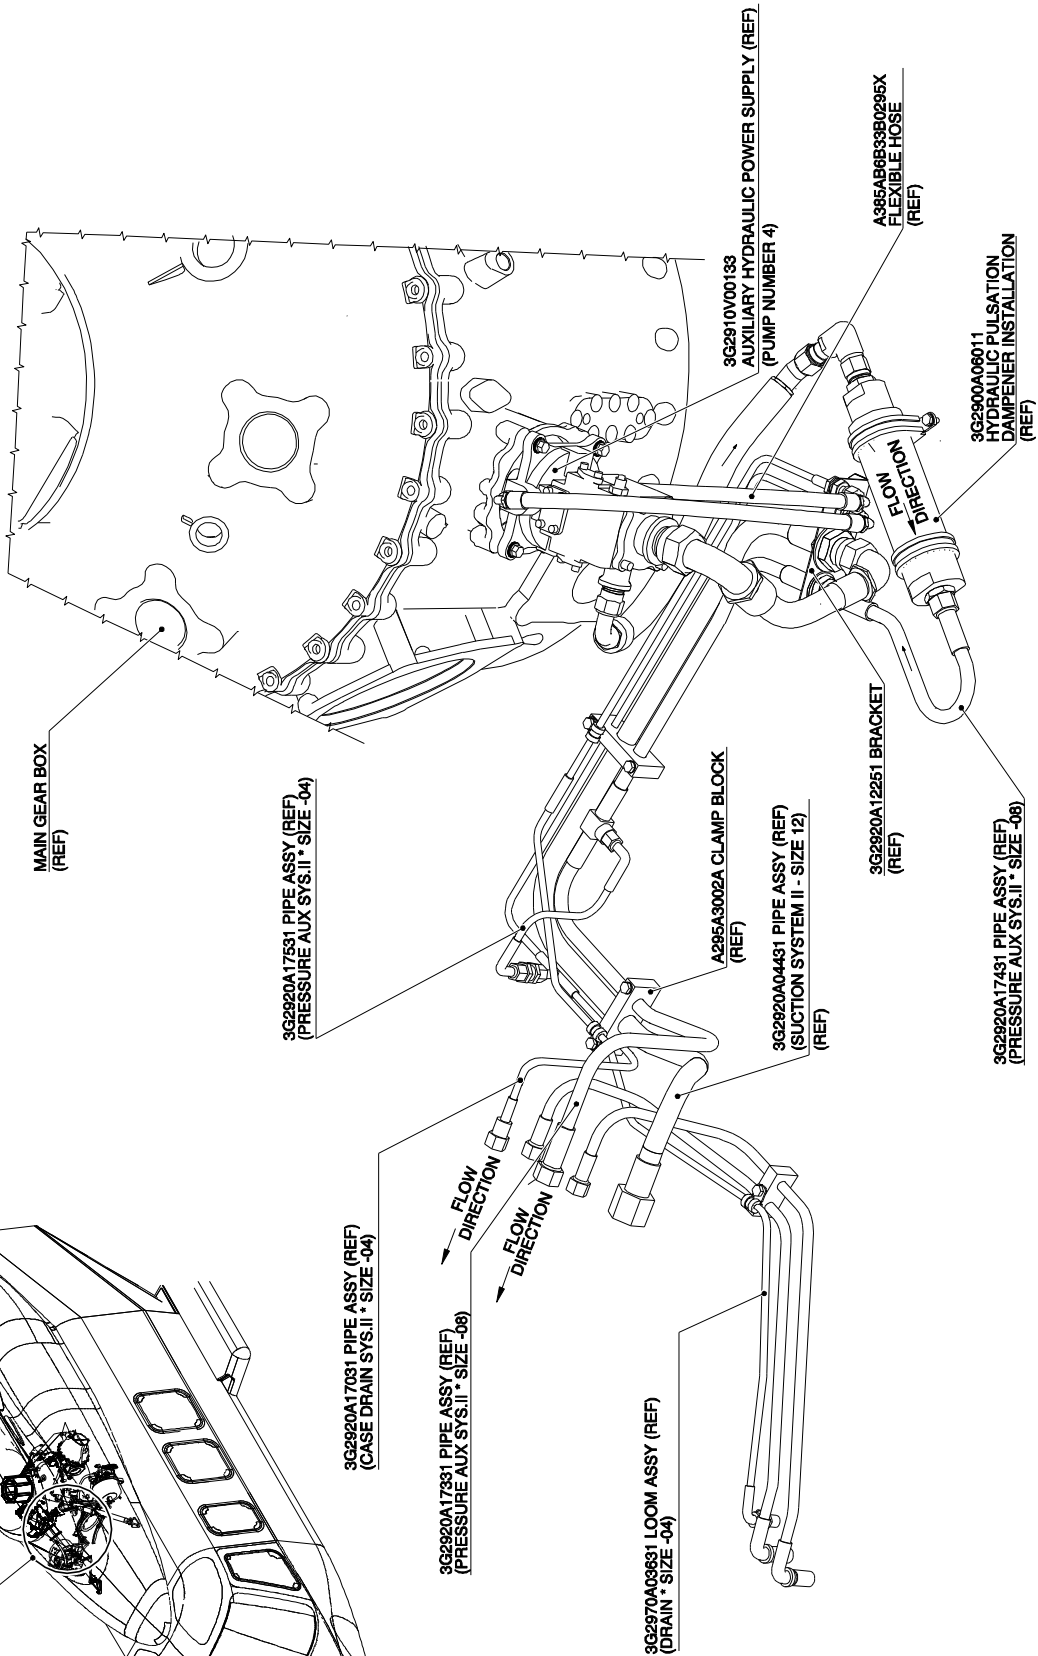
Figure 1

- 7.1 With reference to Figures 1 or 2 or 4, examine the following pipe assemblies for chafing:
- pipe assy P/N 3G2920A17331;
 - pipe assy P/N 3G2920A04431;
 - pipe assy P/N 3G2920A17031.

7. With reference to Figures 1 and 7, disconnect the following pipe and hoses from the side of the bracket P/N 3G2920A12251:
 - Pipe assy P/N 3G2920A17431;
 - Flexible hose P/N A385AG6G00H0255X;
 - Flexible hose P/N A385AB6B69B0436X
 - Flexible Hose P/N A385AB6B33B0295X (if present).

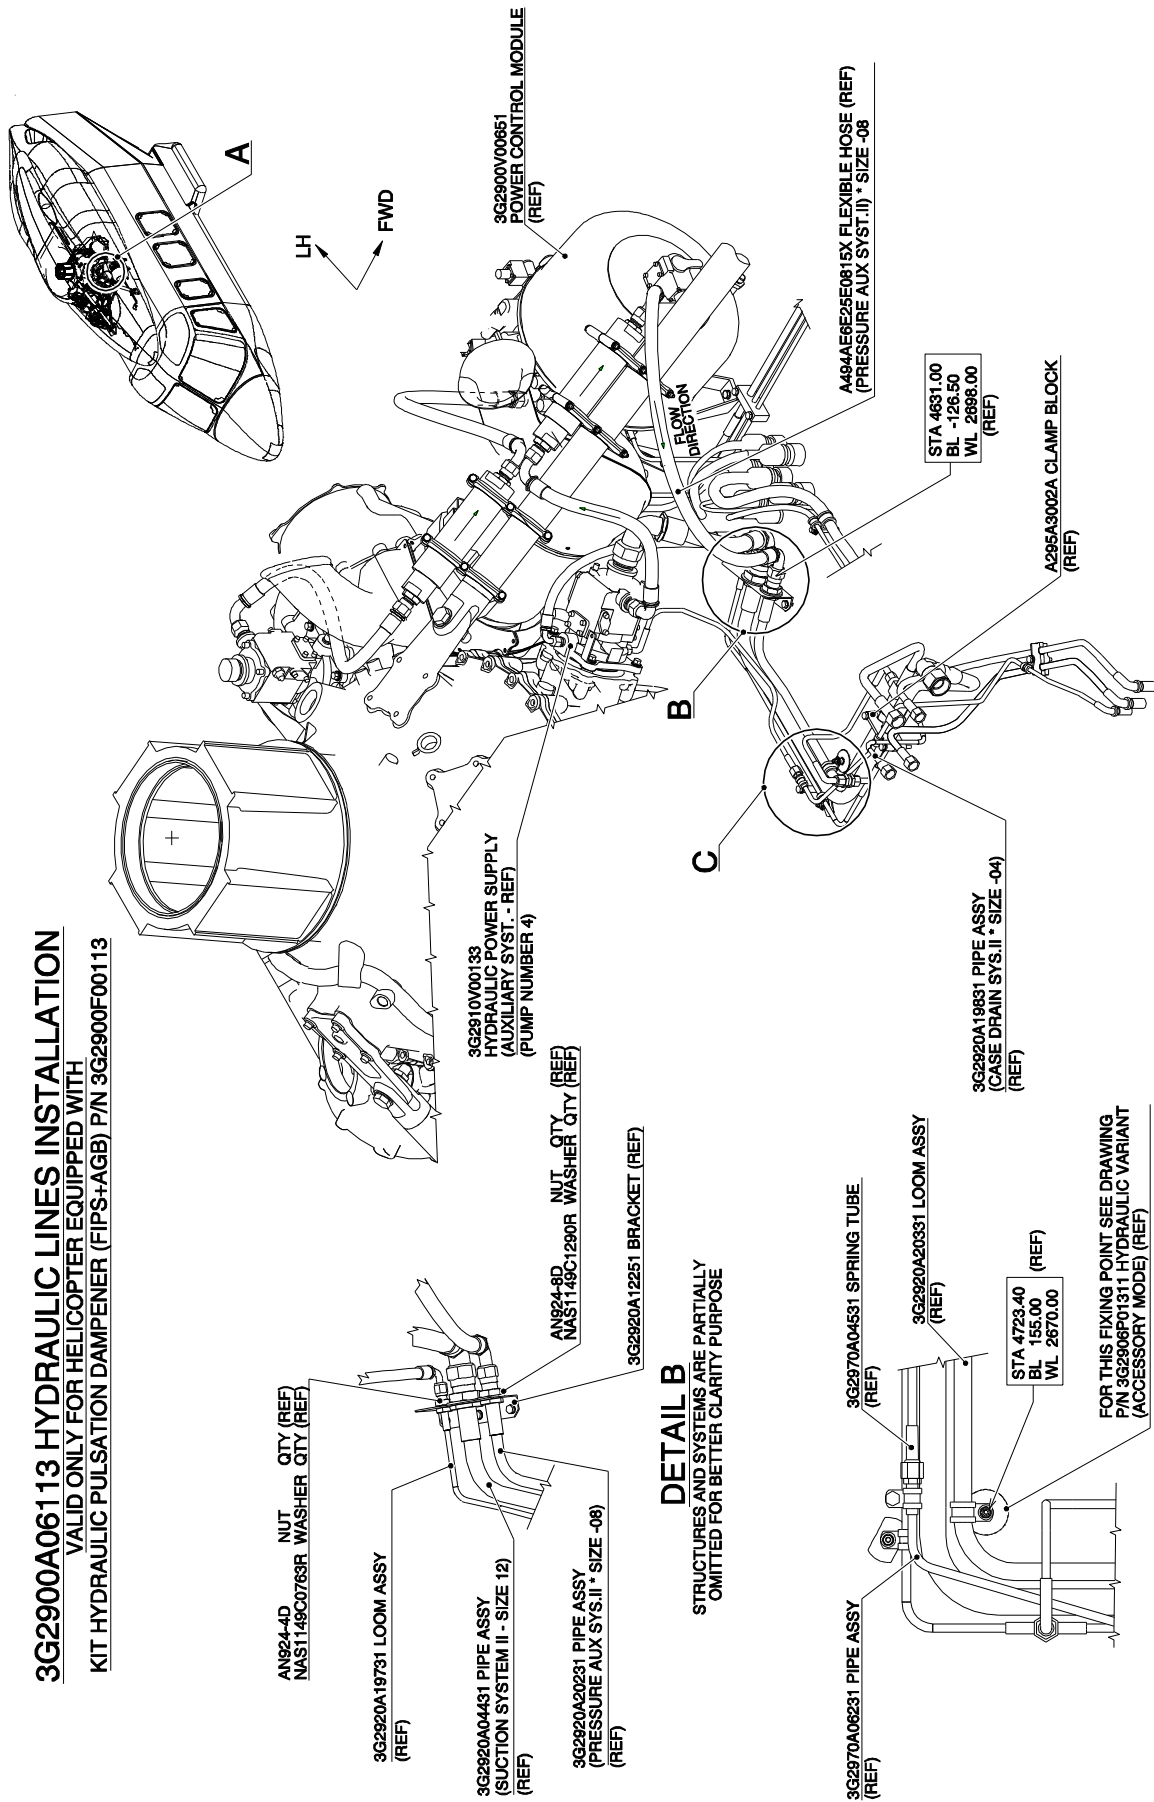
Figure 3

- 7.2 With reference to Figures 3 or 5, examine the following pipe assemblies for chafing:
- pipe assy P/N 3G2920A20231;
 - pipe assy P/N 3G2920A04431;
 - pipe assy P/N 3G2920A19831.

8. With reference to Figures 2 or 3 or 4 or 5 and Figure 7, disconnect the following flexible hoses from the side of the bracket P/N 3G2920A12251:
- Flexible hose P/N A494AE6E25E0815X;
 - Flexible hose P/N A385AG6G00H0255X;
 - Flexible hose P/N A385AB6B69B0436X.

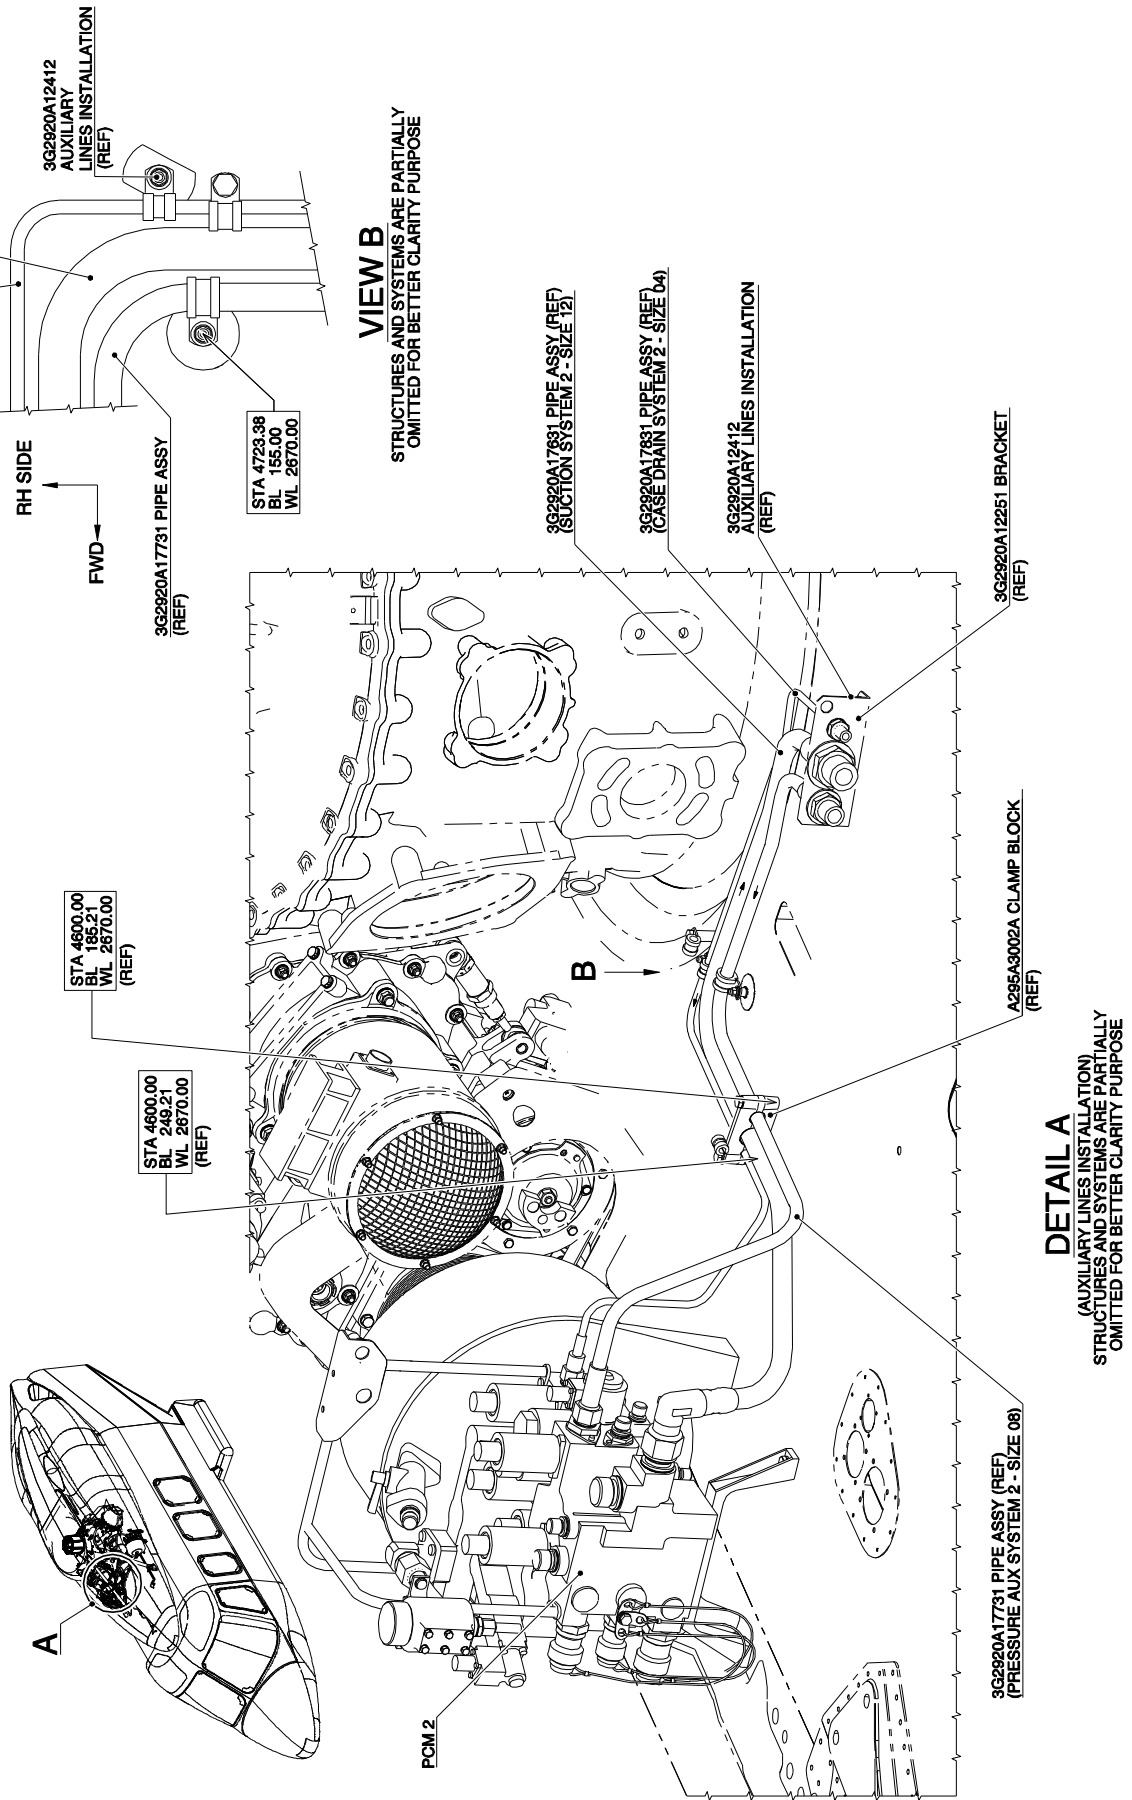
Figure 6

- 7.3 With reference to Figure 6, examine the following pipe assemblies for chafing:
- pipe assy P/N 3G2920A17731;
 - pipe assy P/N 3G2920A17631;
 - pipe assy P/N 3G2920A17831.

9. With reference to Figures 6 and 7, disconnect the following flexible hoses from the side of the bracket P/N 3G2920A12251:
- Flexible hose P/N AW004PFE5E18E0348X;
 - Flexible hose P/N A385AG6G00H0255X;
 - Flexible hose P/N A385AB6B69B0436X;
10. With reference to Figure 8 View B, to release the indicated pipe assemblies from the bracket P/N 3G2920A12251, remove the following fixing hardware:
- at position n°5, remove nut P/N AN924-4D and washer P/N NAS1149C0763R;
 - at position n°6, remove nut P/N AN924-8D and washer P/N NAS1149C1290R;
 - at position n°7, remove nut P/N AN924-12D and washer P/N NAS1149C1790R.
- Retain fixing hardware for later reuse.
11. With reference to Figure 8 View B, remove the bracket P/N 3G2920A12251 and relative fixing hardware from the helicopter.

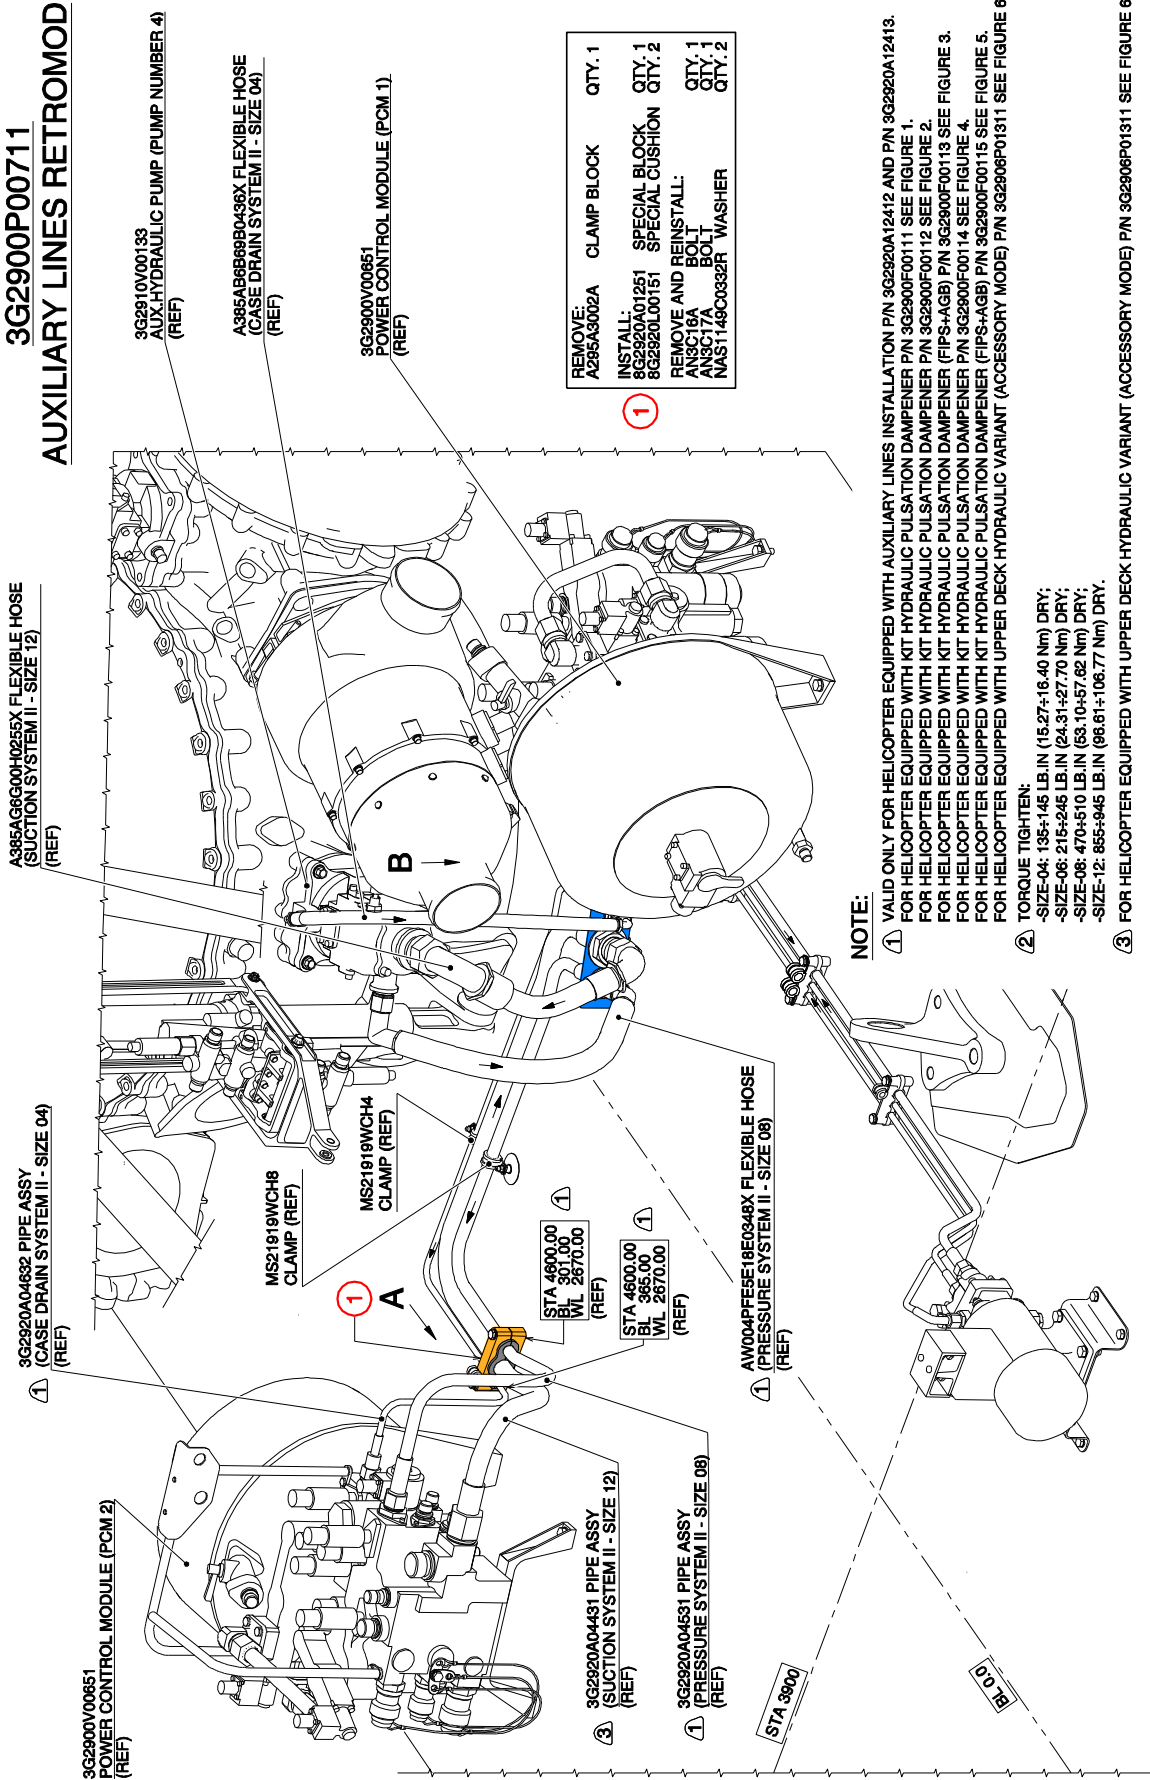
- 7.4 With reference to Figure 7, examine the following pipe assemblies for chafing:
- pipe assy P/N 3G2920A04531;
 - pipe assy P/N 3G2920A04431;
 - pipe assy P/N 3G2920A04632.

4. With reference to Figure 7, at position n°1, remove the clamp block P/N A295A3002A from the helicopter. Retain existing fixing hardware for later reuse.
5. With reference to Figure 7, remove the clamps P/N MS21919WCH8 and P/N MS21919WCH4. Retain for later reuse.
6. In accordance with AMP DM 39-A-12-12-09-00A-228A-A and with reference to Figures 1 thru 7, drain the PCM 2.

18. With reference to Figure 7 and Figure 8 View A, at position n°1, install the special block P/N 8G2920A01251 and n°2 special cushions P/N 8G2920L00151 by means of bolt P/N ANC16A, bolt P/N ANC17A and n°2 washers P/N NAS1149C0332R.
19. With reference to Figure 8 View A, coat exposed bolt heads with corrosion inhibitor TECTYL 891D (C385).
20. With reference to Figure 7, re-install the clamps P/N MS21919WCH8 and P/N MS21919WCH4.
