SERVICE BULLETIN

N° 139-728

DATE: October 11, 2022

ATA 64 – TAIL ROTOR DUPLEX BEARING REPETITIVE INSPECTIONS

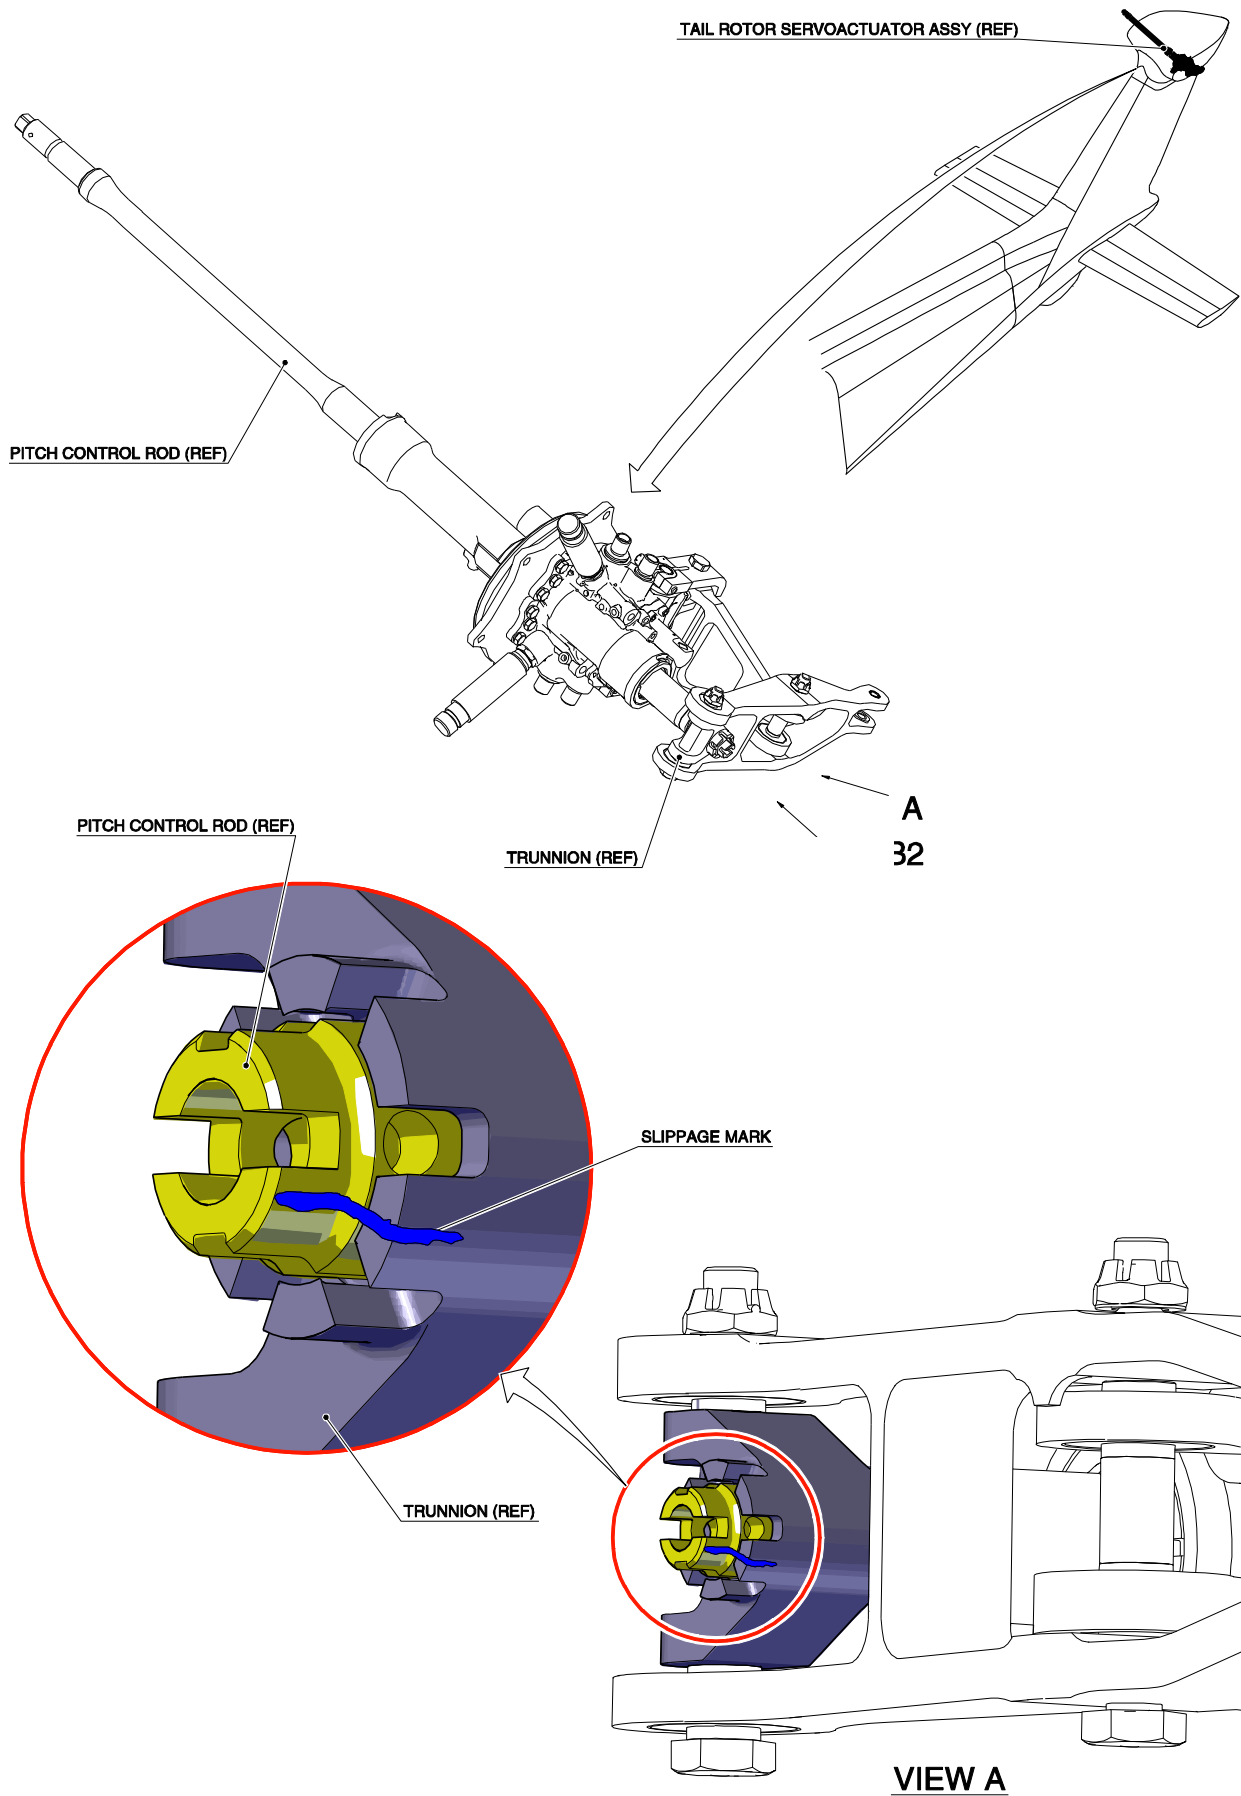
- 3.1.2 With reference to Figure 1 view A and in accordance with the applicable steps of AMP DM 39-A-20-00-00-00A-69CA-A apply a slippage mark on the mating edge between the trunnion and the pitch control rod on the rearward facing side, near the cotter pin.

- 3.2 If the slippage mark is present, with reference to Figure 1 view A, check for the alignment of the slippage mark. If rotation is found proceed to step 4, otherwise skip to step 5.
4. If rotation is found in step 3.1.1 or step 3.2, perform the following procedure before next flight:
 - 4.1 Take a picture of the back-end of the TRA, with clear evidence of the rotation.
 - 4.2 Fill in every part the Inspection Report in Figure 4.
 - 4.3 Submit the picture taken in step 4.1 and the Inspection Report filled in step 4.2 thru technical query on Leonardo WebPortal or to PSE (engineering.support.lhd@leonardo.com) for finding evaluation and to receive related maintenance actions.
5. Return the helicopter to flight configuration and record for compliance with Part I of this Service Bulletin on the helicopter logbook.
6. Send the attached compliance form to the following mail box:

2. In accordance with AMP DM 39-A-06-41-00-00A-010A-A and with reference to Figure 1, remove all external panels as required to gain access to the area affected by the inspection.

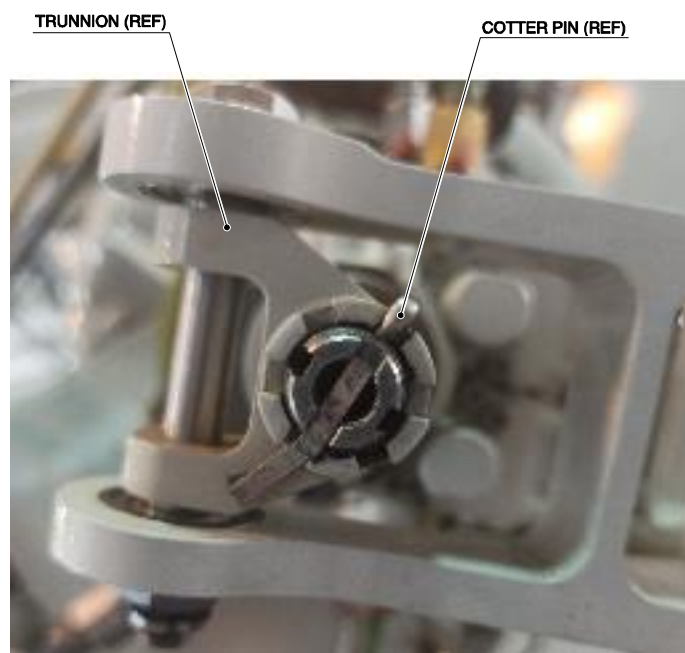
- 3.1.1 With reference to Figure 2 view B, check that the castellated holes of the trunnion are aligned with those of the pitch control rod that goes thru it and check that the cotter pin is perfectly straight and not bended by a rotation movement. If rotation is found skip to step 4.

CORRECT COTTER PIN INSTALLATION WITH NO SIGN OF ROTATION
VIEW B

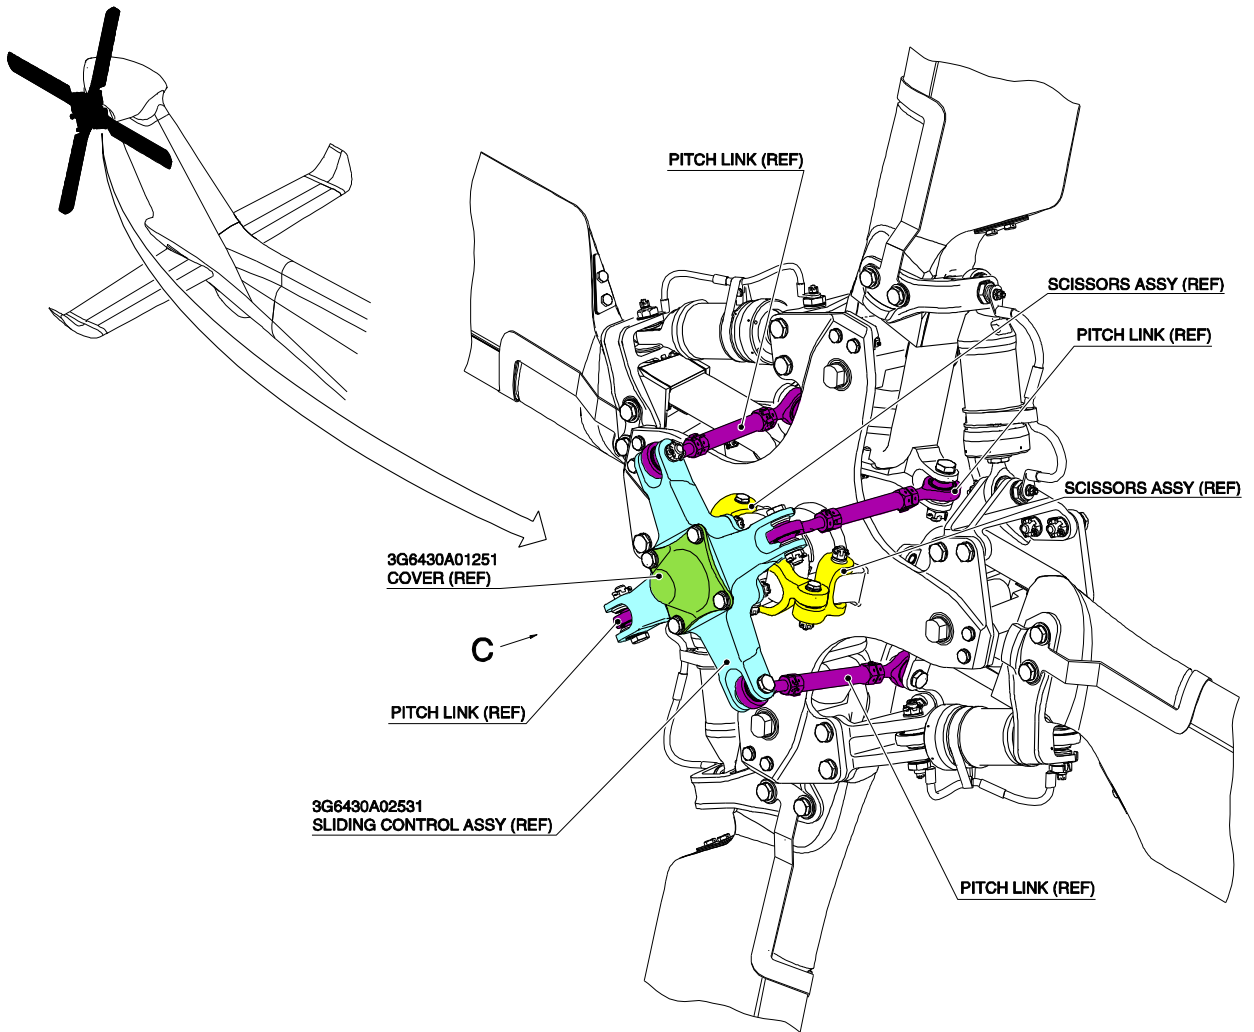
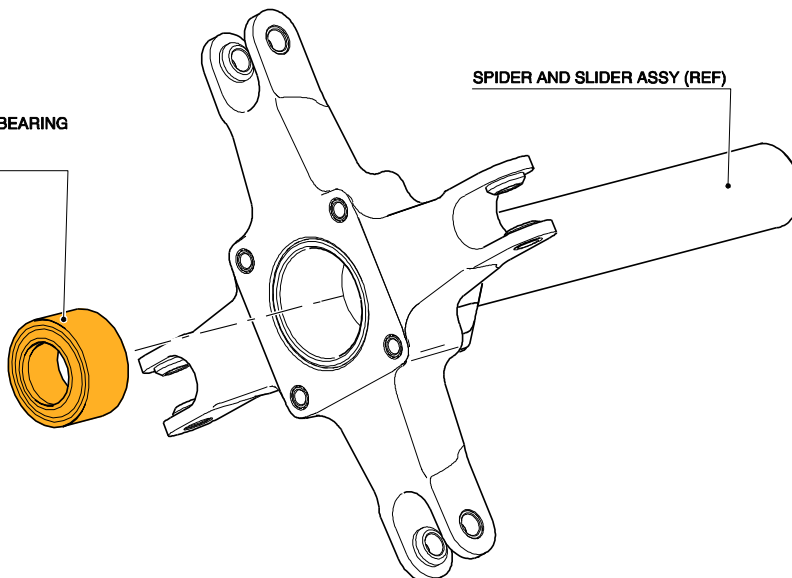
3. Perform the inspection of the TRDB in accordance with the following procedure:
 - 3.1 Inspect the visible parts of the TRDB (including the seals) for absence of wear, damages, corrosion; in case of findings skip to step 4, otherwise proceed to step 3.2.

- 3.2 Check the visible part of the TRDB for particles absence; if particles are present skip to step 4, otherwise proceed to step 3.3.
 - 3.3 Check for grease leakage on the visible part of the TRDB; if any leakage is present proceed to step 3.4, otherwise skip to step 5.

6. Check for absence of axial play when trying to move the spider back and forth along the PCR; if axial play is detected skip to step 9, otherwise proceed to step 7.

8. In accordance with AMP DM 39-A-64-31-04-01A-320A-B, perform the TRDB operation test and check for absence of roughness in its movement. If test fails proceed to step 9, otherwise skip to step 10.

- 4.2 In accordance with AMP DM 39-A-64-31-04-01A-921A-B and with reference to Figure 3 View C, replace the TRDB with a new item and send the removed one to LHD.

- 9.2 In accordance with AMP DM 39-A-64-31-04-01A-921A-B and with reference to Figure 3 View C, replace the TRDB with a new item and send the removed one to LHD.

REMOVE:
TAIL ROTOR DUPLEX BEARING
INSTALL:
NEW ITEM
