SERVICE BULLETIN

N° 139-738

ATA 53 – TAIL BOOM ASSY CORROSION PREVENTION IMPROVEMENT

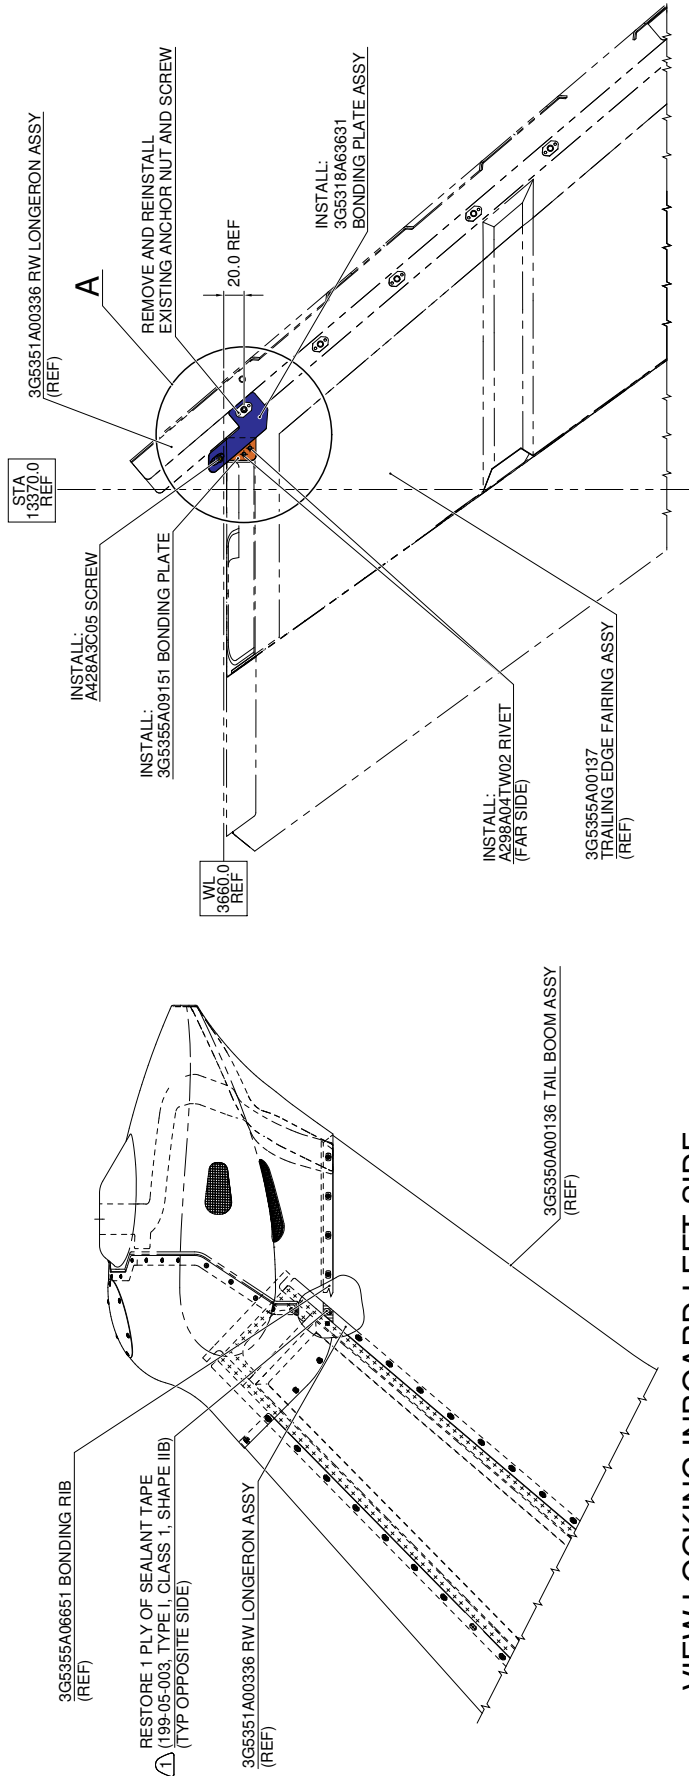
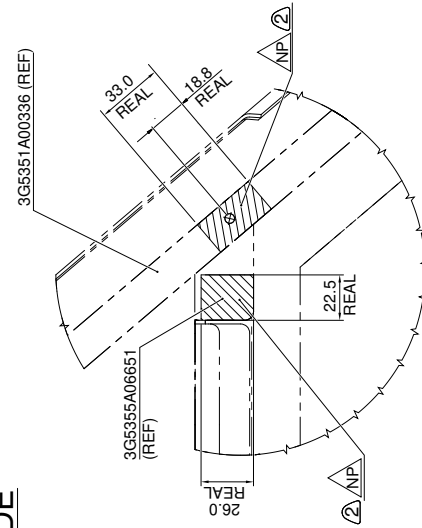
Due to the evidences received from the in-service fleet about recurrent corrosion problems in the area of tail boom assy, the main purpose of this Service Bulletin is to introduce some corrective improvements in order to avoid the formation of corrosion.

- ① RESTORE FINISHING SURFACE BETWEEN 3G5351A00336 RW LONGERON ASSY AND 3G5355A06651 BONDING RIB.
- ② REMOVE IN THE INDICATED AREA THE PROTECTIVE FINISH TO ASSURE GROUND CONTACT.

3. With reference to Figure 1 “View looking outboard left side”, remove existing anchor nut in the indicated position from the RW longeron assy P/N 3G5351A00336. Retain for later reuse.

4. In accordance with AMP DM 39-A-20-10-01-00A-259A-A and with reference to Figure 1 Detail A, prepare the indicated area on the RW longeron assy P/N 3G5351A00336 to assure the correct electrical bonding.

5. With reference to Figure 1 “View looking outboard left side”, install the bonding plate assy P/N 3G5318A63631 and the anchor nut previously removed (Ref. step 3) on the RW longeron assy P/N 3G5351A00336.

6. In accordance with AMP DM 39-A-20-10-01-00A-259A-A and with reference to Figure 1 Detail A, prepare the indicated area on the bonding rib P/N 3G5355A06651 to assure the correct electrical bonding.

7. With reference to Figure 1 "View looking outboard left side", install the bonding plate P/N 3G5355A09151 by means of n°2 rivets P/N A298A04TW02 on the trailing edge fairing assy P/N 3G5355A00137.

8. With reference to Figure 1 "View looking inboard left side", install n°1 ply of sealant tape (C405) to restore finishing surface between RW longeron assy P/N 3G5351A00336 and bonding rib P/N 3G5355A06651.

9. In accordance with AMP DM 39-A-06-41-00-00A-010A-A and with reference to Figure 1, reinstall the trailing edge fairing assy P/N 3G5355A00137 (access panel 360CL) on the tail boom assy. Use the screw P/N A428A08C05 to fix the bonding plate P/N 3G5355A09151 to the bonding plate assy P/N 3G5318A63631.
