SERVICE BULLETIN

N° **189-242**

REV. : A - July 9, 2020

ATA 62 - MAIN ROTOR (MR) BLADE TAPE INSTALLATION

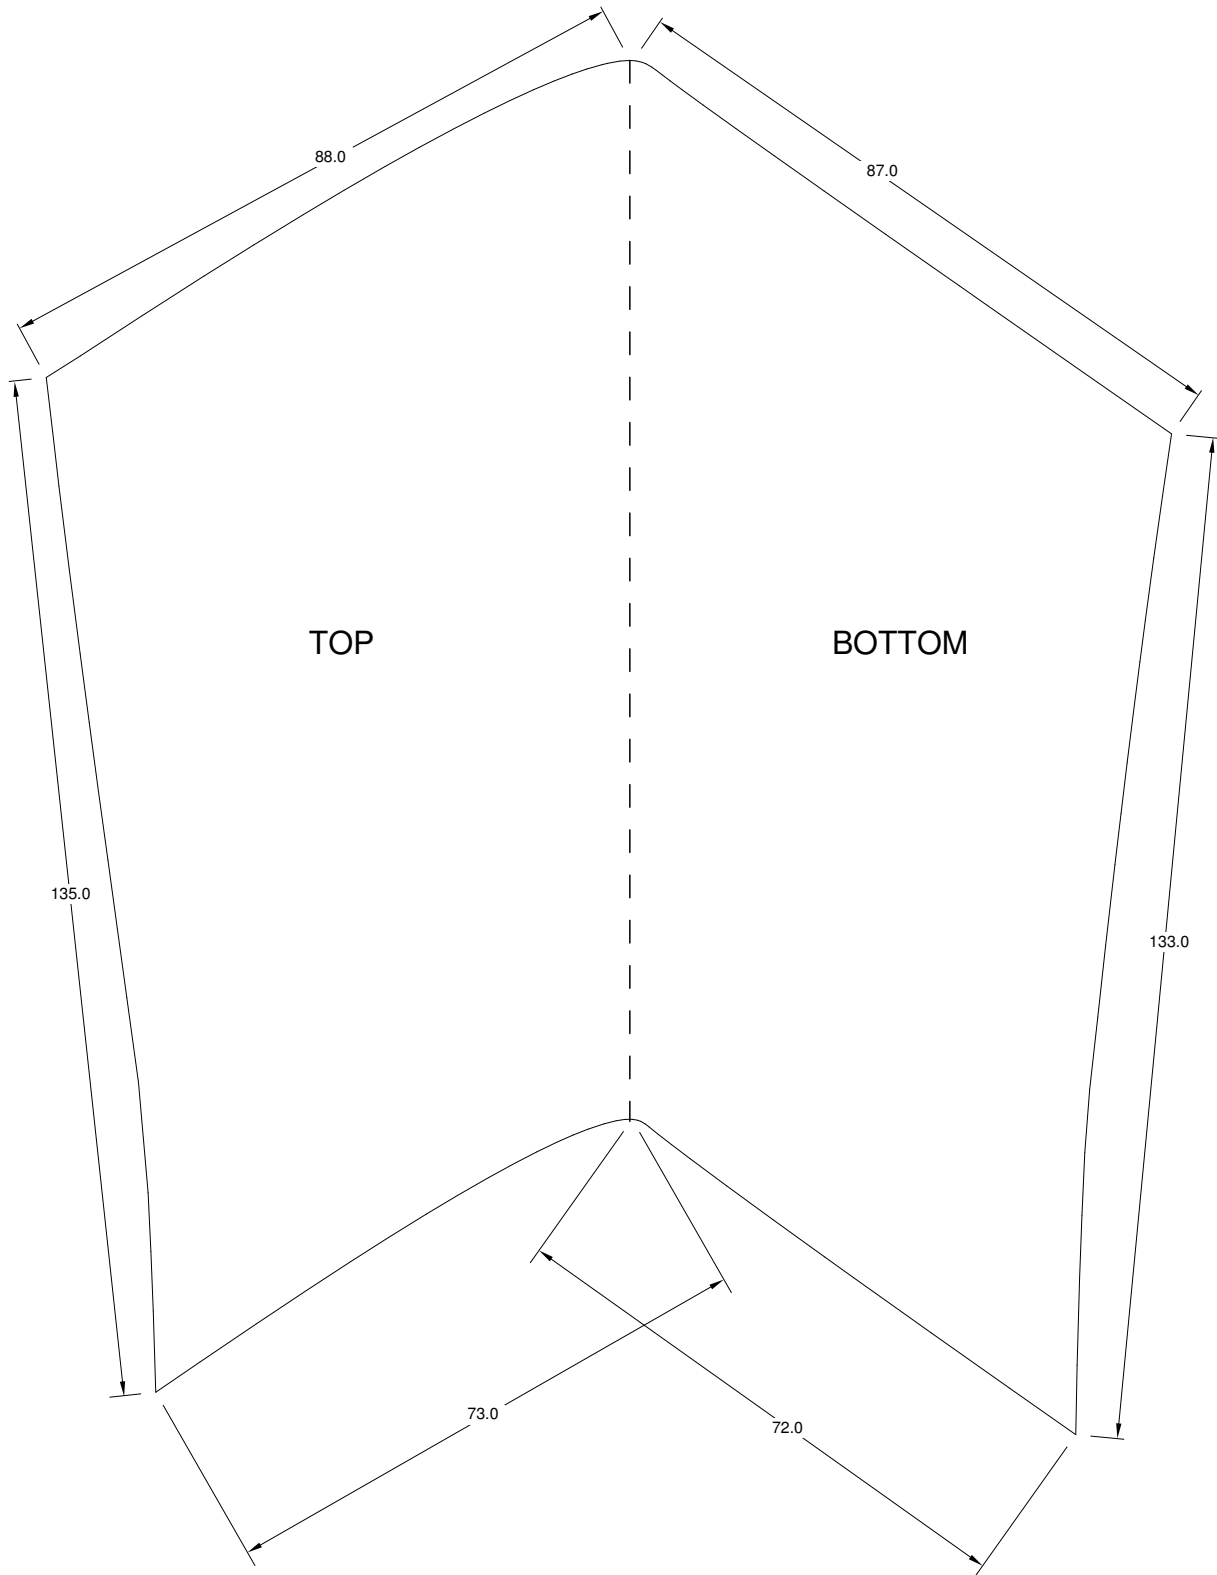
FLATTENED TAPE SHAPE

- 4.1 Print the template reported in Figure 1 with its real dimensions on an A4 size paper sheet; check the dimensions after the printing.
 - 4.2 Cut the polyurethane protective tape 8542HS using the template printed.

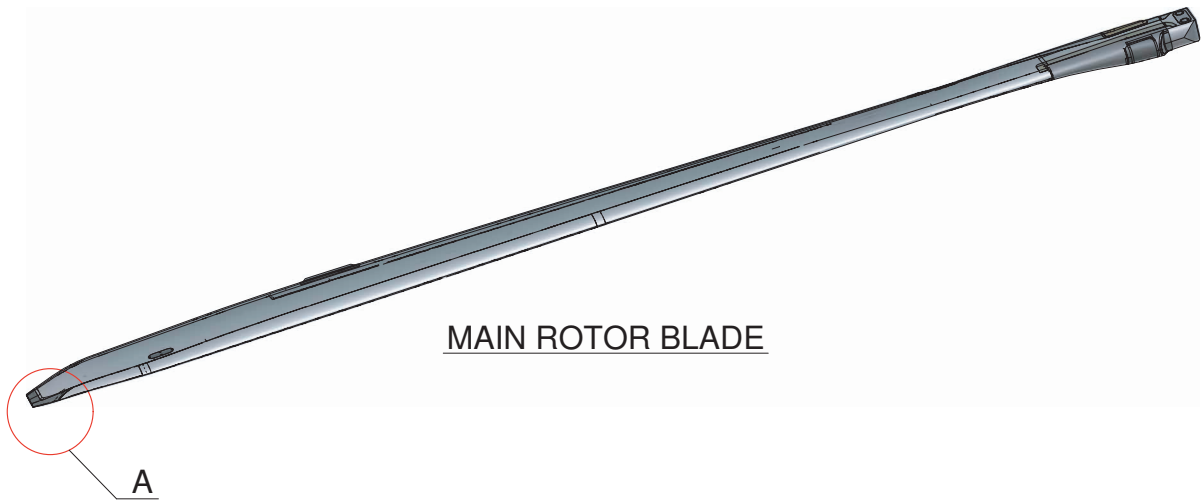
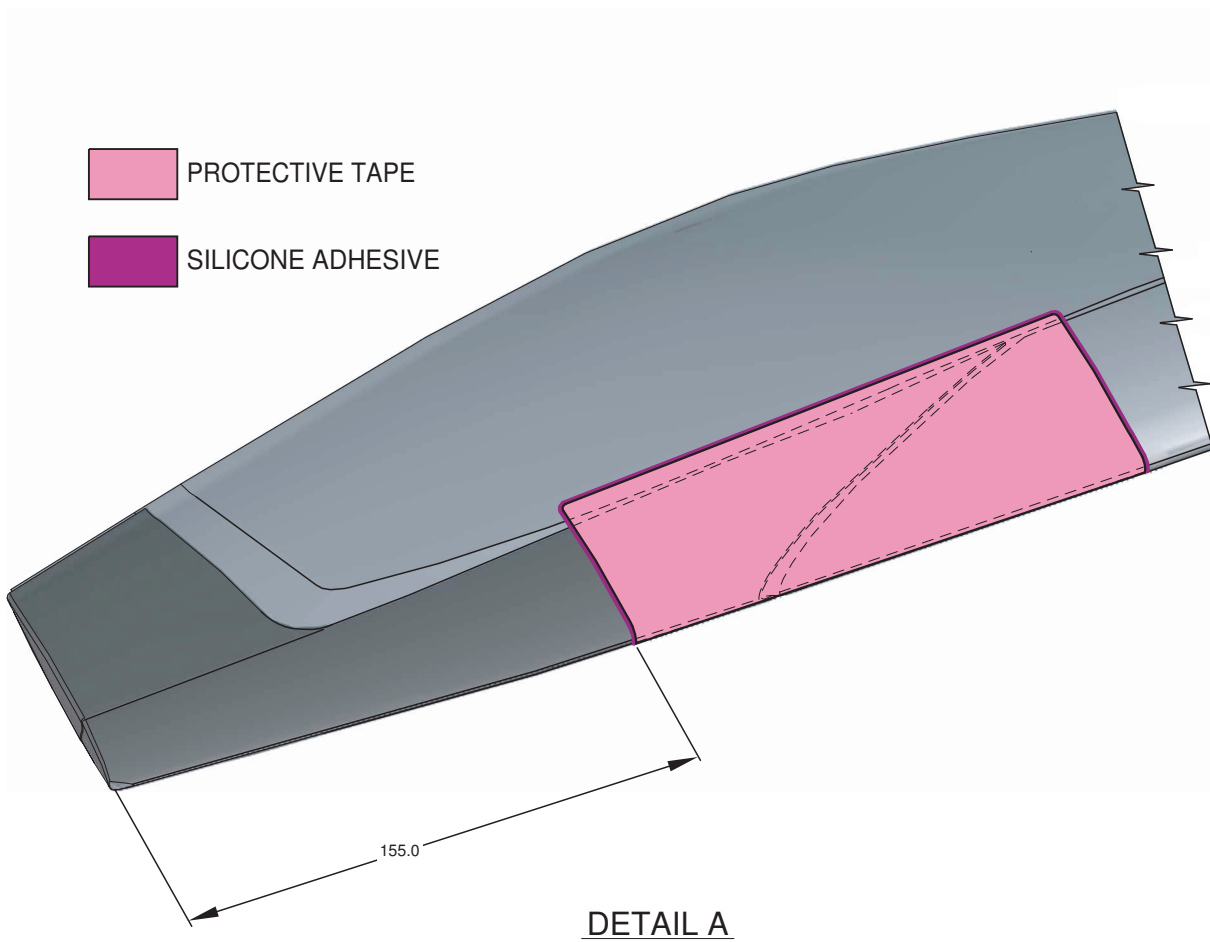
On the AW 189 MR blade it has been experienced some occurrences about filler-caulking eroded below forward edge between tip cap erosion shield and swept tip erosion shield. As preventive action a visual inspection of the filler-caulking has been scheduled every 50 FH (refer to SB189-243).

- 3.1 In accordance with applicable steps of AMP DM 89-A-62-11-01-00A-310A-A, perform a visual inspection of the tip cap area of each MR blade.
 - 3.2 With reference to Figure 2 and in accordance with AMP DM 89-A-62-11-01-01A-663A-B, if the caulking between tip erosion shield and tip swept erosion shield is not in good condition perform the procedure to restore it. Otherwise, skip to Step 4.

- 4.4 With reference to Figure 2, lay the patch, before removing the paper liner, on the upper surface of the blade. Position the outer side of the tape at 155 mm from the blade tip as shown.
- 4.5 Apply masking tape on the surfaces where you do not apply the polyurethane tape.
