SERVICE BULLETIN**N° 189-243****DATE:** October 29, 2019**REV. :** A - July 9, 2020

TITLE**ATA 62 - MAIN ROTOR (MR) BLADE TIP INSPECTION****REVISION LOG**

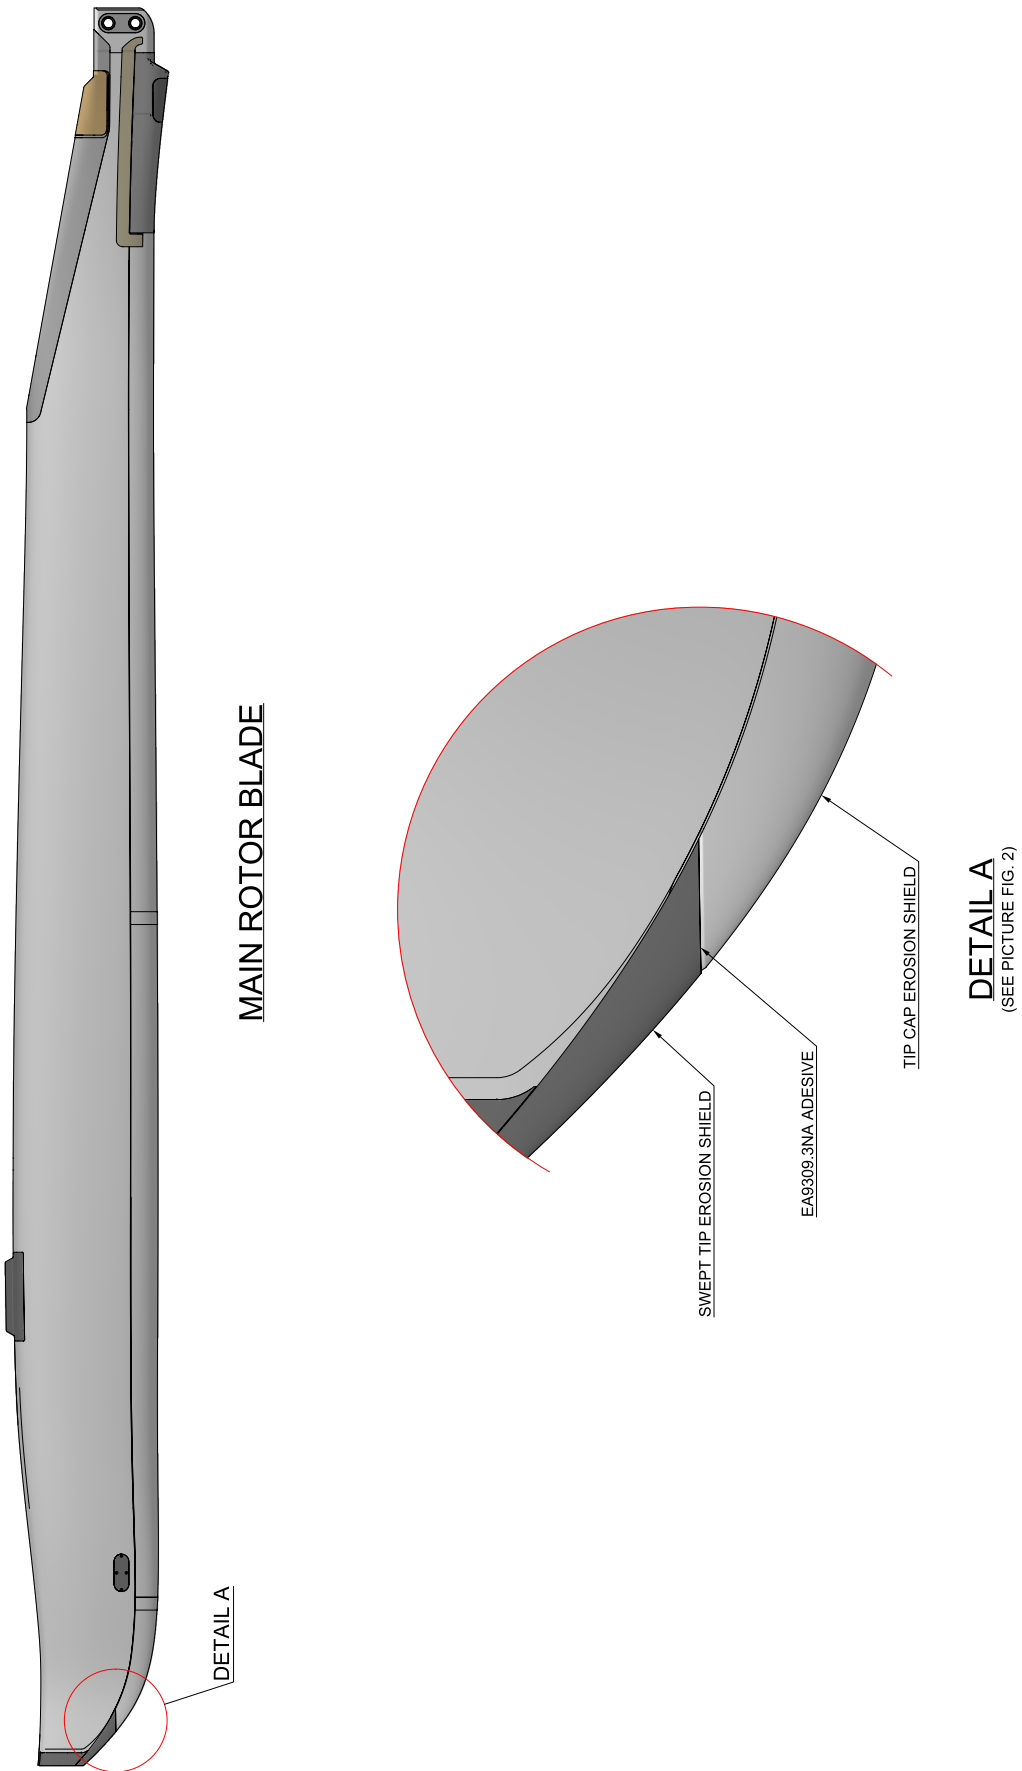
Figure 1

On the AW 189 MR blade it has been experienced some occurrences about filler-caulking eroded below forward edge between tip cap erosion shield and swept tip erosion shield. This Service Bulletin has been issued in order to prescribe a set of inspections and corrective actions to restore existing filler-caulking.

Typical filler / caulking eroded below forward edge between
tip cap erosion shield and swept tip erosion shield.

1. In accordance with AMP DM 89-A-00-20-00-00A-120A-A, prepare the helicopter on ground for a safe maintenance. Disconnect the battery, all electrical power sources and/or the external power supply.
2. With reference to Figure 1, Detail A, and Figure 2 and in accordance with applicable steps of AMP DM 89-A-62-11-01-00A-310A-A, perform a visual inspection of the tip cap area of each MR blade.
3. With reference to Figure 2 and in accordance with AMP DM 89-A-62-11-01-01A-663A-B, if the caulking between tip erosion shield and tip swept erosion shield is not in good condition perform the procedure to restore it. Otherwise, skip to Step 4.
4. Return the helicopter to flight configuration and record for compliance with Part I of this Service Bulletin on the helicopter logbook.
5. Send the attached compliance form to the following mail box:

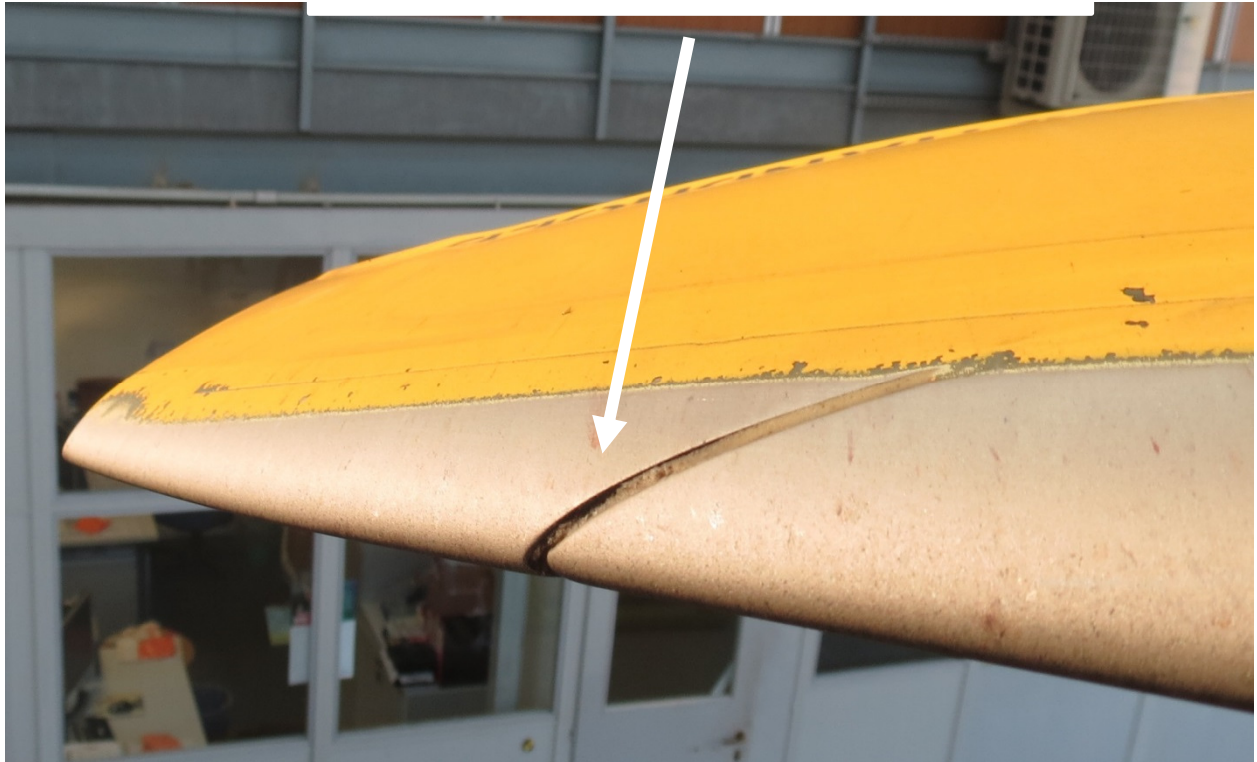
Figure 2

See Detail A Figure 1.
