AgustaWestland Products

SERVICE BULLETIN

_{N°} 189-245

ATA 33 - INSPECTION AND REINFORCEMENT OF SEARCHLIGHT SUPPORT

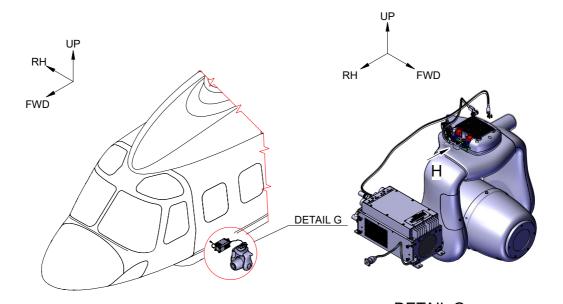
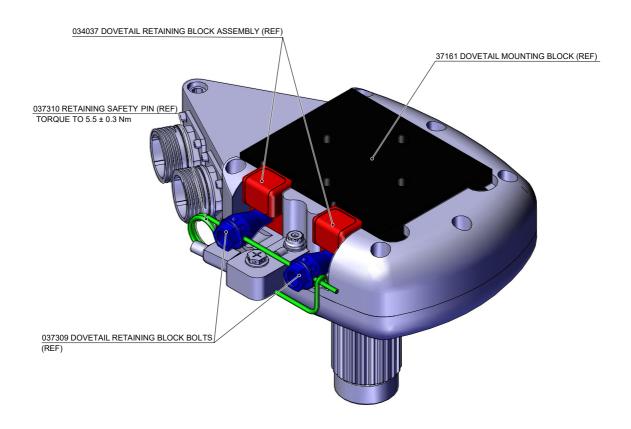
<u>Part II</u> provides the instructions on how to torque the bolt which fixes the lanyard to the dovetail assembly of the searchlight with the correct torque value.

- 1. In accordance with AMP DM 89-A-00-20-00-00A-120A-A, prepare the helicopter on ground for a safe maintenance. Disconnect the battery, all electrical power sources and/or the external power supply.
- 2. In accordance with AMP DM 89-A-06-41-00-00A-010A-A gain access to the area affected by the installation.
- 3. With reference to Figure 4 View H, remove and retain for later reuse the retaining safety pin P/N 037310.
- 4. With reference to Figure 4 View H, tighten the dovetail retaining block bolts P/N 037309 to a torque of 5.5 ± 0.3 Nm.

If the holes in the retaining bolts do not line up, tighten the two bolts until the holes line up and the safety pin can be inserted. Do not loosen the bolts or retaining them more than 6.5 Nm to achieve this.

- 5. With reference to Figure 4 View H, insert the retaining safety pin P/N 037310 through the matching holes in the heads of the dovetail retaining bolts P/N 037309 in the direction shown in the illustration.
- 6. Return the helicopter to flight configuration and record for compliance with Part II of this Service Bulletin on the helicopter logbook.
- 7. Send the attached compliance form to the following mail box:
