# SERVICE BULLETIN

# № **189-278**

**DATE:** February 18, 2021 **REV.:** A - July 27, 2021

ATA 21 - ECS ELECTRIC LINES CLIPPING MODIFICATION

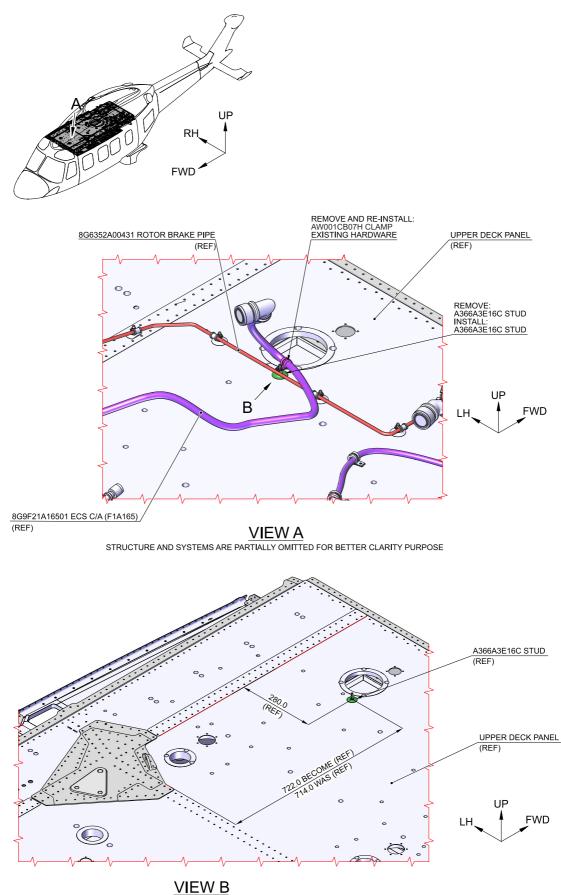
Leonardo Helicopters identified a possible interference on the upper deck between the rotor brake hydraulic line and a stud which is part of the ECS kit electrical harness clipping.

- In accordance with AMP DM 89-A-06-41-00-00A-010A-A and with reference to Figure 1, open the sliding cowling 451A and get access to the area affected to perform the repositioning of the stud P/N A366A3E16C:

- 2.1 With reference to Figure 1 View A, remove and retain the clamp P/N AW001CB07H and its fixing hardware from the existing stud P/N A366A3E16C.
  - 2.2 In accordance with the applicable steps of AMP DM 89-A-20-10-16-02A-920A-A and with reference to Figure 1 View A, remove the stud P/N A366A3E16C from the upper deck panel.

- 2.3 In accordance with the applicable steps of AMP DM 89-A-20-10-16-02A-920A-A and with reference to Figure 1 View A and View B, install the stud P/N A366A3E16C in the new position on the upper deck panel in accordance with the dimensions shown.

- 2.4 With reference to Figure 1 View A, re-install the clamp P/N AW001CB07H previously removed on the stud P/N A366A3E16C by means of the existing hardware.
