SERVICE BULLETIN

N° **189-279**

ATA 25 - EMERGENCY LIFE-RAFT SYSTEM, ONE-TIME INSPECTION OF ACTUATION SYSTEM

AERO SEKUR SERVICE BULLETIN SB-189-25-009 REV. 1 |

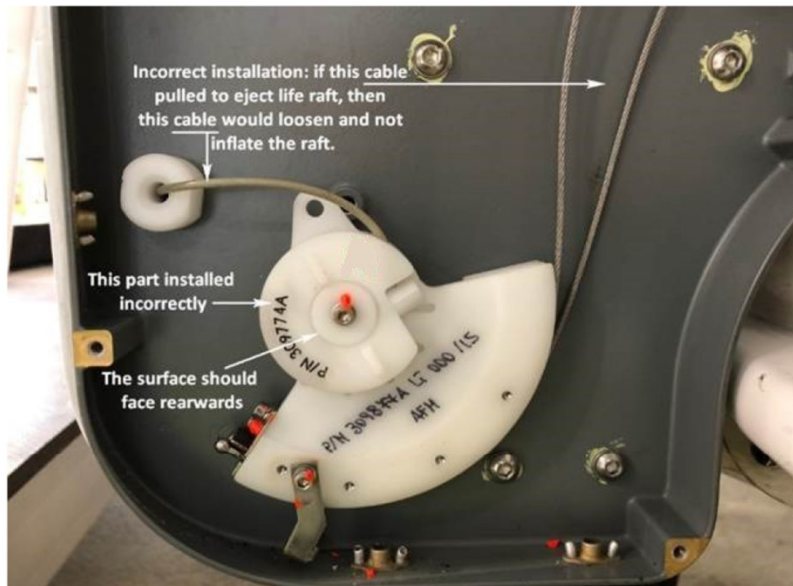
A case of incorrect installation of the raft actuation system on AW189 Emergency Liferaft System (ELS) has been reported, refer to Figure 1.

The Upper pulley P/N 309774A is a single component mounted specularly on both left-hand and right-hand ELS installations; this can lead to an incorrect installation of it and particular attention must be taken during assembly phase because its position on the Lower pulley varies for left-hand and right-hand installation. A not proper installation of the Upper pulley P/N 309774A and raft activation cable imply the incorrect functioning of the ELS in emergency condition.

Figure 1 – Incorrect installation on the RIGHT AW189ELS

- 2 Otherwise, if you see the part number on the upper pulley as, go to step (5).
- (5) In case of incorrect installation detected, refer to Service Bulletin 189-25-010 to replace the components incorrectly installed.

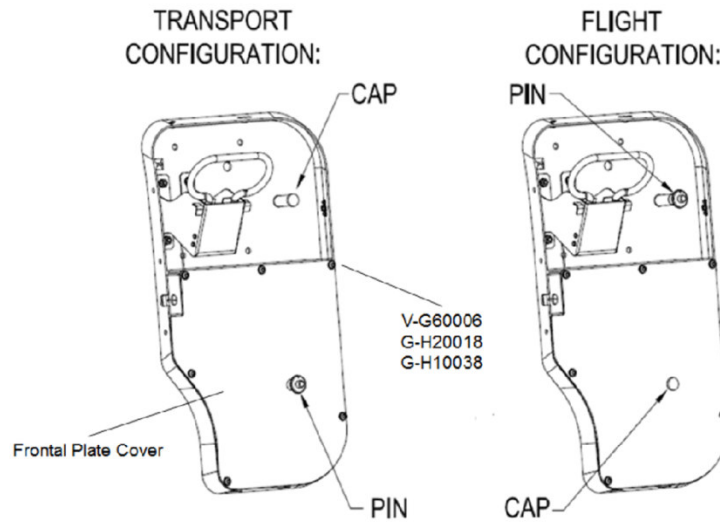
Figure 2 – Transport and flight configuration mode

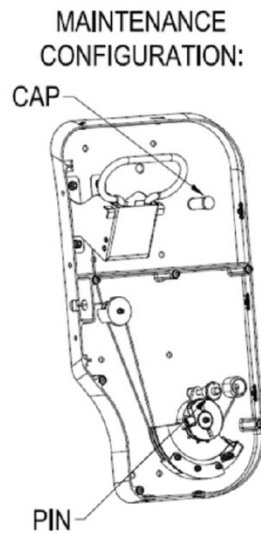
Figure 3 – Maintenance configuration mode

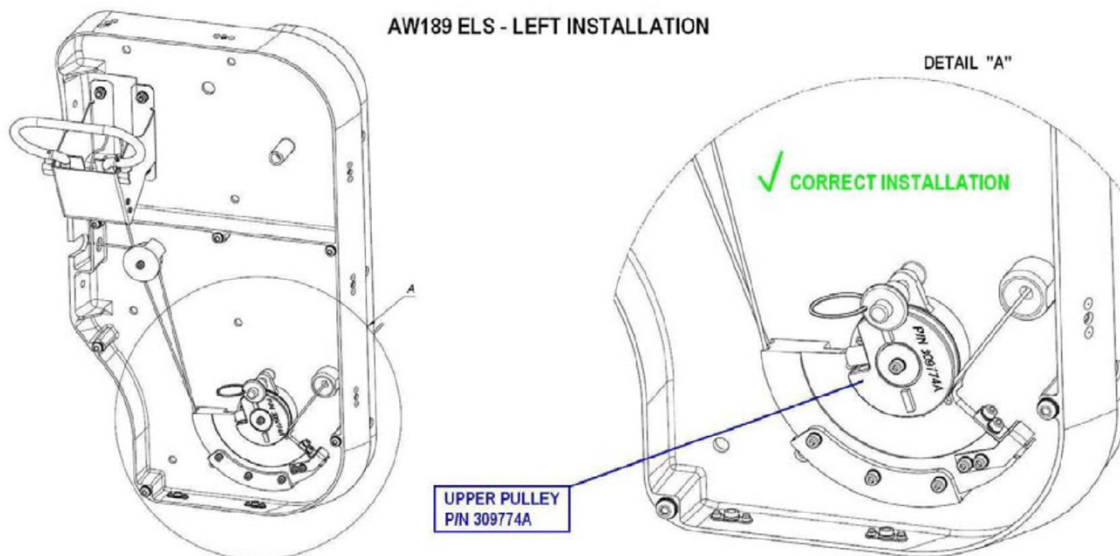
- (4) Visually inspect the installation of the raft actuation cable and the Upper pulley P/N 309774A, checking that:
 - (a) For Left Emergency Liferaft System, you must read the part number (P/N 309774A) of the Upper Pulley in case of correct installation; refer to Figure 4.
 - 1 If the raft actuation cable and the Upper pulley P/N 309774A are correctly installed as per Figure 4, skip to step (6).
 - 2 Otherwise, if you don't see the part number on the upper pulley, go to step (5).

The marked part number is showed on the Upper Pulley surface; So, the Part number is in-sight.

Figure 4 – Correct installation on LEFT AW189ELS

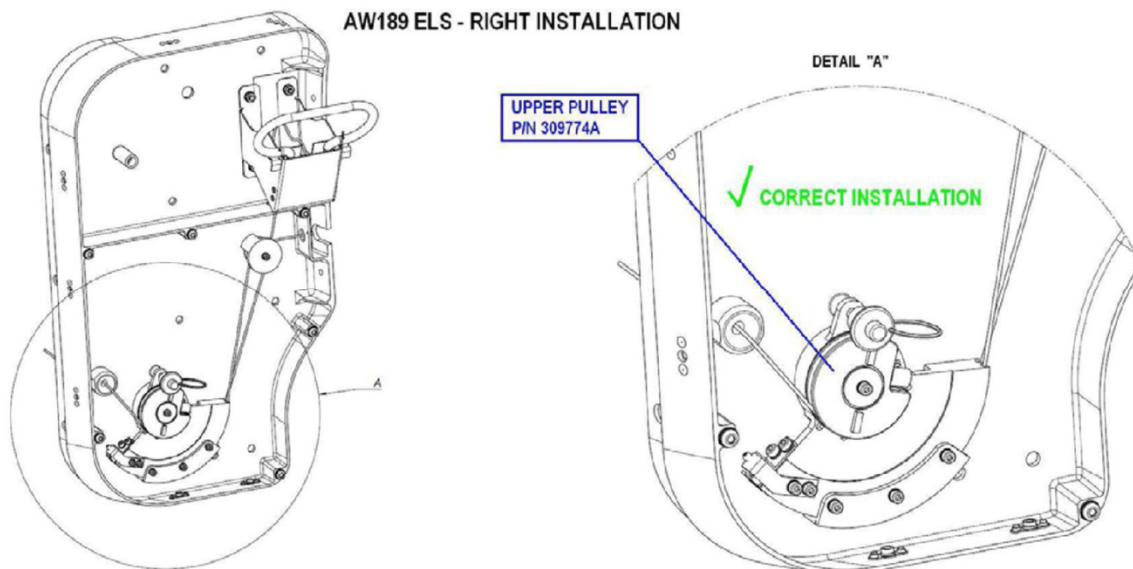
- (b) For Right Emergency Liferaft System, in case of correct installation, you cannot read the part number (P/N 309774A) of the Upper Pulley.
 - 1 If the raft actuation cable and the Upper pulley P/N 309774A are correctly installed as per Figure 5, skip to step (6).

The item part number is marked on the Upper Pulley surface mating with Lower Pulley; So, the Part number is not in-sight.

Figure 5 – Correct installation on RIGHT AW189ELS
