SERVICE BULLETIN

N° 189-279

ATA 25 - EMERGENCY LIFE-RAFT SYSTEM, ONE-TIME INSPECTION OF ACTUATION SYSTEM

AERO SEKUR SERVICE BULLETIN SB-189-25-009

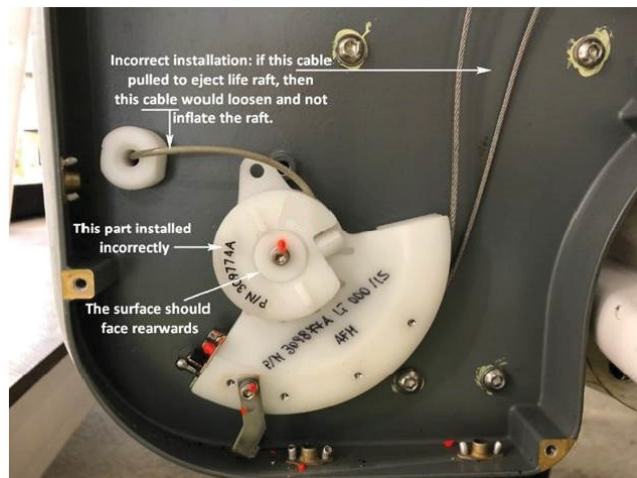
Figure 1 – Incorrect installation on the RIGHT AW189ELS

A case of incorrect installation of the raft actuation system on AW189 Emergency Liferaft System (ELS) has been reported, refer to Figure 1.

The Upper pulley P/N 309774A is a single component mounted specularly on both left-hand and right-hand ELS installations; this can lead to an incorrect installation of it and particular attention must be taken during assembly phase because its position on the Lower pulley varies for left-hand and right-hand installation. A not proper installation of the Upper pulley P/N 309774A and raft activation cable imply the incorrect functioning of the ELS in emergency condition.

(d) Remove the Upper pulley P/N 309774A from the Main bush P/N 309772A and re-install the Upper pulley P/N 309774A as detailed in Figure 3 for left ELS and Figure 4 for right ELS.

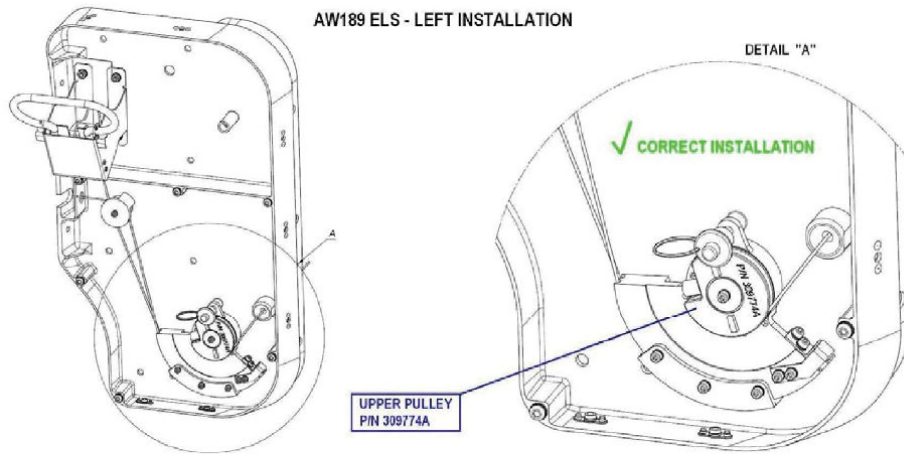
Figure 4 – Correct installation on LEFT AW189ELS

- (4) Visually inspect the installation of the raft actuation cable and the Upper pulley P/N 309774A, checking that:
 - (a) For Left Emergency Liferaft System, you must read the part number (P/N 309774A) of the Upper Pulley in case of correct installation; refer to Figure 4.

The marked part number is showed on the Upper Pulley surface: So, the Part number is in-sight.

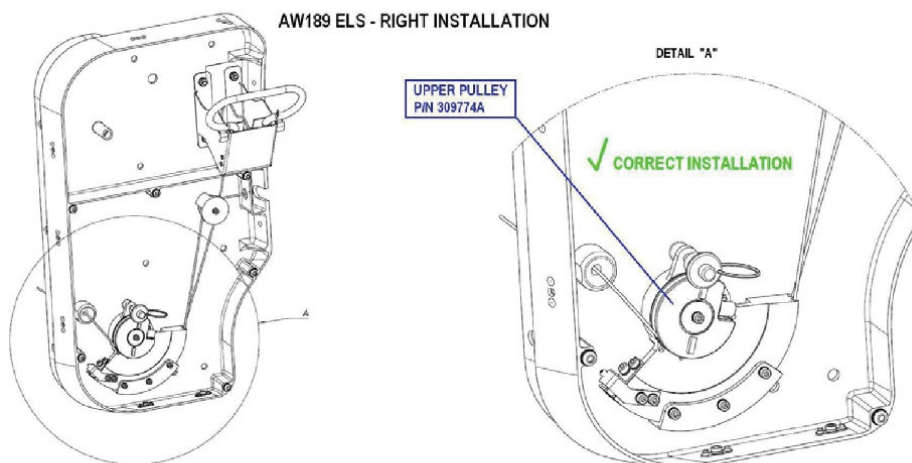
Figure 5 – Correct installation on RIGHT AW189ELS

- (b) For Right Emergency Liferaft System, in case of correct installation, you cannot read the part number (P/N 309774A) of the Upper Pulley.
 - 1 If the raft actuation cable and the Upper pulley P/N 309774A are correctly installed as per Figure 5, skip to step (6).

The item part number is marked on the Upper Pulley surface mating with Lower Pulley: So, the Part number is not in-sight.
