**SERVICE BULLETIN**

<sub>N°</sub> 189-299

**DATE:** May 15, 2023

ATA 53 - INTERMEDIATE GEARBOX HINGED ACCESS PANEL RETROMOD

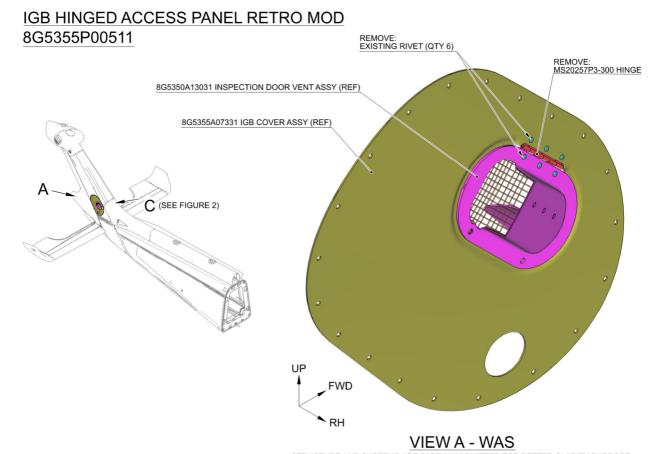
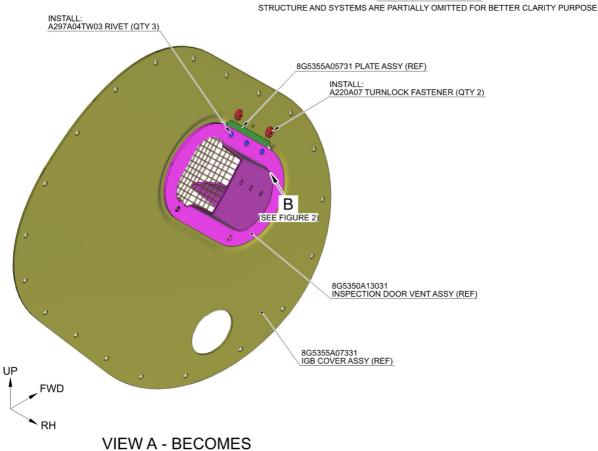
LHD receive a report of an IGB access panel found partially detached after a flight on an AW189 helicopters. The investigation showed that the damage has been caused by the failure of the hinge pins of the IGB access panel.

- 2. In accordance with AMP DM 89-A-06-41-00-00A-010A-A and with reference to Figures 1 and 2, remove from the helicopter the access panel 493A and install the IGB hinged access panel retromod P/N 8G5355P00511 as described in the following procedure:

- 2.1 With reference to Figure 1 View A "Was", remove the hinge P/N MS20257P3-300 and n°6 existing rivets from the IGB cover assy P/N 8G5355A07331 and the inspection door vent assy P/N 8G5350A13031.

- Apply a layer of sealant MC780 C (C465) on faying surfaces.
- Wet assemble fixing fasteners using sealant MC780 C (C465).
- 2.4 With reference to Figure 1 View A "Becomes" and Figure 2 View C, install the plate assy P/N 8G5355A05731 to the inspection door vent assy P/N 8G5350A13031 by means of n°3 rivets P/N A297A04TW03 and to the IGB cover assy P/N 8G5355A07331 by means of n°4 turnlock fasteners P/N A220A07.
- 3. In accordance with AMP DM 89-A-06-41-00-00A-010A-A, re-install the reworked access panel 493A.
- 4. Return the helicopter to flight configuration and record for compliance with this Service Bulletin on the helicopter logbook.
- 5. Gain access to My Communications section on Leonardo WebPortal and compile the "Service Bulletin Application Communication".
