SERVICE BULLETIN

N° 189-303

DATE: March 1, 2022

**ATA 25 - EMERGENCY LIFE-RAFT SYSTEM, ONE-TIME UPGRADE FOR ACTUATION
PULLEYS INSTALLATION**

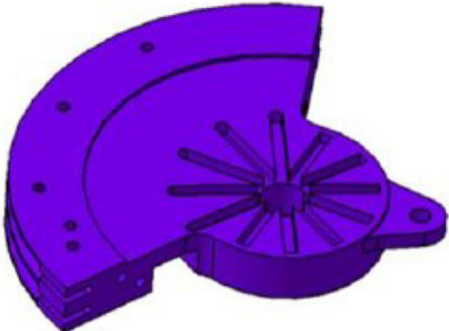
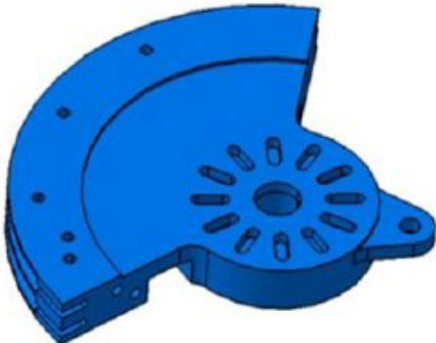
This Service Bulletin introduces the new configuration of actuation pulleys. The previous upper pulley P/N 309774A is a single component mounted specularly on both left-hand and right-hand for ELS installations; this can lead to an incorrect installation of it and special attention must be taken during assembly phase because its position on the Lower pulley varies for left-hand and right-hand installation. An improper installation of Upper pulley P/N 309774A and raft activation cable implies the incorrect functioning of the ELS in emergency condition.

<p style="text-align: right;">SYMMETRIC RIBS</p>

<p style="text-align: right;">ASYMMETRIC RIBS</p>
Upper Pulley P/N 309774A rev.B	Upper Pulley P/N 309774B rev.A

This Service Bulletin provides a new P/Ns for an upgrade kit, containing the new configuration of Upper and Lower Pulleys, to be used to replace the ones for the earlier configuration:
