SERVICE BULLETIN

N° 189-327

DATE: May 31, 2022

ATA 26 - DETECTOR FIRE INSTALLATION AUXILIARY POWER UNIT RETROMOD

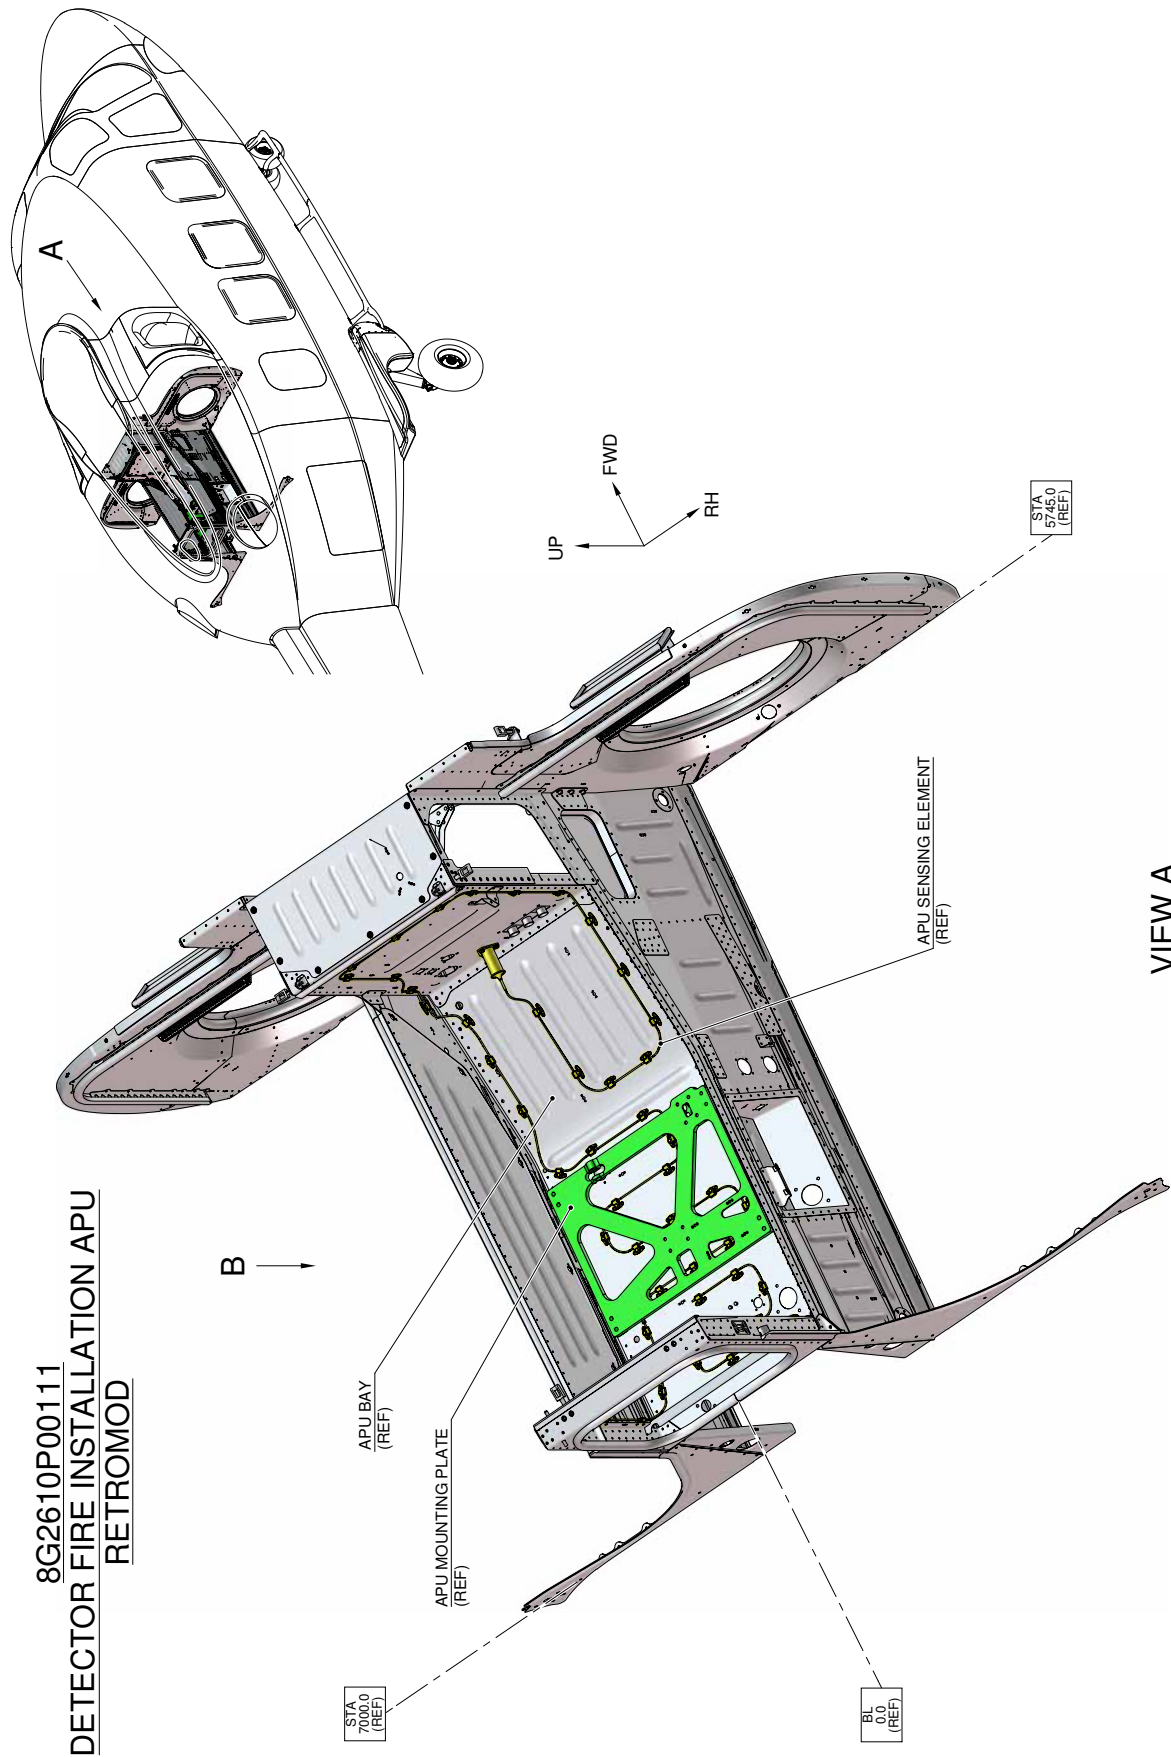
Figure 1

4. With reference to Figure 1, perform an inspection of the APU fire detector sensing element as described in the following procedure:
 - 4.1 Perform a visual inspection of the APU sensing element. Make sure that it is not damaged.
 - 4.2 If the APU sensing element is damaged, verify if the “APU FIRE DET” caution and “APU FIRE DET” maintenance message have been generated on the helicopter; if so, proceed with the following step, otherwise skip to Step 5.
 - 4.3 In accordance with AMP DM 89-A-26-14-01-00A-520A-A, remove the APU sensing element from the helicopter. Discard the APU sensing element.
 - 4.4 In accordance with AMP DM 89-A-26-14-01-00A-720A-A, install a new APU sensing element P/N 6360-24-450/170C-6M on the helicopter.

5. With reference to Figures 1 and 2, install n°10 sensor bushings P/N 3106 by means of sealing compound DAPCO 2100 (C095) in the indicated positions on the APU sensing element. Sealant RTV106 can be used as alternative to DAPCO 2100.
6. In accordance with AMP DM 89-A-49-11-01-00A-720A-A, re-install the auxiliary power unit on the helicopter.
7. Return the helicopter to flight configuration and record for compliance with this Service Bulletin on the helicopter logbook.
8. Send the attached compliance form to the following mail box:

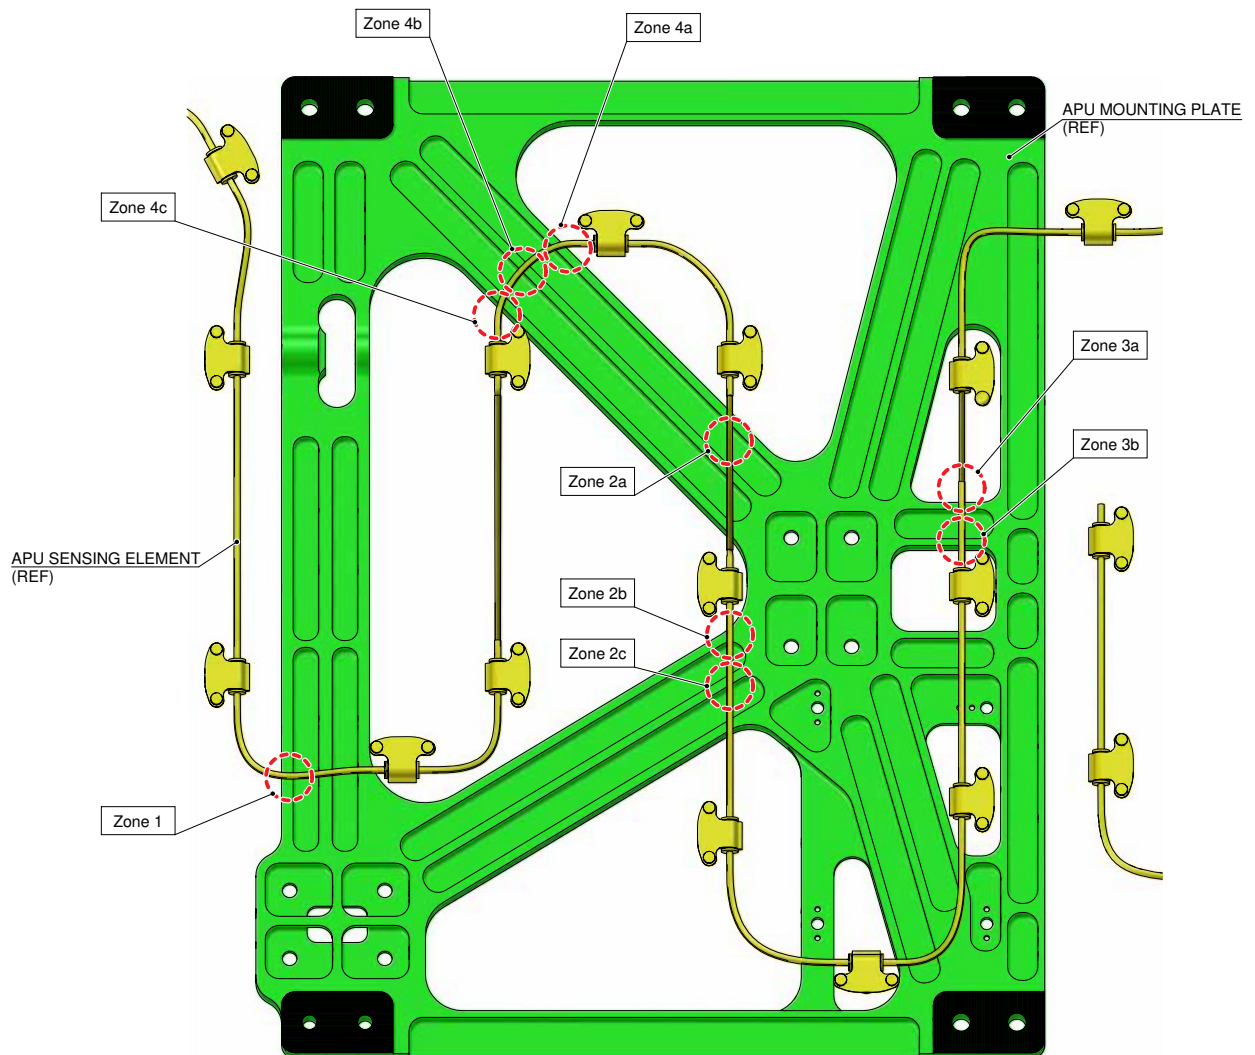
- 3.2 Check for damage to the APU mounting plate in the indicated areas of possible contact between the APU mounting plate and the APU sensing element.

Zone	MAXIMUM DAMAGE DEPTHS (mm)
1	1.00
2a	0.80
2b	0.20
2c	0.40
3a	1.00
3b	1.00
4a	0.15
4b	0.12
4c	0.10

DETAIL D
DAMAGE ZONE LOCATIONS
 (VIEW LOOKING AT THE APU MOUNTING PLATE FROM THE BOTTOM)
 STRUCTURES AND SYSTEMS ARE PARTIALLY
 OMITTED FOR BETTER CLARITY PURPOSE

- 3.3.2 If the damage found is within the allowable limits specified on the table in the Figure 3 skip to Step 3.4. Otherwise proceed with the following step.

- 3.3.4 Discard the damaged APU mounting plate.
 - 3.4 In accordance with the applicable steps of AMP DM 89-A-49-11-01-00A-721A-B, install the APU mounting plate assy P/N 8G4910A00332 on the auxiliary power unit.
