SERVICE BULLETIN

N° 189-331

DATE: June 20, 2022

ATA 24 - NUMBER 1 VOLTAGE CONVERTER UNIT TIGHTENING TORQUE CALIBRATION

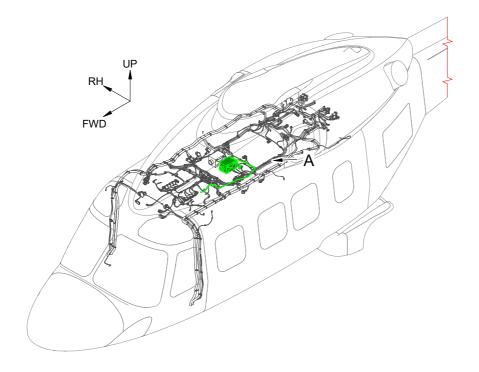
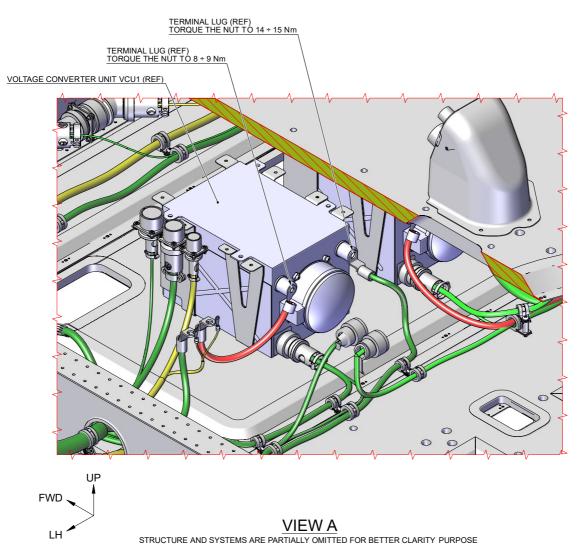
This Service Bulletin is issued in order to provide the necessary instructions on how to apply the right tightening torques to the terminal lug nuts on the Number 1 Voltage Converter Unit (VCU).

LHD received a report about omitted tightening torque calibration procedure on Number 1 VCU on a batch of production helicopters.

The missing application of this SB does not have any effects on the safety of operation but could lead to a degradation of the electrical performance.

- 2.1 In accordance with applicable steps of AMP DM 89-A-24-31-01-00A-520A-A and with reference to Figure 1 View A, get access to VCU 1 and temporarily remove the indicated nuts from the two terminal lugs.

- 2.2 In accordance with applicable steps of AMP DM 89-A-24-31-01-00A-720A-A and with reference to Figure 1 View A, reinstall the previously removed nuts on the terminal lugs and tighten them to the correct torque value.
