SERVICE BULLETIN

N° 189-345

DATE: April 13, 2023

ATA 63 - MGB ROD ASSY RETROMOD INSTALLATION

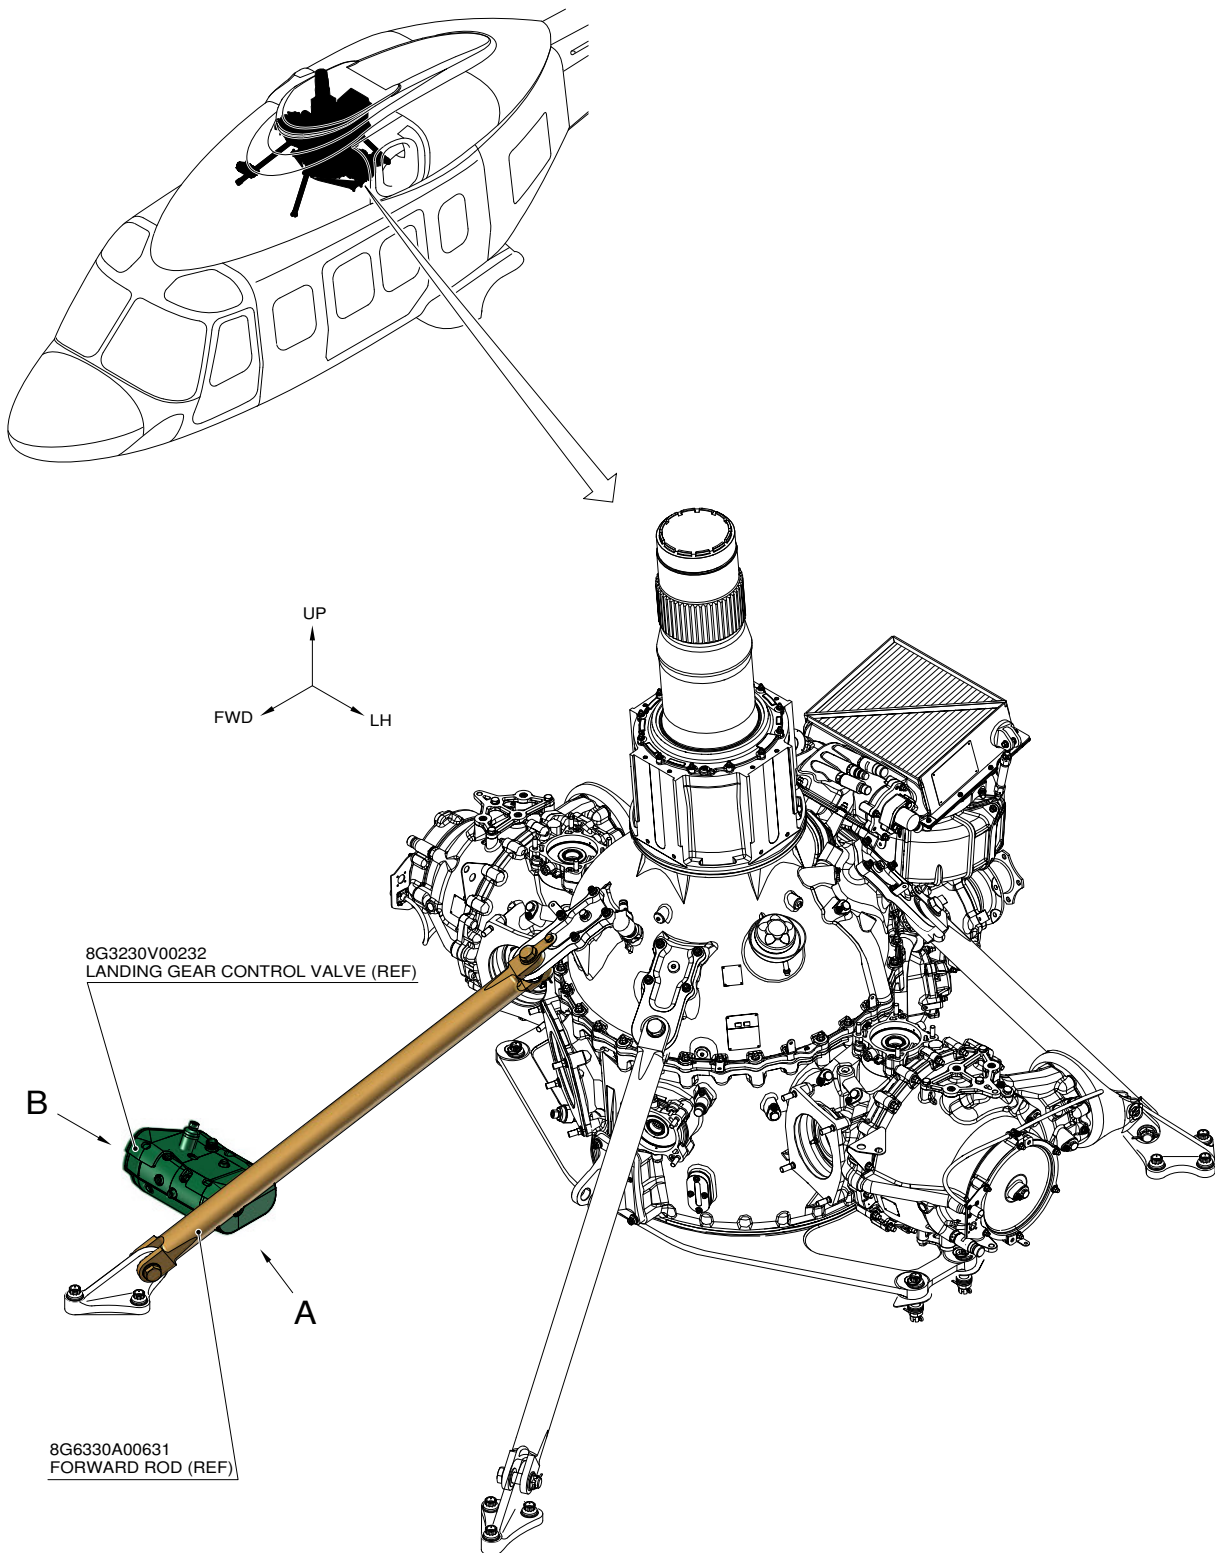
Figure 1

2. In accordance with AMP DM 89-A-06-41-00-00A-010A-A and with reference to Figure 1, open the access door 451A to gain access to the “MGB forward rod assy RH” P/N 8G6330A00631.

- 4.3 If the depth measured in the Step 4.2 exceeds 0.25 mm, perform the following procedure:
 - 4.3.1 In accordance with AMP DM 89-A-63-31-03-00A-520A-A and with reference to Figure 1, remove the “MGB forward rod assy RH” P/N 8G6330A00631.

- 4.3.2 In accordance with AMP DM 89-A-63-31-03-00A-720A-A and with reference to Figure 1, install a new rod P/N 8G6330A00631 by means of the previously removed hardware. Skip to Step 5.

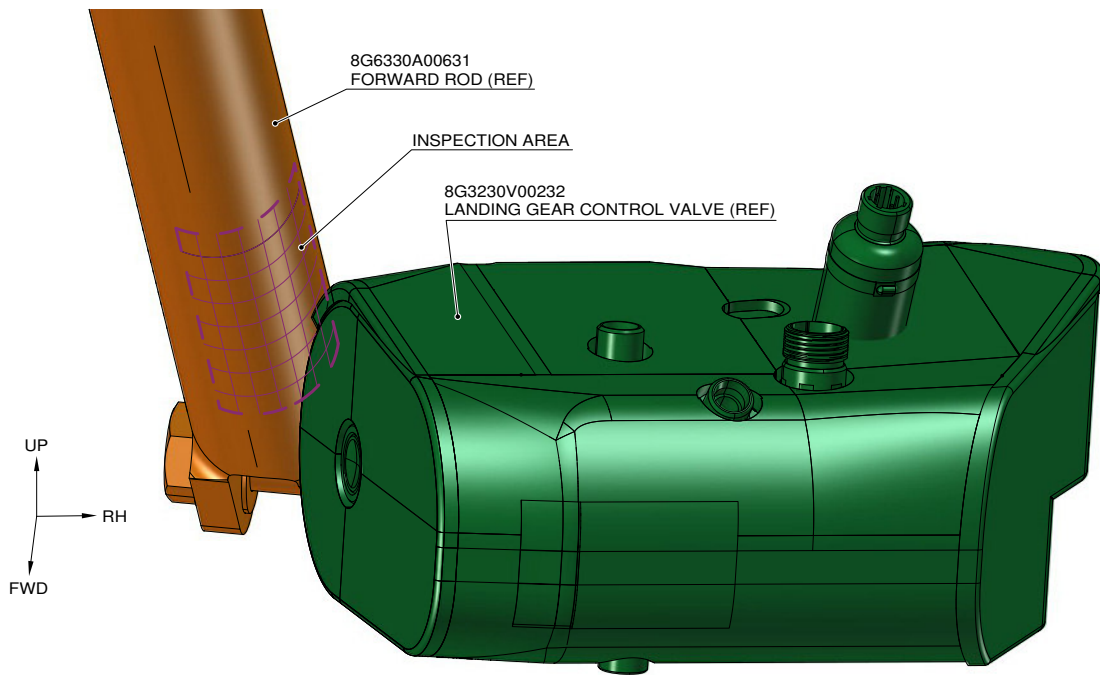
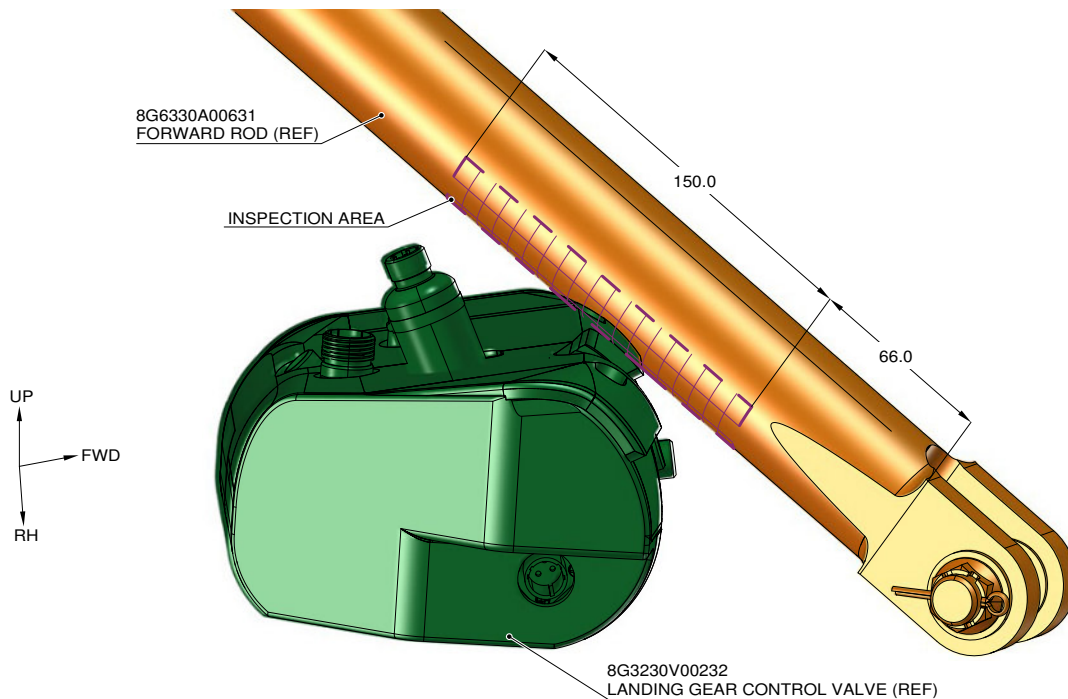
Figure 2

LHD received a few reports from Customers about the MGB forward rod assy RH P/N 8G6330A00631 slightly worn by the cover of the Landing Gear Control Valve (LGCV) P/N 8G3230V00232.

3. With reference to Figure 2, visually inspect the indicated area for evidence of wear or damage on the “MGB forward rod assy RH” P/N 8G6330A00631. If necessary, use a mirror and a source of light to completely inspect the area. If no damage is present, skip to Step 5.

4. In case of findings, perform the following procedures:
 - 4.1 Take a picture of the damage and of the LGCV installed (including the cover). Send the pictures to Leonardo Engineering Dept. at the following mail box: engineering.support.lhd@leonardo.com.

- 4.2 Measure the depth of the wear or damage in the MGB rod (do not consider the thickness of paint/primer). Note the value in the Inspection Report in Figure 4.

- 4.4 If the depth measured in the Step 4.2 is less than 0.25 mm, touch-up the exposed areas of the repaired zones with primer and paint to restore the original aspect of the MGB road in the damaged area, then proceed with Step 5.
