**SERVICE BULLETIN****N° 109EP-175****ALERT****DATE:** April 26, 2021**REV. :** A - May 18, 2021

**TITLE****ATA 64 - INSPECTION OF TAIL ROTOR SHAFT ASSY P/N 109-0445-08-(ALL DASHES)  
AND TAIL ROTOR SLEEVE ASSY P/N 109-0130-90-117/-121****REVISION LOG**

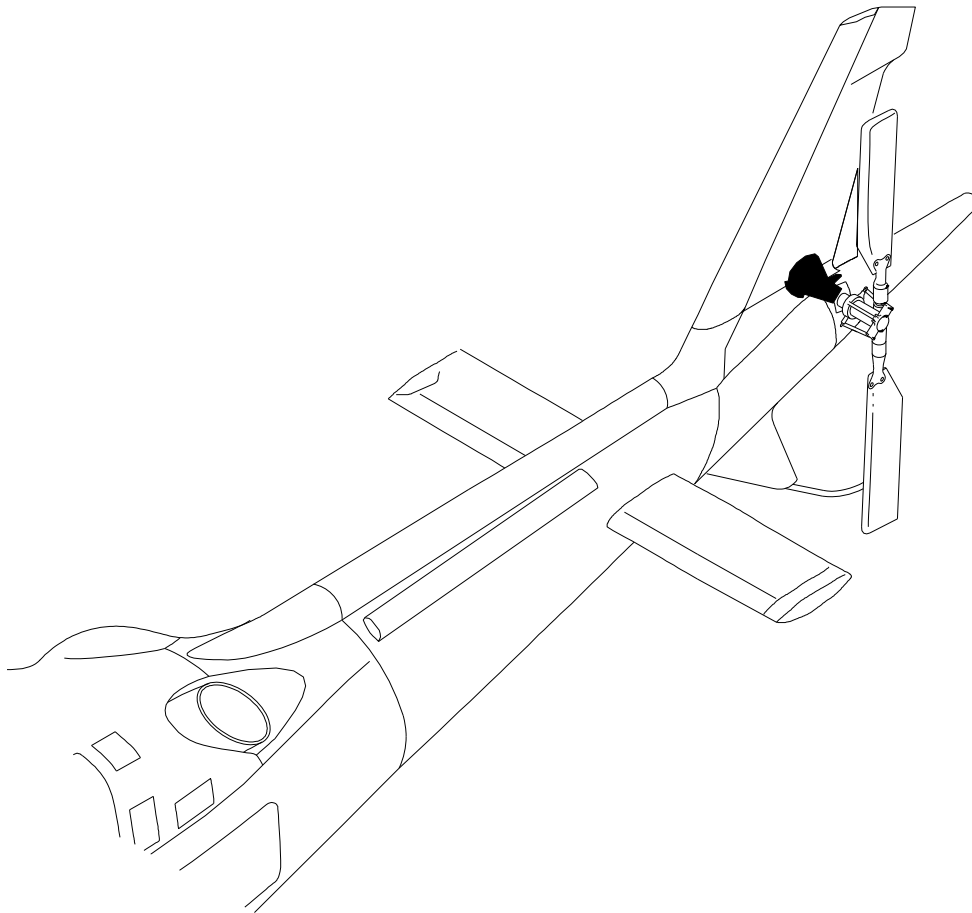
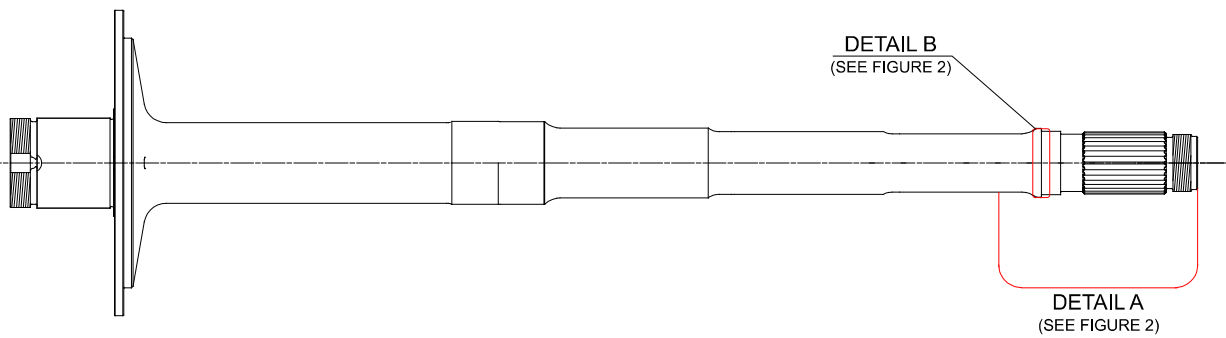
**Figure 1**

During tail rotor system inspections required after an abnormal vibration event, an extensive crack has been found on the tail rotor mast of an A109E helicopter at the interface with the tail rotor sleeve. In order to assure the airworthiness of the fleet and to collect data for the investigation, LH decided to issue this SB to perform (Part I) a tail rotor and mast visual inspection together with a dye penetrant fluorescent liquid inspection in the area potentially affected by the issue and (Part II) a recurrent check for condition of the TR sleeve bushing. In case of sleeve bushing debonding is found, instructions are given to replace it (Part III). Part IV provides instruction to restore, if necessary, solid lubricant protection on the area inspected with dye penetrant fluorescent liquid.

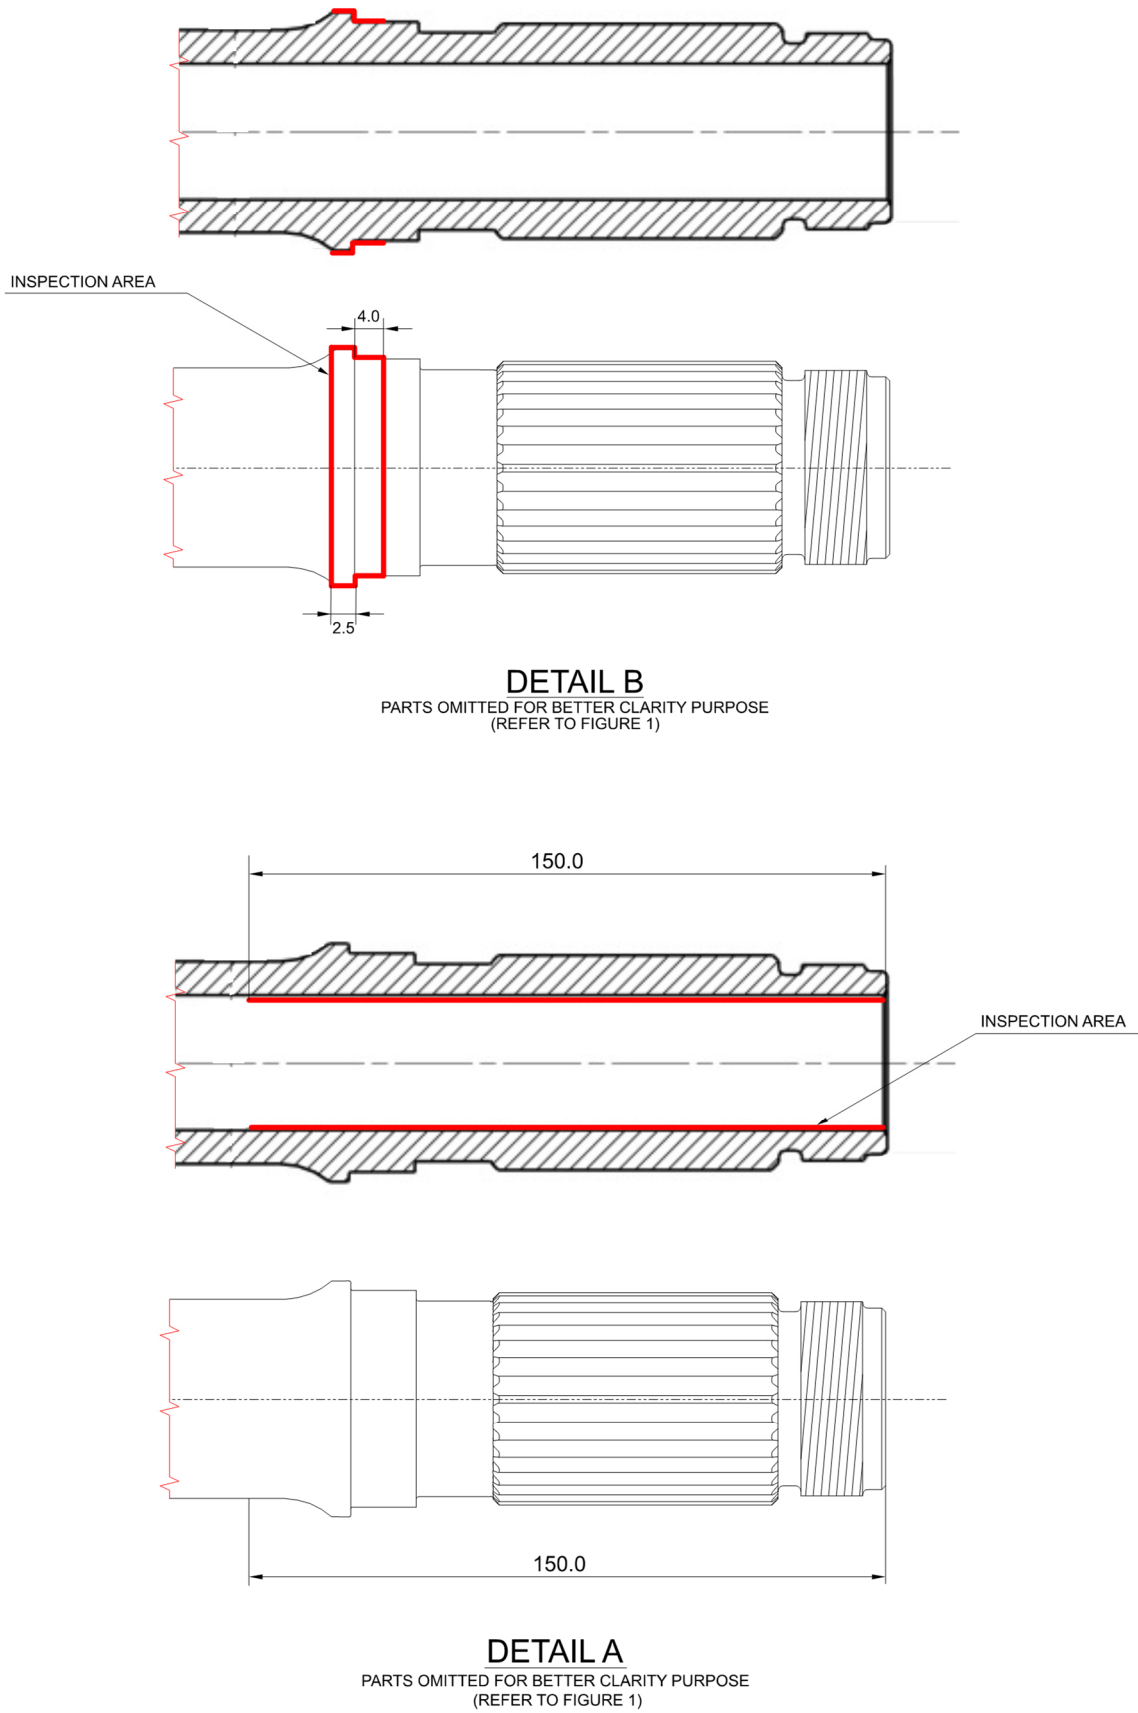
**Figure 2**

1. During application of tail rotor gearbox 400 FH scheduled inspection, with reference to Figure 2 Detail B, verify the presence of solid film lubricant on “inspection area” (it should be present only on the “4.0mm section” and on vertical side of shoulder). If necessary, restore the layer of solid film lubricant MIL-L-23398 Type II as follows:
  - 1.1 Mask off surrounding areas near the inspection zone (Figure 2, Detail B) with adhesive Aluminium tape.
  - 1.2 Clean the part with a clean cloth soaked with Class 2 solvent listed in QPL-AMS-2644.
  - 1.3 In accordance with CPCP 20-70-10, touch up where necessary with solid film lubricant with MIL-L-23398 Type II product.
2. Record for compliance with Part IV of this Service Bulletin on the helicopter logbook.
3. Send the attached compliance form to the following mail box:

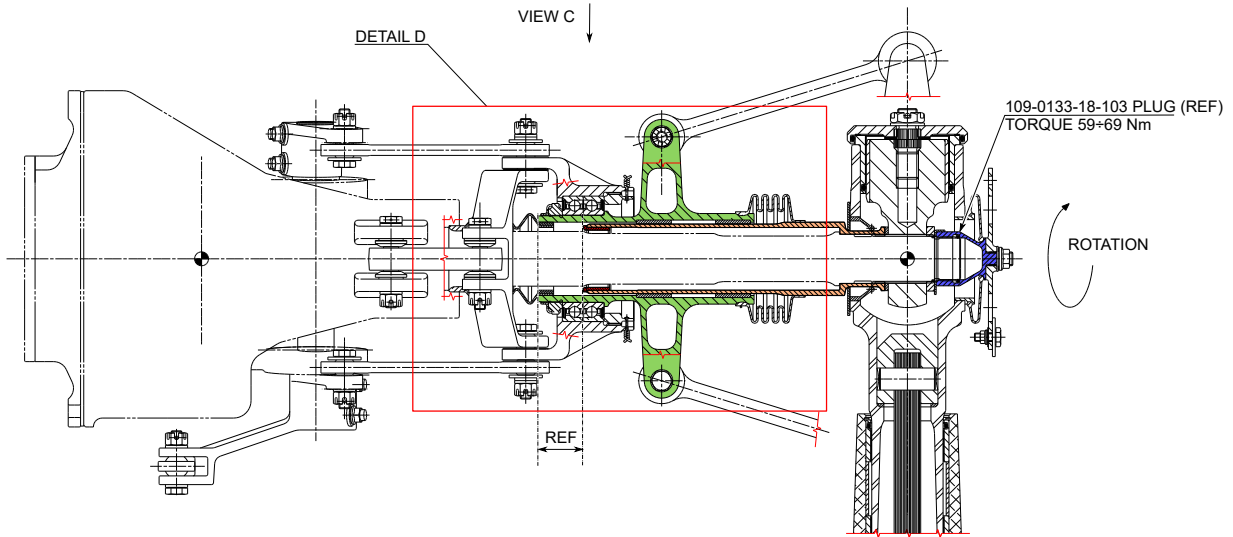
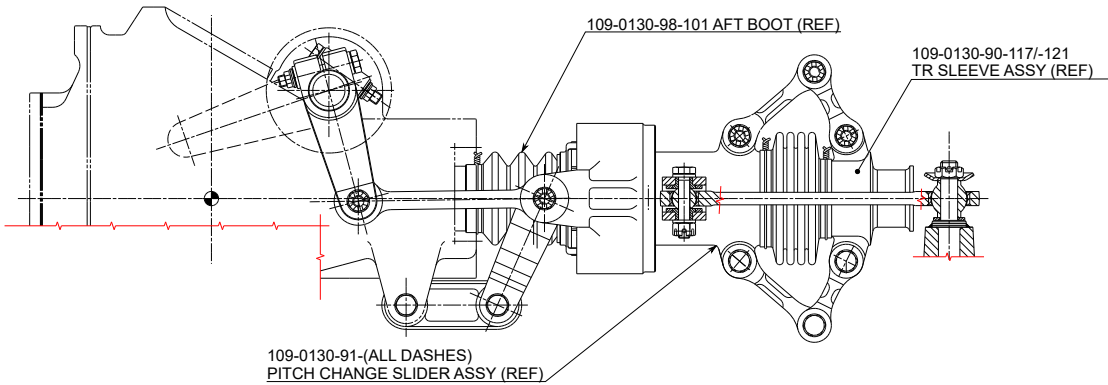
**Figure 3**

- 4.3 In accordance with Figure 3, verify that plug P/N 109-0133-18-103 (or P/N 109-0130-85-1) is torqued at 59÷69 Nm.
  - 4.4 Record the torque value on the Detailed Inspection Form and proceed with next step.

3. With reference to Figure 3, detach aft boot from pitch change slider assy.
4. With reference to Figure 4, move aft boot and, using bushing displacement measuring tool, verify that the distance from bushing to pitch change slider assy has not changed since last inspection. If the distance decreases (long side of tool not in contact with slider assy, ref. Figure 4 Detail E), proceed as follows, otherwise proceed to step 5:

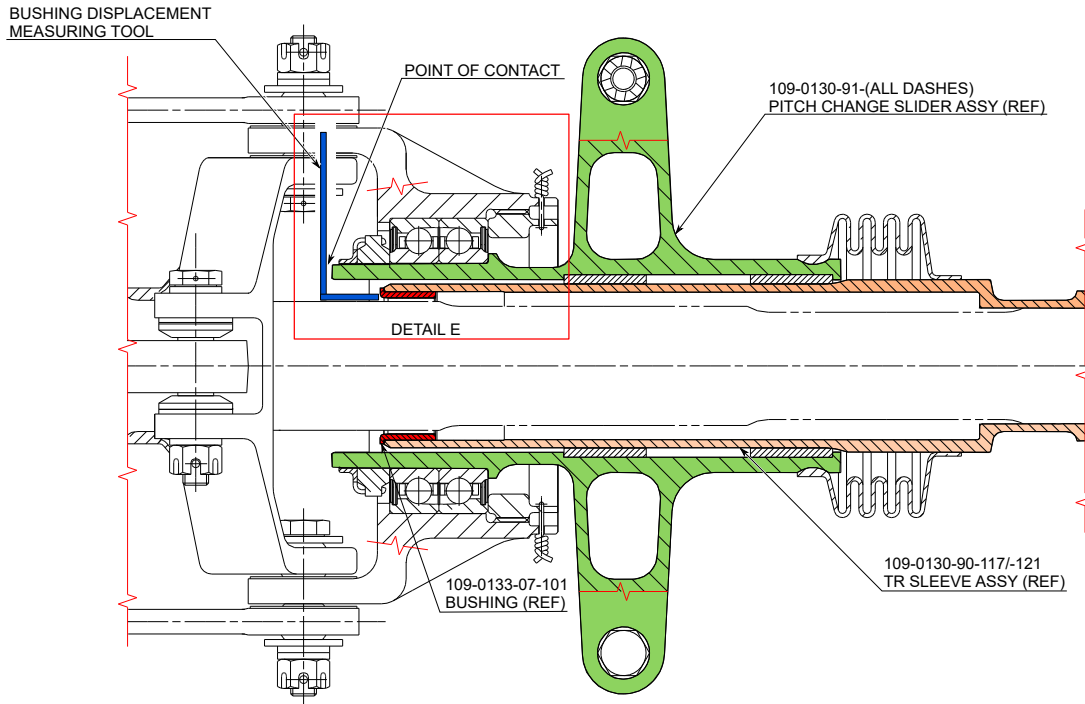
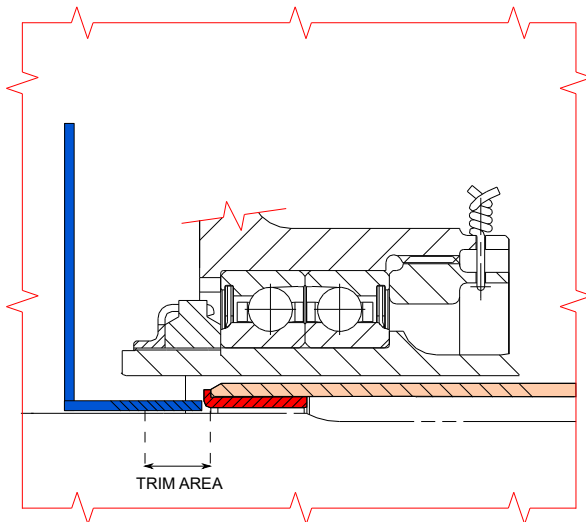
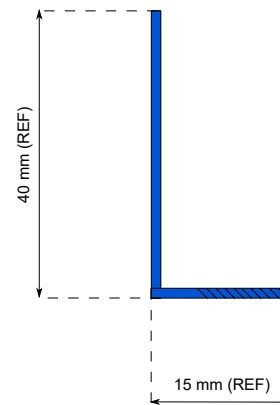
**Figure 4**

11. In accordance with Figure 4, manufacture on site the bushing displacement measuring tool following the next steps:
  - 11.1 Starting from a metal sheet of 55x5 mm (1 mm thickness), bend it to obtain an “L” shape with the size indicated in Figure 4.
  - 11.2 In accordance with Figure 4 Detail E, insert the tool between pitch change slider assy and tail rotor shaft assy until reaching the bushing of the TR sleeve assy.

- 11.3 If gap is present between the vertical leg of the tool and the pitch change slider assy, start trimming the short segment until gap is removed.
  - 11.4 Record the dimension of the tool and retain it for Part II inspection.
12. With reference to Figure 3, attach aft boot P/N 109-0130-96-101 on pitch change slider assy.
13. Return the anti torque pedal to center. In accordance with MM Paragraph 00-10-10, disconnect the hydraulic test bench from the helicopter.
14. Return the helicopter to a ready to flight condition and record for compliance with Part I of this Service Bulletin on the helicopter logbook.

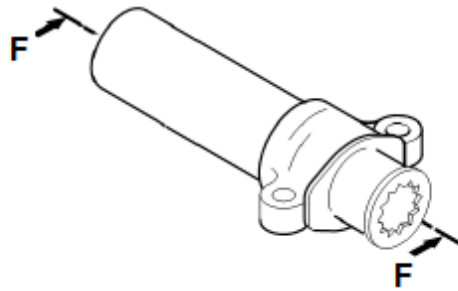
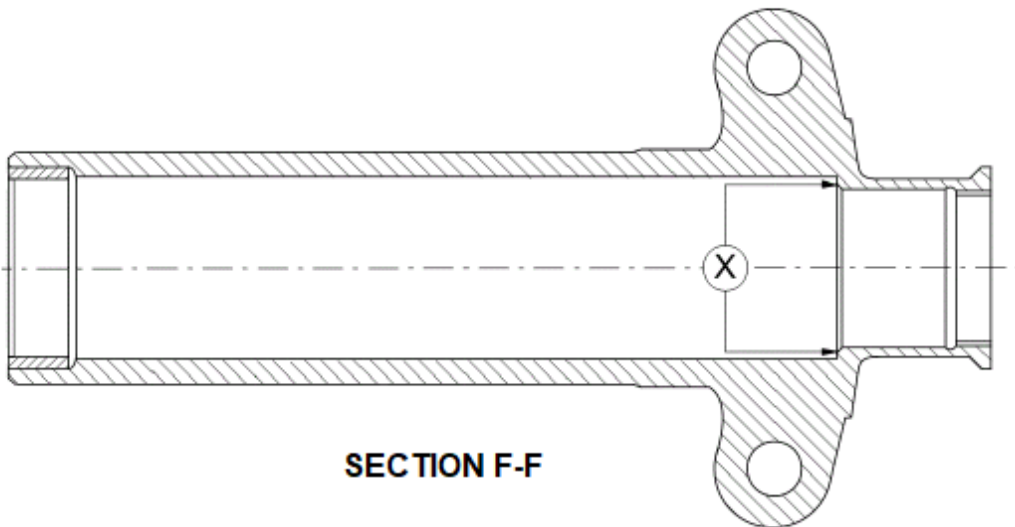
- 3.4 With reference to Figure B1, Detail F, examine the mating surface between the sleeve and the tail rotor shaft assy (X Area), for wear and stepping. No wear or stepping is permitted. In case of any doubt, clean with the cleaning solvent MIL-PRF-680, Type II and perform again the inspection. If the presence of damage is confirmed, replace the sleeve.
