**SERVICE BULLETIN**

**N° 109EP-179**

**ATA 53 - CENTRAL FUSELAGE FRAME ASSY AT STA 1815 INSPECTION OF**

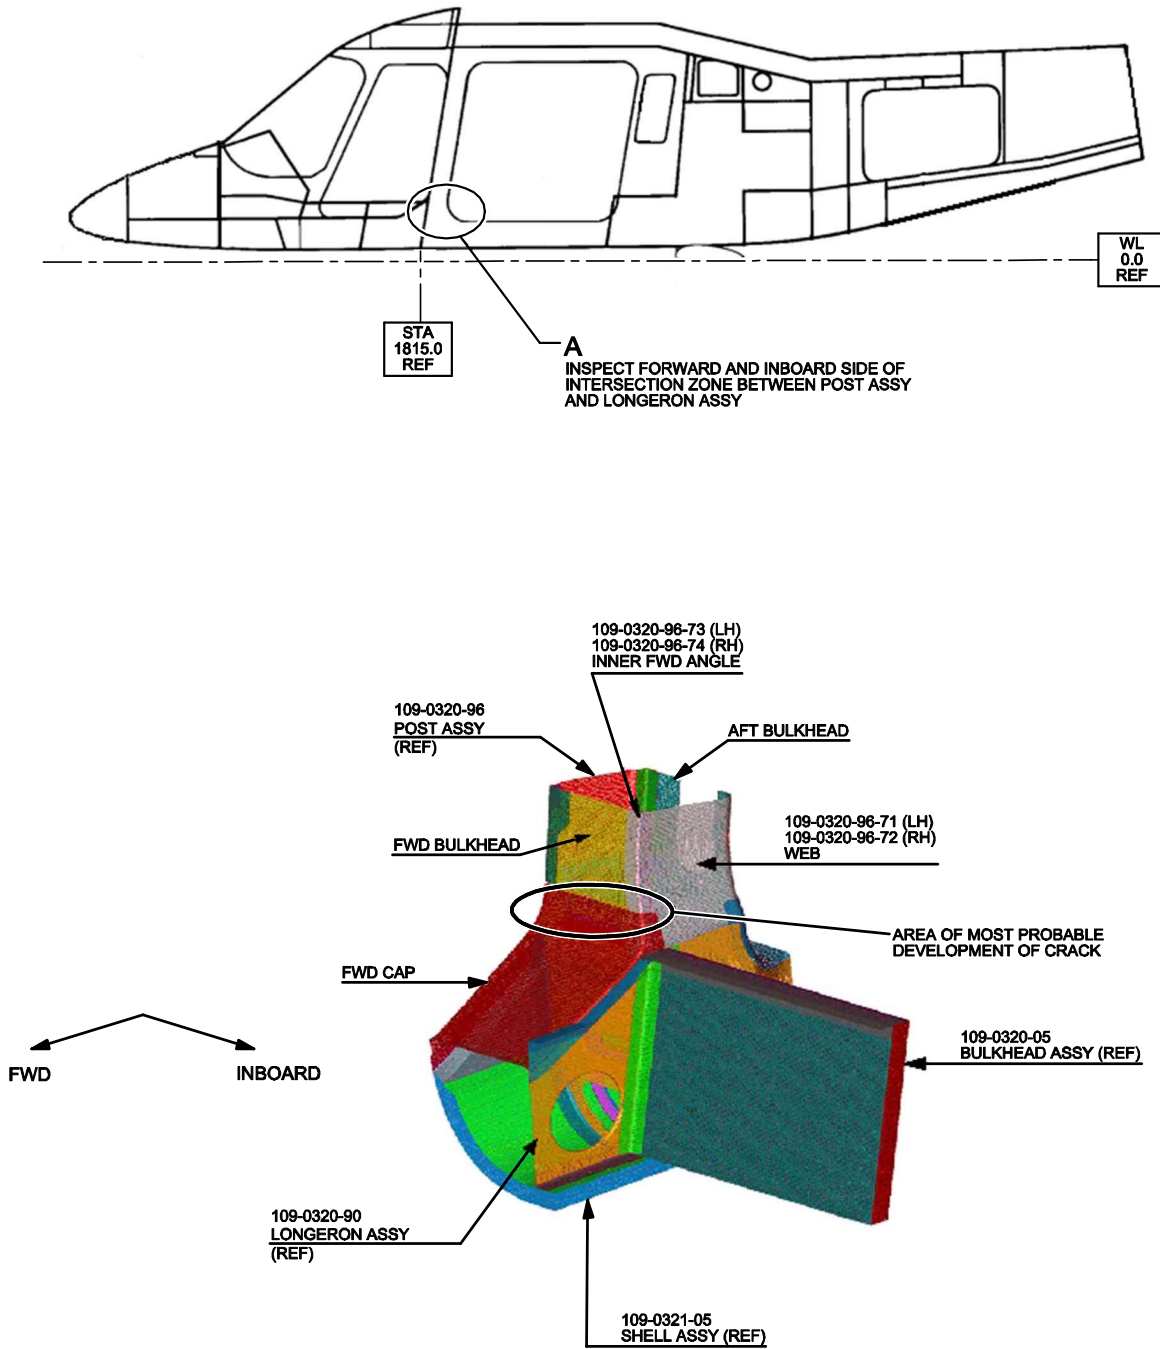
**Figure 1**

An occurrence of cracks has been found in the fuselage of the LH A109E helicopters at the intersection of the lateral pylon with the floor spar at the STA 1815, in both the LH and RH sides.

7. With reference to Figure 1, using a bright light source, visually inspect the whole zone of intersection between the lateral post and the floor spar, on both sides of the fuselage, for evidence of cracks. Pay particular attention to the forward area of the post (toward cockpit) and to inboard side of the post.

**A**  
INSPECT FORWARD AND INBOARD SIDE OF  
INTERSECTION ZONE BETWEEN POST ASSY  
AND LONGERON ASSY

AREA OF MOST PROBABLE  
DEVELOPMENT OF CRACK

8. In case of no findings, reinstall all the components removed from Step 3 to Step 5 and continue with Step 10.
9. In case of findings, in accordance with CSRP standard repair procedures perform a fluorescent liquid penetrant inspection of the crack to determine the exact extent, then stop-drill at both ends of crack to relieve the stresses in the extremities and to prevent any further propagation.

- 9.1 If the length of crack on the FWD CAP does not exceed 50 mm and no other damages are detected in the affected area, contact Leonardo for repair within and not later than 25 flight hours, at the following mail box:  
[engineering.support.lhd@leonardo.com](mailto:engineering.support.lhd@leonardo.com).

- 9.2 If the length of crack on the FWD CAP exceed 50 mm, or any other crack is found, contact Leonardo for immediate repair before the next flight, at the following mail box:  
[engineering.support.lhd@leonardo.com](mailto:engineering.support.lhd@leonardo.com).

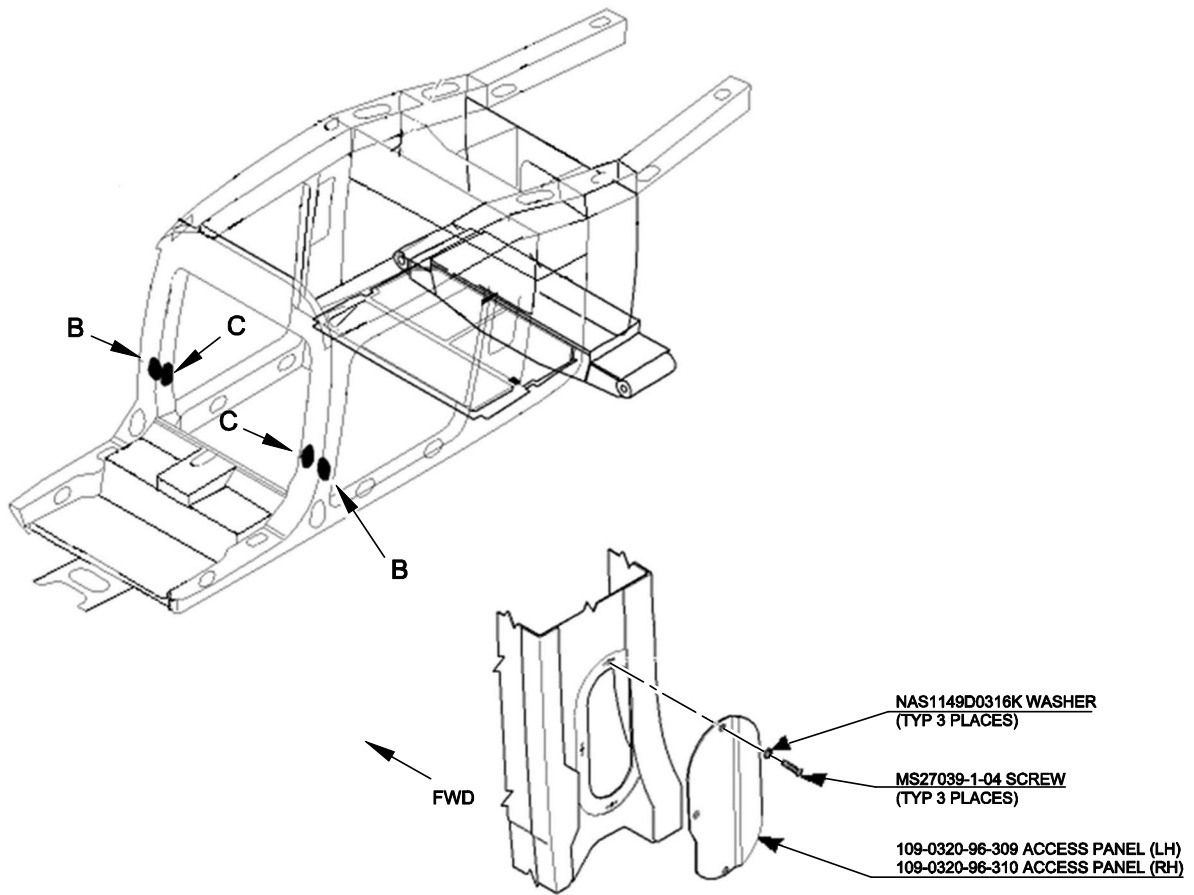
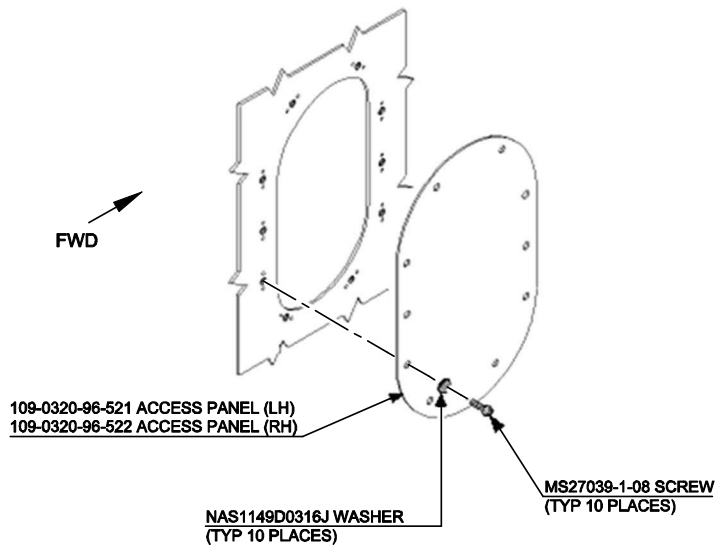
**Figure 2**

5. With reference to Figure 2, on both lateral posts, remove the access panels on the aft side (P/N 109-0320-96-309 on LH side and P/N 109-0320-96-310 on RH side) and on the inboard side (P/N 109-0320-96-521 on LH side and P/N 109-0320-96-522 on RH side). Retain all the fixing hardware for later reuse.
