SERVICE BULLETIN

N° 109EP-181

ATA 62 – INSPECTION AND REPLACEMENT OF MAIN ROTOR BLADE TIP CAP

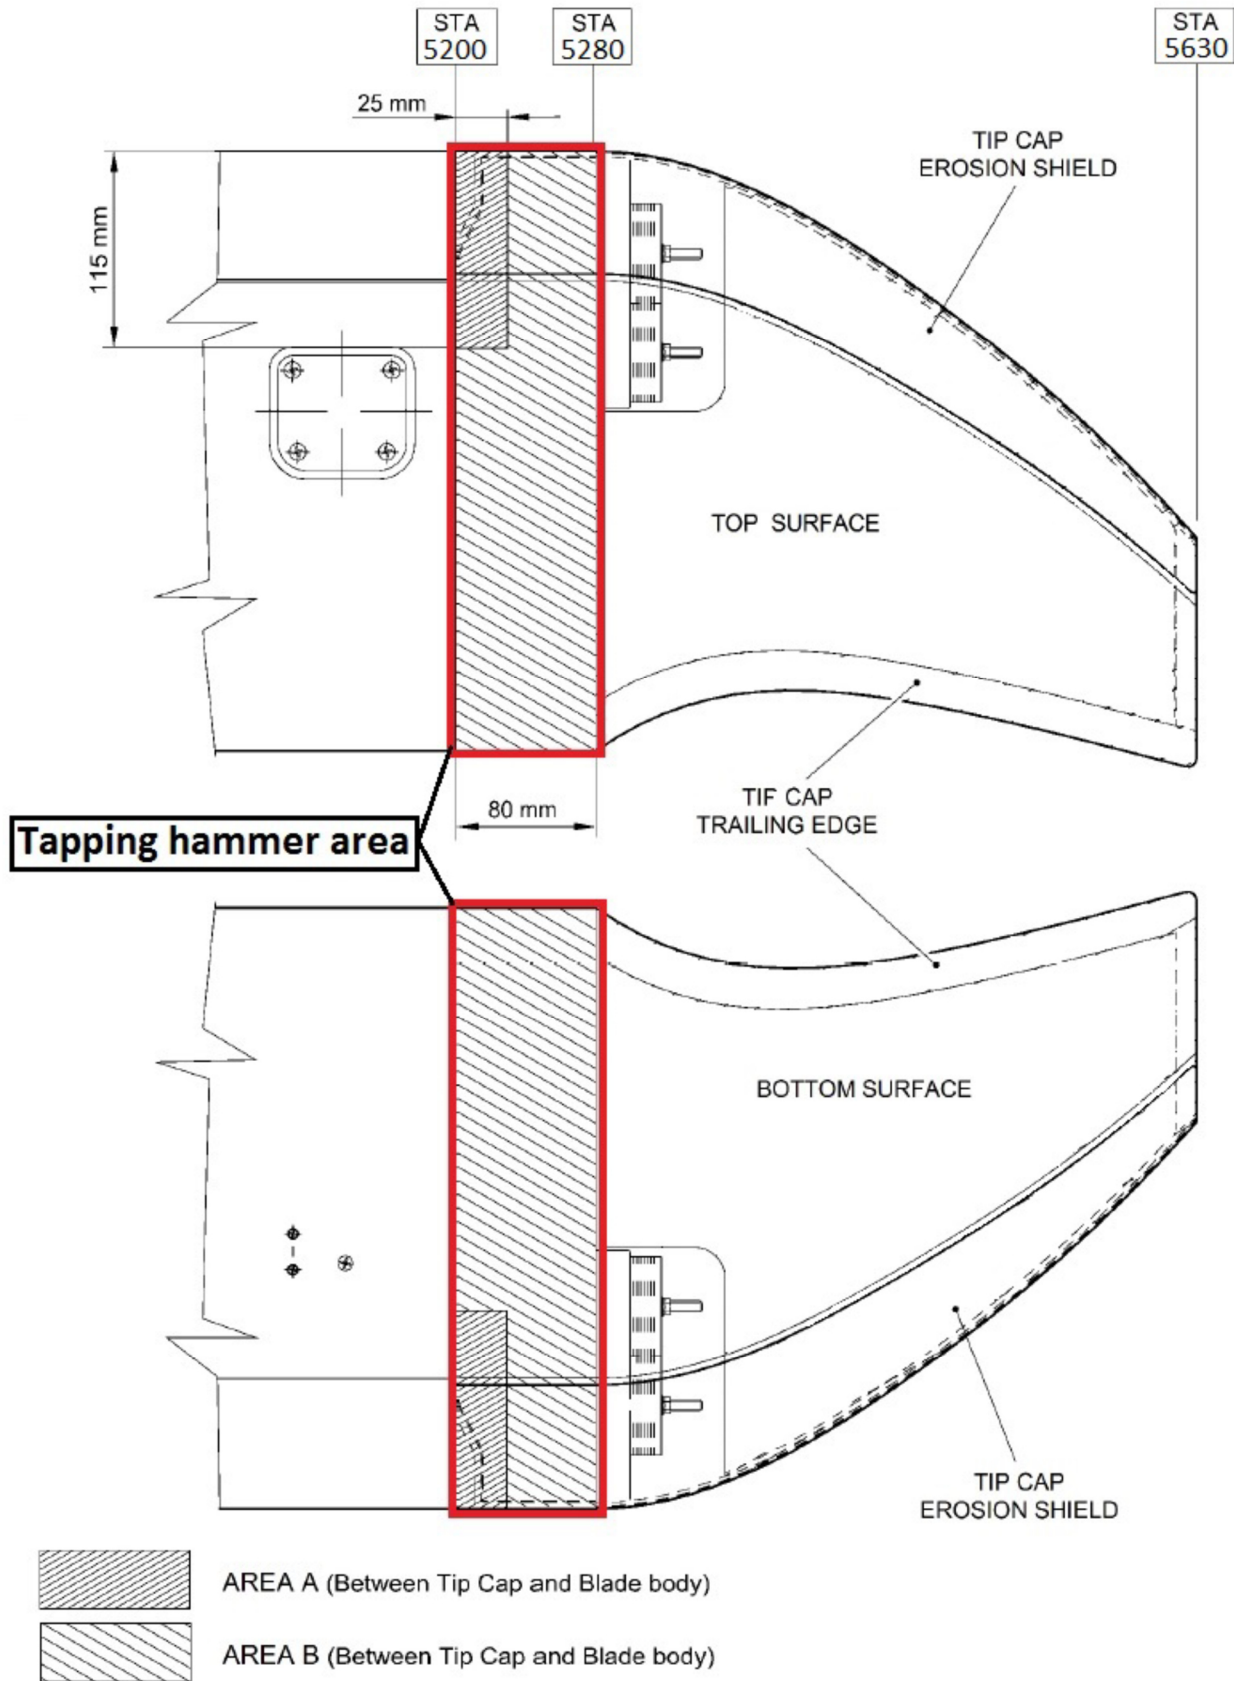
Figure 1

A quality escape affecting a defined batch of Main Rotor Blades (MRB) has been identified. The escape identified affects a list of MRB P/N 709-0103-01-111 that had the Tip Cap replaced following a procedure and using tools not in accordance with LH Technical Publication. This non conformity could lead to premature debonding of the Tip Cap and ultimately to its detachment.

3. In accordance with CSPP DM CSPP-A-60-30-02-01A-913A-D and with reference to Figure 1, perform a tapping test on Main Rotor Blade Tip Cap.
 - 3.1 In case no debonding is found, proceed with step 4.
 - 3.2 In case debonding is found, check its dimensions with MM Paragraph 62-11-24 (debonding limits).
 - 3.2.1 In case debonding is found within acceptable limits, proceed with step 4.
 - 3.2.2 In case debonding is found outside the acceptable limits, apply Part II of this Service Bulletin before next flight and inform LH.
4. Return the helicopter to flight configuration and record for compliance with Part I of this Service Bulletin on the helicopter logbook.
5. Gain access to My Communications section on Leonardo WebPortal and compile the "Service Bulletin Application Communication".
