SERVICE BULLETIN**N° 139-569****ALERT****DATE:** December 28, 2018**REV. :** B - July 25, 2022

TITLE**ATA 64 – TAIL ROTOR SLIDER ASSY DETAILED INSPECTION****REVISION LOG**

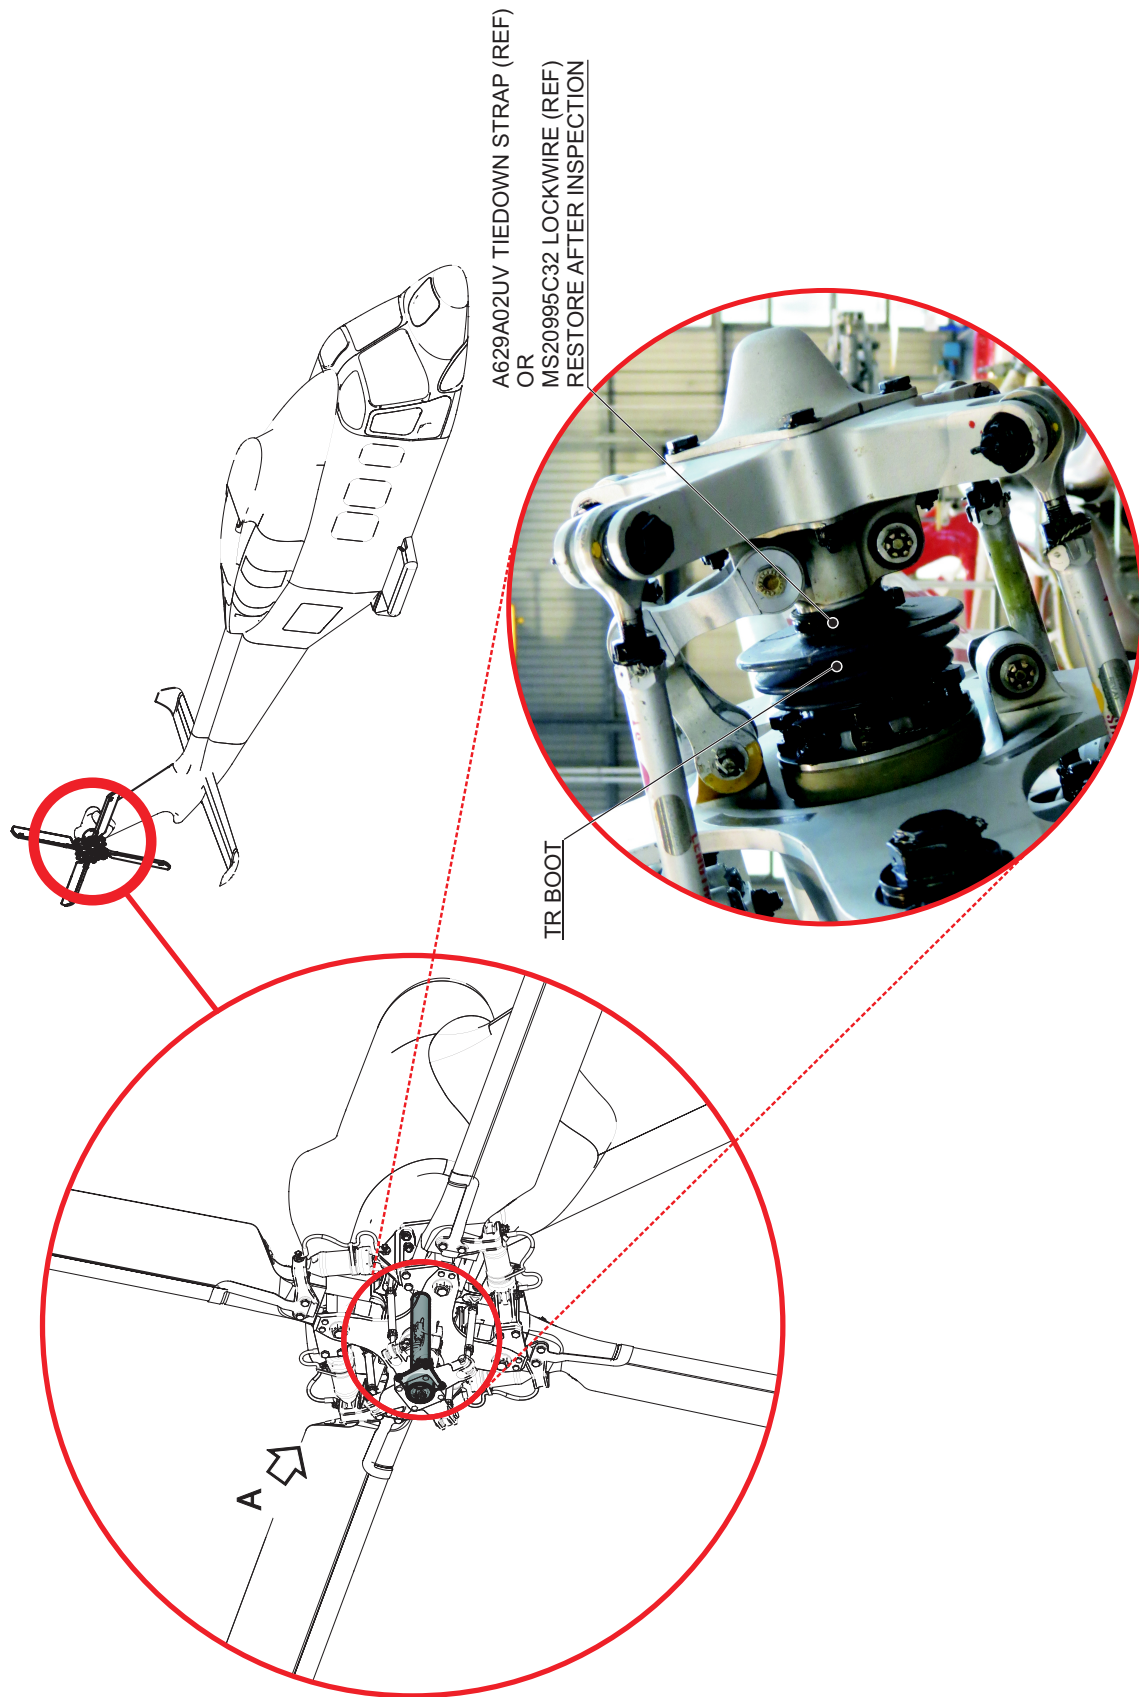
Figure 1

VIEW A
TR SCISSORS REMOVAL IS NOT REQUIRED
TO PERFORM THE INSPECTION

3. With reference to Figure 1, get access to the TR, remove the installed tiedown strap or lockwire and move the boot to expose the area shown in Figure 2 Detail C.

10. If no corrosion and no refinishing signs are found, no further action is required.
11. With reference to Figure 1, move the boot in the right position on the slider assy and install the tiedown strap or lockwire.

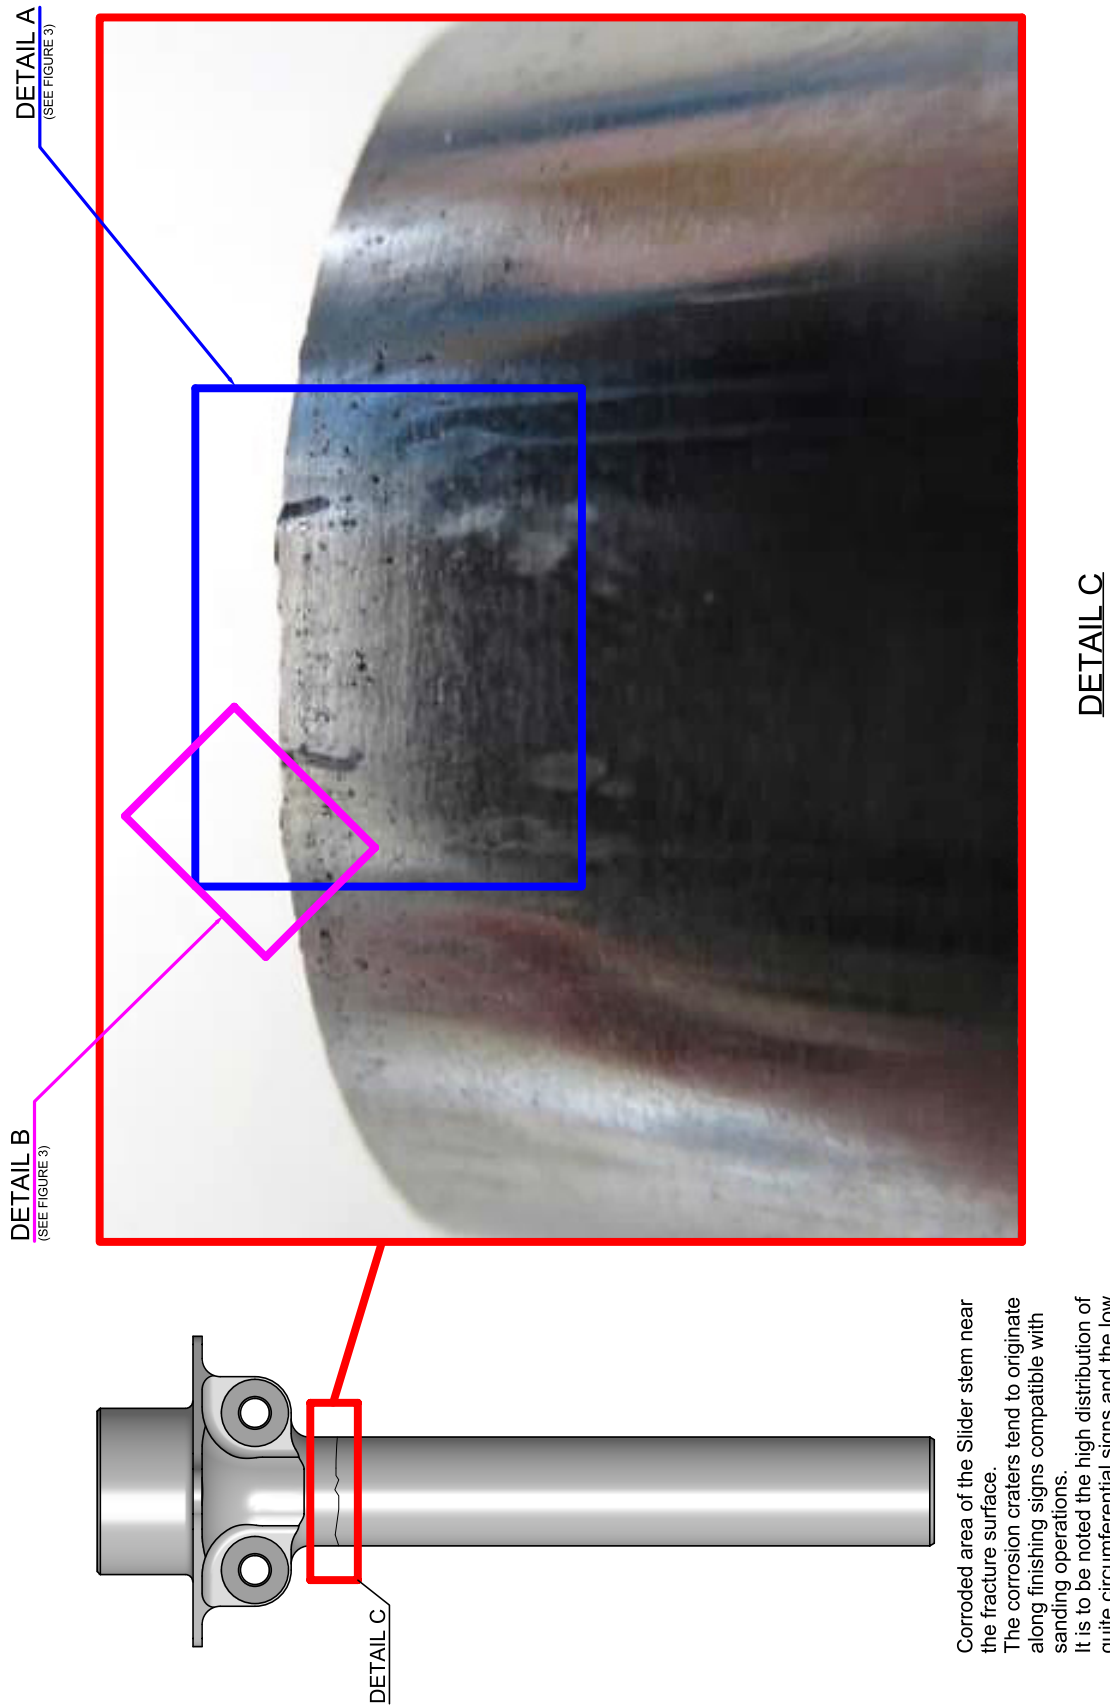
Figure 2

In particular, the investigation on the cracked slider highlighted presence of corrosion craters on its surface, originated along finishing signs compatible with low grit sanding operations, possibly generated from a maintenance activity not allowed in service.

This condition, if not detected and corrected, could lead to the breakage of the slider.

Corroded area of the Slider stem near the fracture surface.
 The corrosion craters tend to originate along finishing signs compatible with sanding operations.
 It is to be noted the high distribution of quite circumferential signs and the low distribution of craters visible on the thin edge of the fracture surface.

5. With reference to Figures 2 and 3, identify on the slider stem the area enclosed within the Detail C and compare its finishing with the one shown in Details A and B.

6. If you find suspected evidences of corrosion signs as per Figures 2 and 3, perform following step 7, otherwise go to step 9.
7. Check the suspected evidences of corrosion signs as described in the following procedure:

- 7.3 After polishing, examine the slider:
 - 7.3.1 If the signs of corrosion are confirmed as per Figure 3, go to Part II to replace the slider assembly with a serviceable part.

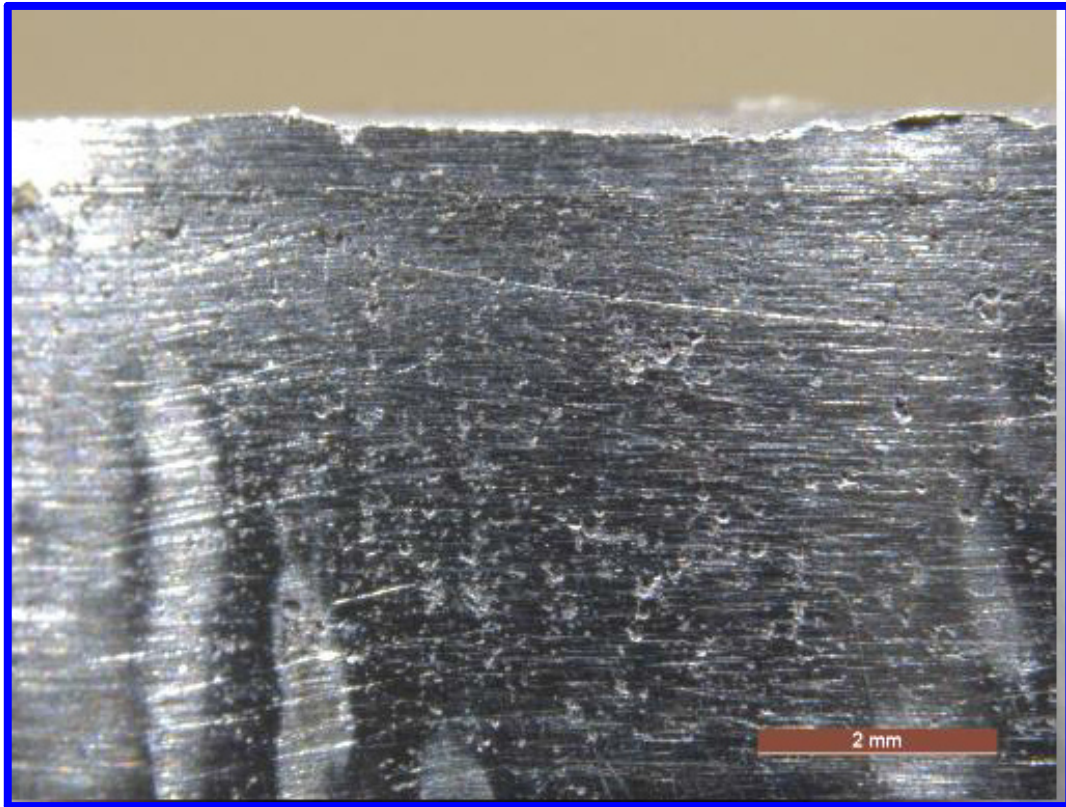
DETAIL A
(REF TO FIGURE 2)

Figure 2 and Figure 3 Details A and B show evidence of corrosion damage and signs of surface imperfections from refinishing with improper abrasives.
