SERVICE BULLETIN

N° 139-648

DATE: August 10, 2020

ATA 25 – LIFERAFT RESERVOIR INSPECTION AND REPLACEMENT

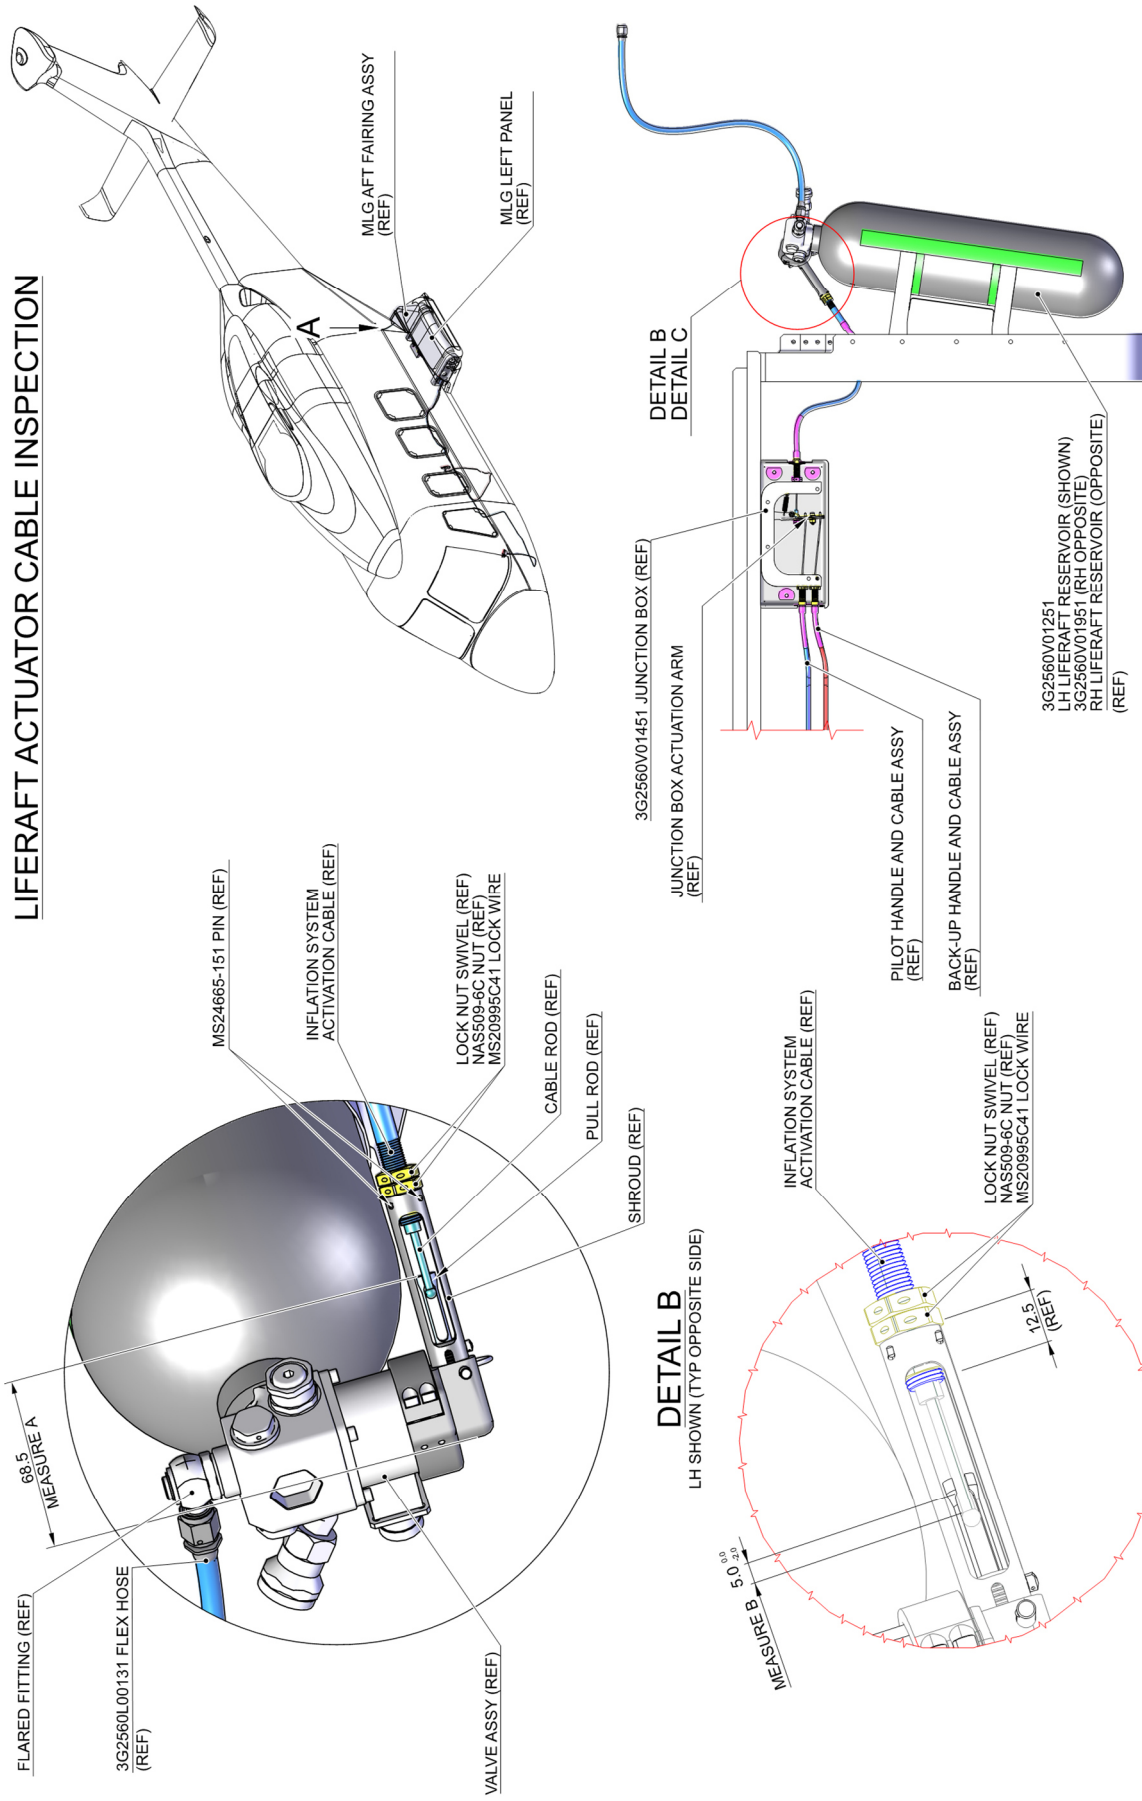
1. In accordance with AMP DM 39-A-00-20-00-00A-120A-A, prepare the helicopter on ground for a safe maintenance, if required. Disconnect the battery, all electrical power sources and/or the external power supply.
2. In accordance with AMP DM 39-A-06-41-00-00A-010A-A and with reference to Figure 1, gain access to the affected area.
3. With reference to Figure 1 Detail B, disconnect the flex hose P/N 3G2560L00131 from the bottle valve.
4. With reference to Figure 2 Detail A, install the diffuser cap P/N 601.2382.
5. With reference to Figures 1 and 2, perform the valve pull rod inspection as described in the following procedure:
 - 5.1 With reference to Figure 1 Detail B and Figure 2 Detail B, perform the measurement of the actuation cable between the face of the pull rod and the back of the valve cap and compare it with the maximum allowed of 68.5 mm (see measure A).

5. With reference to Figure 1, perform the life raft actuator cable inspection as described in the following procedure:
 - 5.1 With reference to Figure 1 View A and Detail C, with the junction box actuation arm in its rest position (90° with respect to the helicopter longitudinal axis), verify the presence of a $5.0^{+0.0}_{-2.0}$ mm clearance between the sphere at the end of the cable and the activation system in accordance with the measurement range shown (see measure B).

- 5.2 If the measurement value exceeds the allowed limit, perform the life raft activation cable adjustment in accordance with Annex A.
6. With reference to Figure 2 Detail A, remove the diffuser cap P/N 601.2382 from the valve.

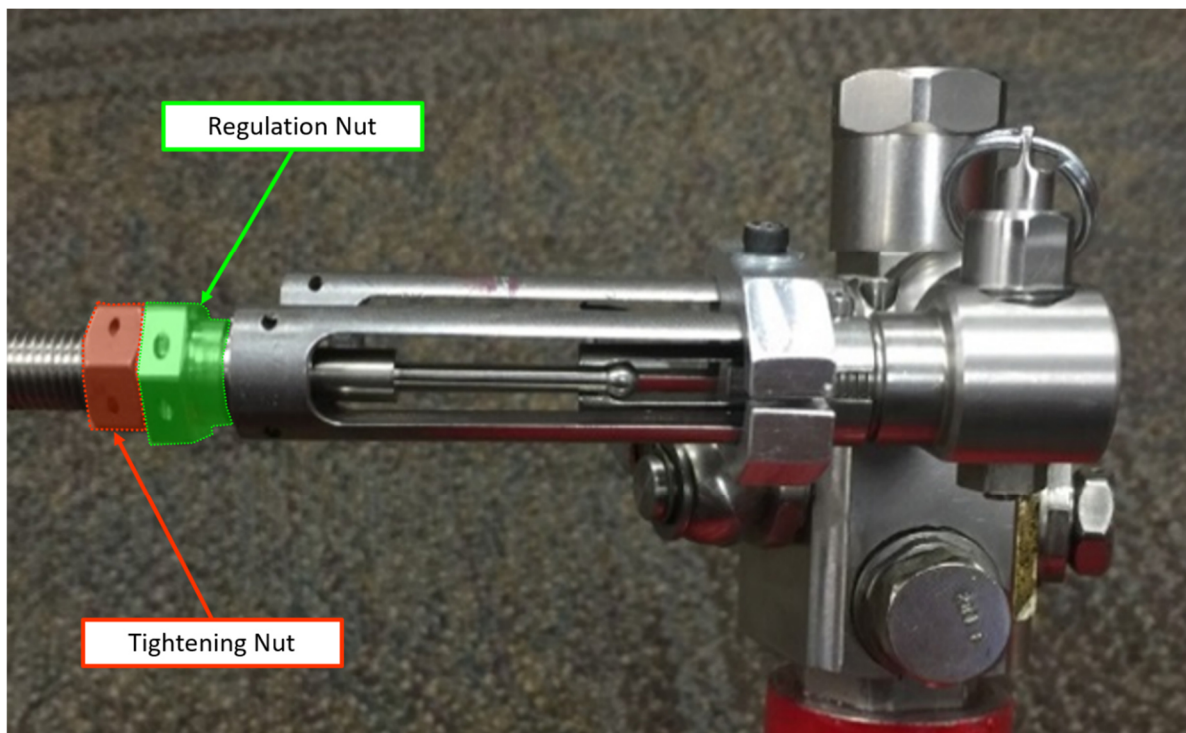
Figure A1 – Activation cable zone

In order to obtain a clearance of 5 mm ± 2 between the spherical end of the cable and the Pull Rod adjust the cable length acting on the lock nuts at the end of the activation cable zone (**Figure A1**).

- 1.1 Unscrew the 9/16" tightening nut.
- 1.2 Adjust the cable length acting on the 5/8" regulation nut.
 - TO INCREASE THE GAP: unscrew the regulation nut;
 - TO DECREASE THE GAP: screw the regulation nut.
- 1.3 Screw the 9/16" tightening nut in order to block the regulation nut.

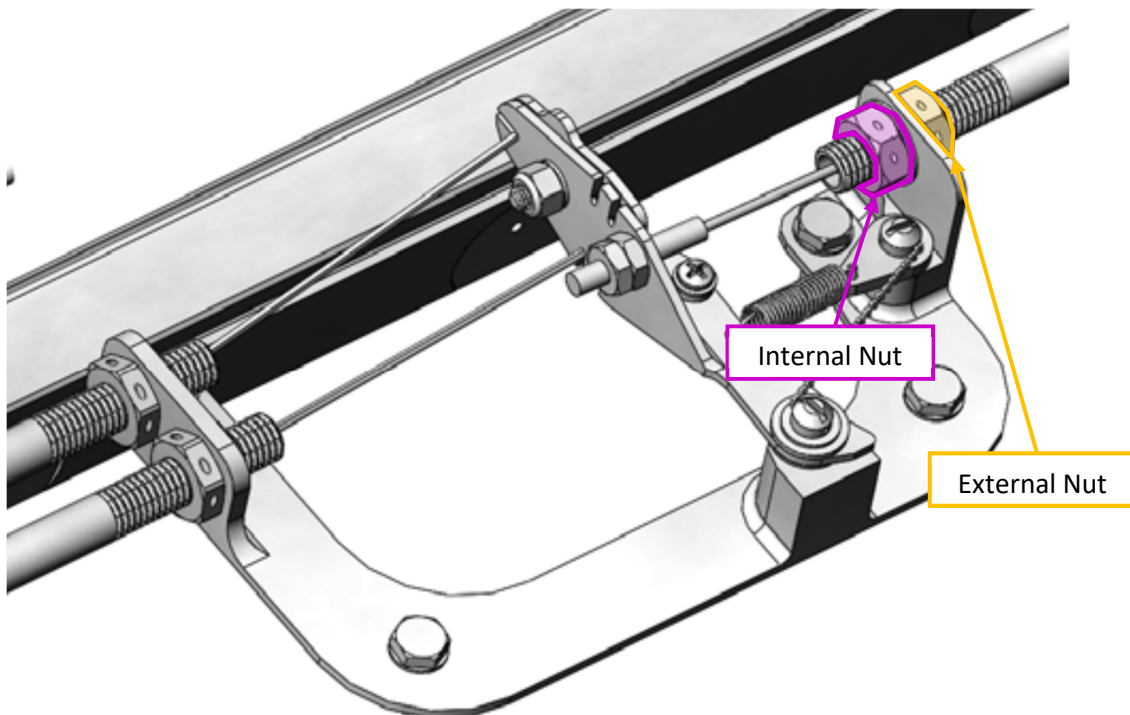
Figure A2 – Junction box zone

If this first adjustment reveals to be not sufficient, act also on the locking nuts in the Junction Box zone (**Figure A2**) and then make small corrections acting on the locking nuts at the end of the activation cable.

2.2 Adjust the gap as follows:

2.3 Once the correct gap is achieved, make sure that both the internal and the external nuts are in contact with the structure and tightened at the standard torque value.

2.4 Safety the external nut and the internal nut with stainless steel (302/304) medium strong safety wire.
