SERVICE BULLETIN

N° 139-686

ATA 53 – TAIL GEAR BOX FITTING INSPECTION

All AB/AW139 helicopters installing TGB fittings P/N 3G5351A01151 or P/N 3G5351A01152 with more than 3000 FH.

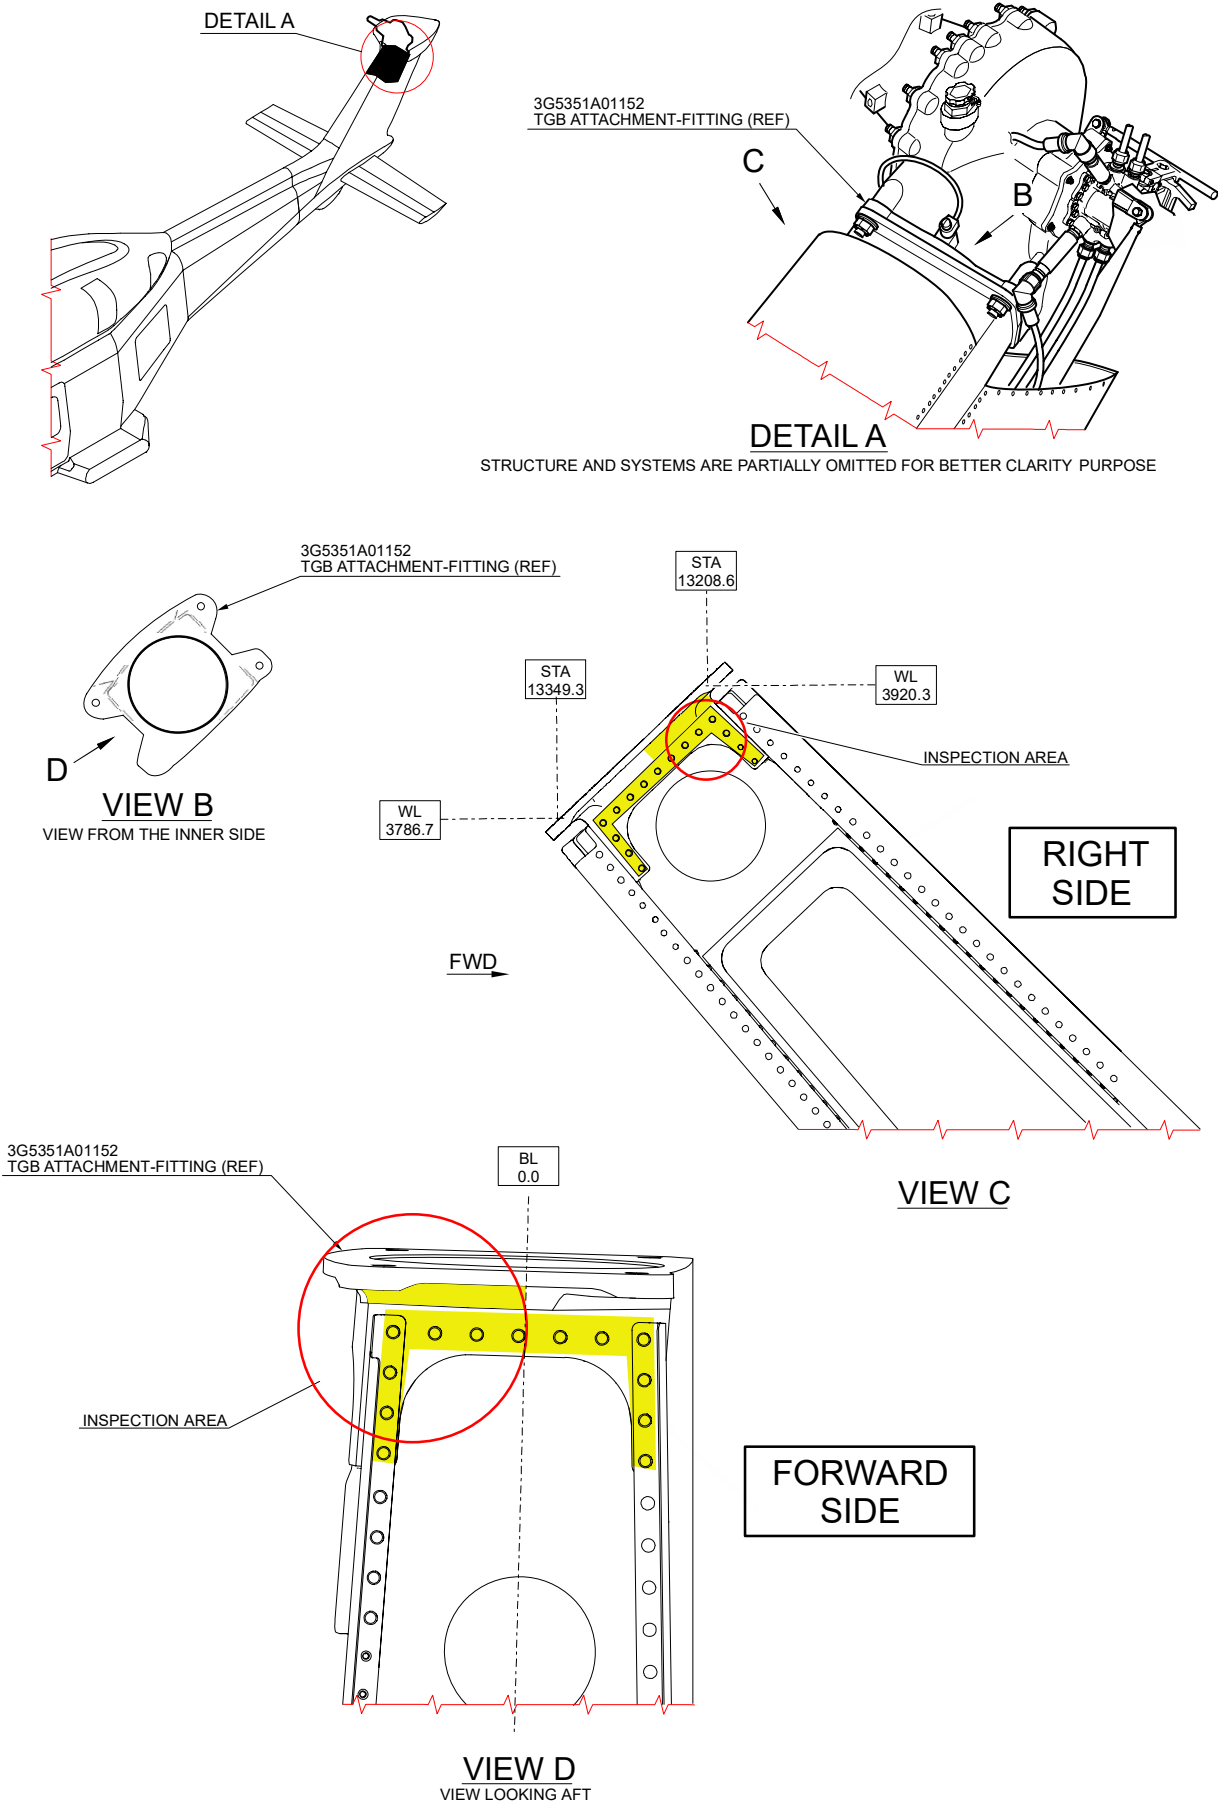
5. With reference to Figures 1 and 2 perform, with the use of a borescope, a detailed inspection for cracks of the RH and FWD sides of the TGB fitting (area delimited by circles in Figure 1) in accordance to the following procedure:
 - 5.1 Properly illuminate the area to inspect (if necessary use a flash light).
 - 5.2 Clean the area to inspect with the Cheesecloth (C028) and the Aliphatic naphtha (C059) or Cleaning solvent (C010).
 - 5.3 With reference to Figure 1 View C and View D, accurately examine the outer surfaces of the forward and right side of TGB fitting body above the horizontal row of fastener holes (area delimited by circles in figure), making sure there are not cracks or damage.
 - 5.4 Accurately examine the area around the vertical and horizontal row of fastener

6. In case of any finding resulting from the inspection required by step 5, take a picture of the crack and of the involved area and contact Product Support Engineering (engineering.support.lhd@leonardocompany.com) to send photos of the cracks. Record for compliance with Part I of this Service Bulletin on the helicopter logbook and immediately proceed with Part II.

2. In accordance with ASRP DM 39-A-53-52-07-00A-920A-D replace the damaged TGB fitting with a new one.
3. In accordance with AMP DM 39-A-52-44-01-00A-720A-A, install all the access panels previously removed.
4. Remove the platforms from the fuselage sides.
5. Return the helicopter to flight configuration and record for compliance with Part II of this Service Bulletin on the helicopter logbook.
6. Send the attached compliance form to the following mail box:

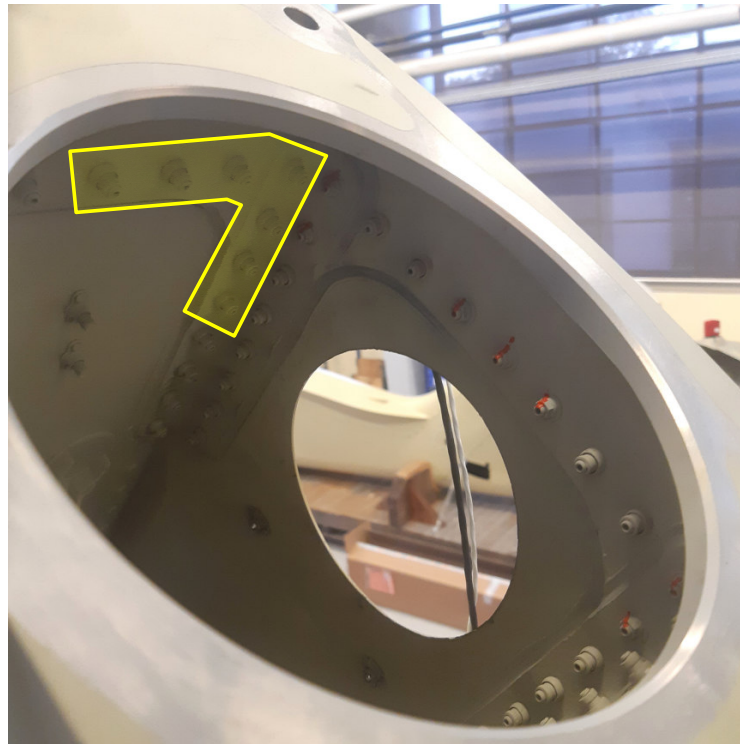
VIEW LOOKING FORWARD SIDE OF TGB FITTING
(FOR REFERENCE ONLY)

holes (refer also to Figure 2 “View looking forward side of TGB fitting”) of the inner forward side of the tail gearbox attachment-fitting.

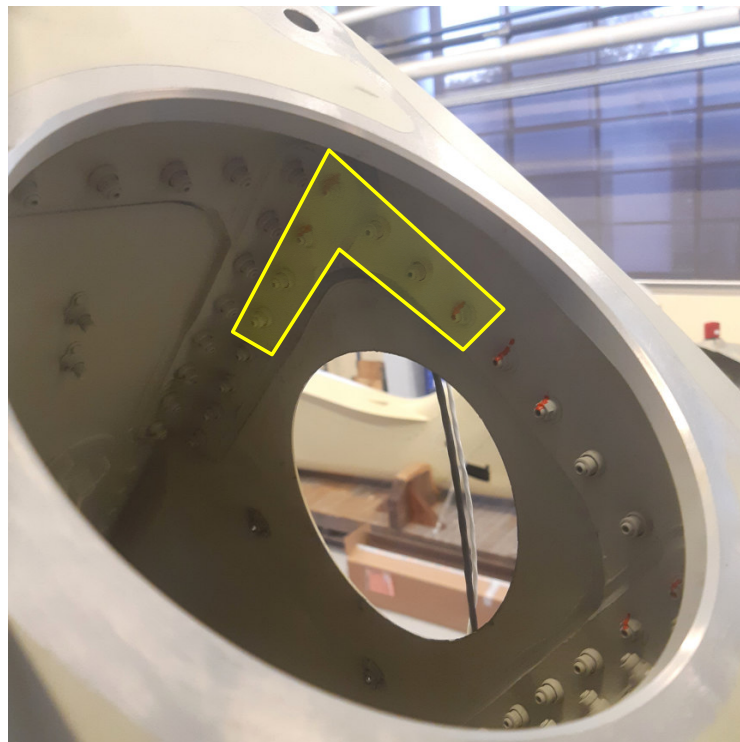
VIEW LOOKING RIGHT SIDE OF TGB FITTING
(FOR REFERENCE ONLY)

- 5.5 Accurately examine the area around the vertical and horizontal row of fastener holes (refer also to Figure 2 “View looking right side of TGB fitting”) of the inner right side of the tail gearbox attachment-fitting.
