SERVICE BULLETIN

N° 139-724

REV. : A - September 19, 2022

ATA 64 – TAIL ROTOR DAMPER BRACKET INSPECTION

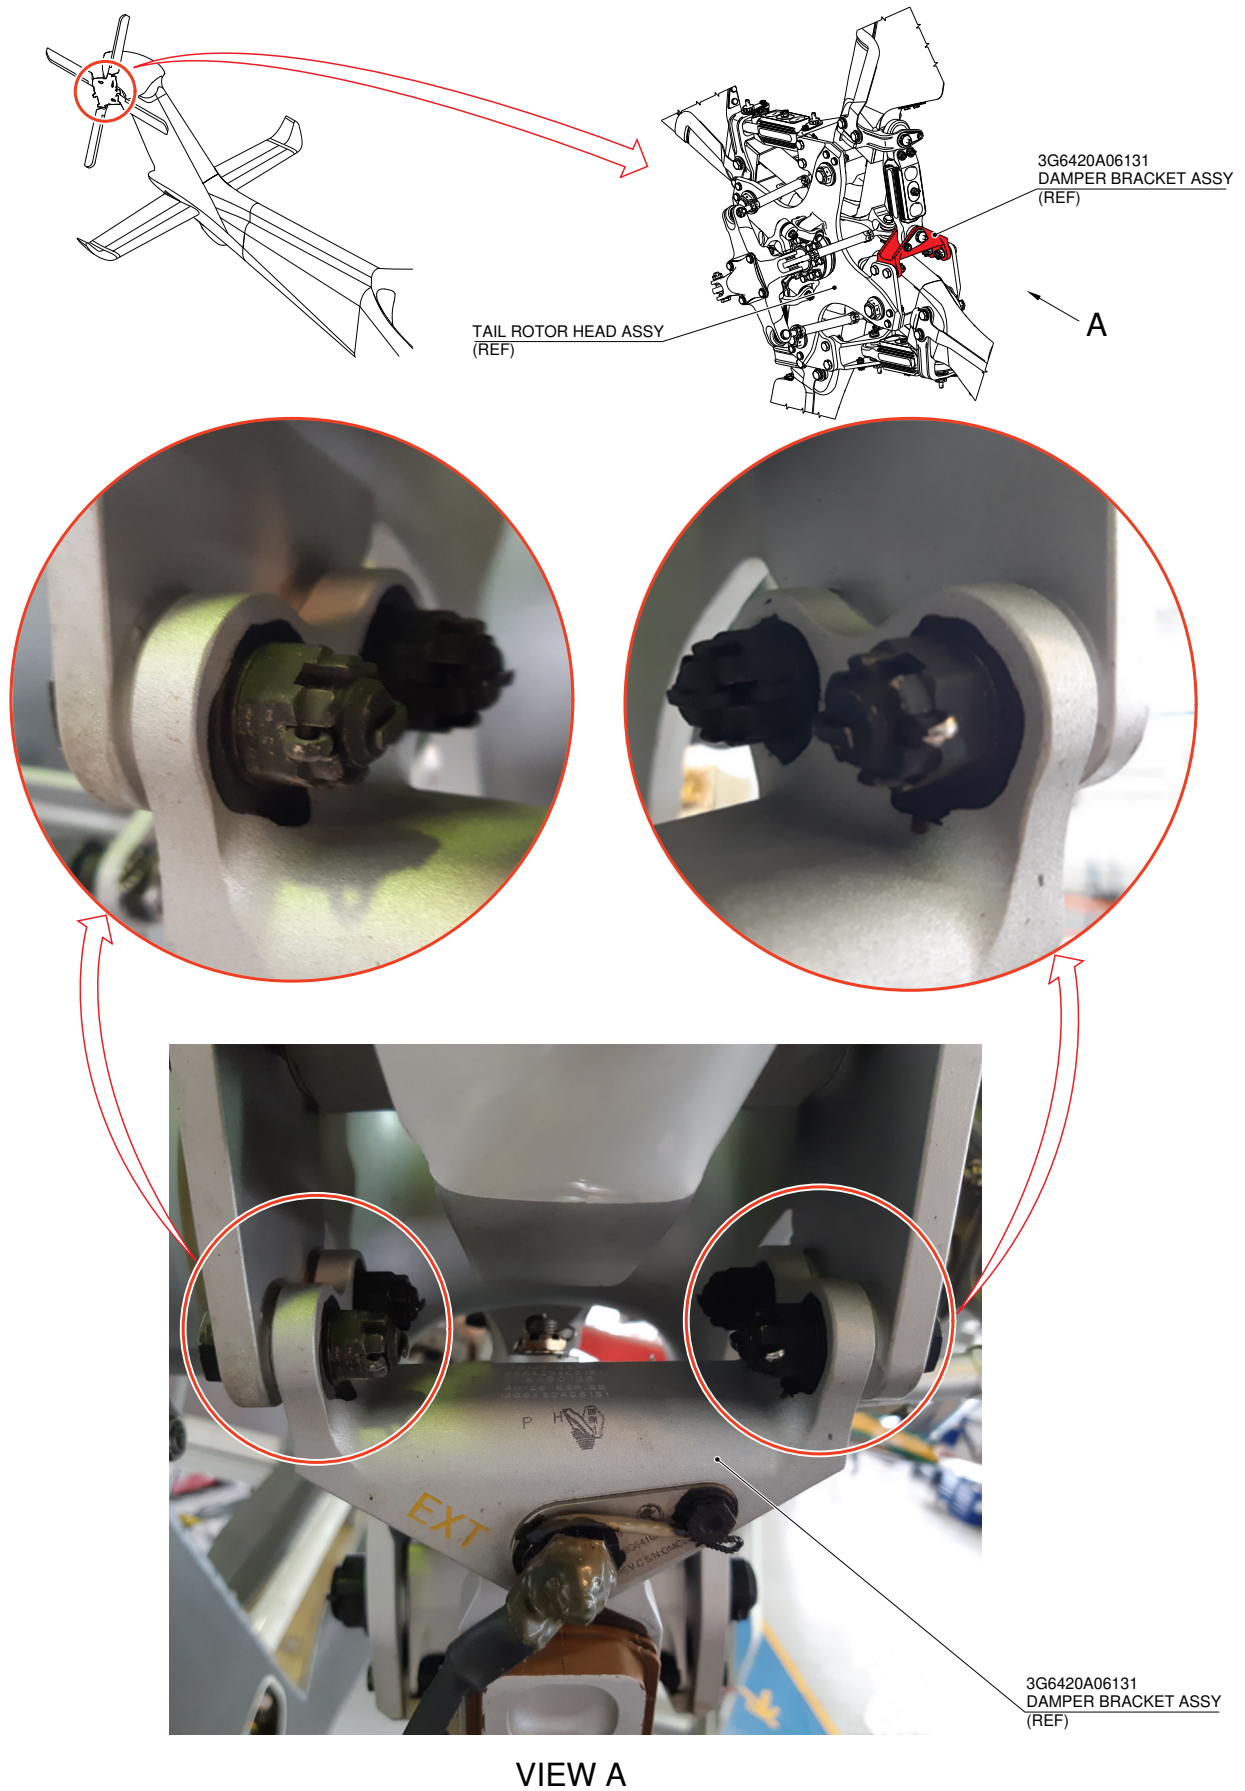
3. With reference to Figure 1, gain access to the component P/N 3G6420A06131 object of the inspection.
4. With reference to Figure 1 (View A) perform a detailed inspection for cracks and for corrosion of the TR damper bracket P/N 3G6420A06131 in accordance with the following procedure:
 - 4.1 Properly illuminate the area to be inspected (using a flash light, a mirror and a magnifying glass 10 power).
 - 4.2 Clean the area to be inspected with the Cheesecloth (C028) and the Aliphatic naphtha (C059) or Cleaning solvent (C010).

5. In case of cracks replace the TR damper bracket P/N 3G6420A06131 according to the following procedure:
 - 5.1 In accordance with the applicable steps of AMP DM 39-A-64-11-02-00A-520A-A disconnect the blade damper attachment assy P/N 3G6410A00831 from the blade assy (without removing the lag damper from the damper attachment assy).

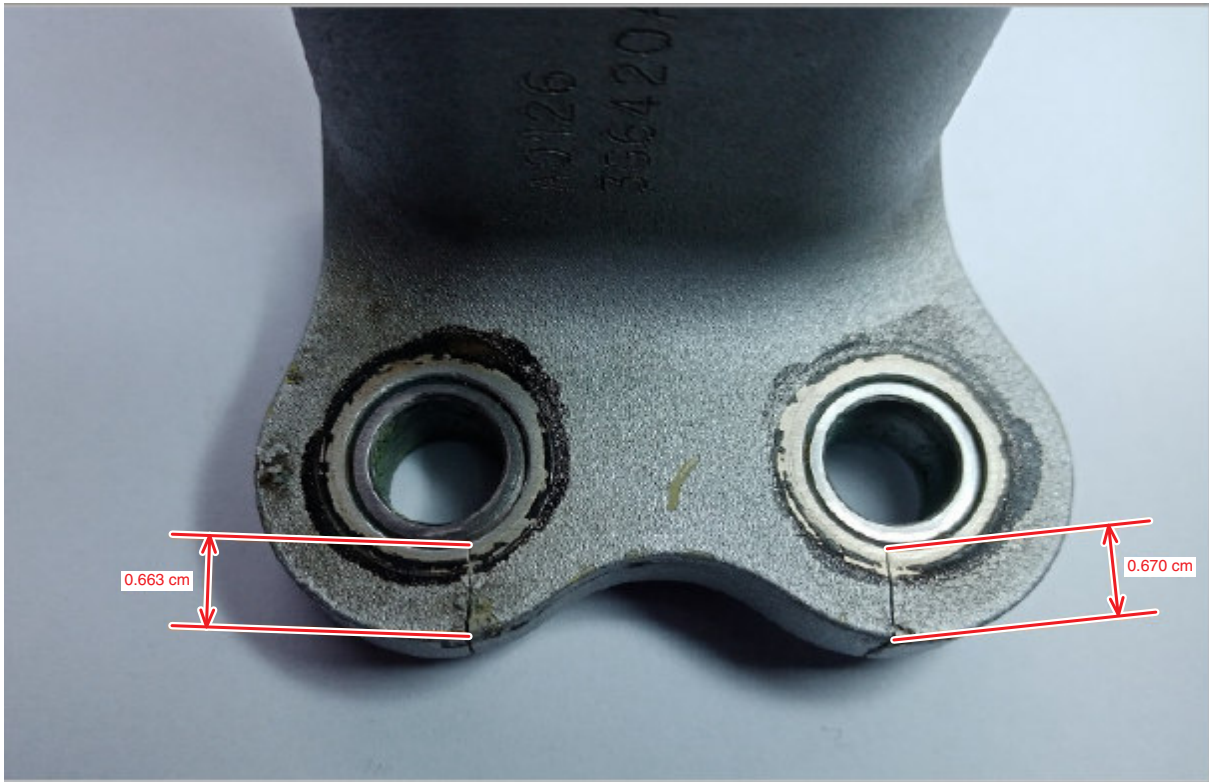
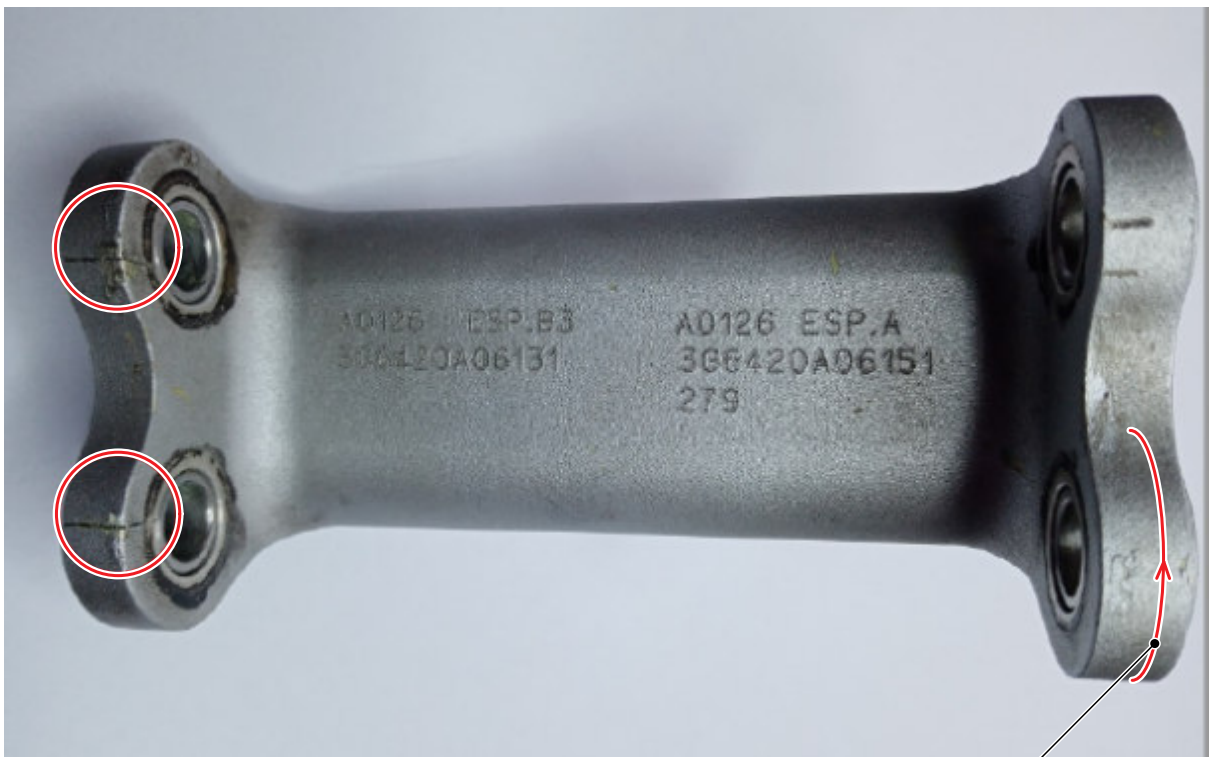
Refer to Figure 2 for an example of the cracks that might be found during the inspection.

- 4.3 With reference to Figures 1 and 2, accurately examine the surface of the bracket, paying particular attention to the area around the four holes.

- The Scotch Brite must be used only in the direction of the circumference of each bracket eyelet (ref. to Fig. 2 “polishing direction”);
 - The Scotch Brite must be used only with your hands.
6. If no cracks are found, but suspected evidences of corrosion signs are found, gently polish the interested area with a very light Scotch Brite (C015).
 7. After polishing, examine the bracket:
 - 7.1 If, after polishing, the suspected signs of corrosion are no longer evident, treat the component with alodine or equivalent in accordance with CSRP DM CSRP-A-51-21-06-00A-644A-D.

- 5.4 Replace the damper bracket P/N 3G6420A06131 with a new one and discard the damaged one.
 - 5.5 In accordance with the applicable steps of AMP DM 39-C-64-21-02-00A-720A-A, reconnect the new TR damper bracket to the elastomeric damper previously disconnected.
