**SERVICE BULLETIN**

**N° 139-724**

**DATE:** July 27, 2022

**ATA 64 – TAIL ROTOR DAMPER BRACKET INSPECTION**

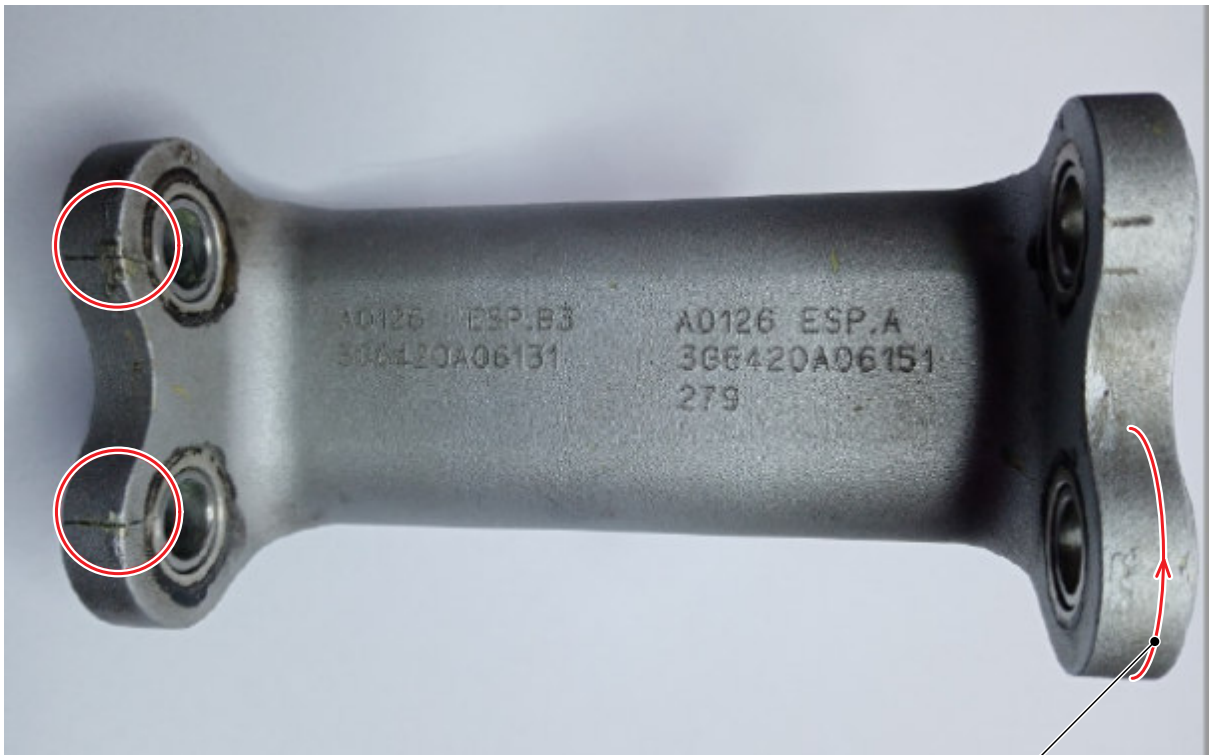
**Figure 2**

Due to some events where cracks have been found on the TR damper bracket, this Service Bulletin prescribes a detailed inspection of the TR damper bracket P/N 3G6420A06131 in order to detect potential cracks and corrosion. If cracks are found, it is required the immediate replacement of the component. Then, a recurrent inspection is required too.

Refer to Fig. 2 for an example of the cracks that might be found during the inspection.

- 4.3 With reference to Figures 1 and 2, accurately examine the surface of the bracket, paying particular attention to the area around the four holes.

5. In case of cracks replace the TR damper bracket P/N 3G6420A06131 according to the following procedure:
  - 5.1 In accordance with the applicable steps of AMP DM 39-A-64-11-02-00A-520A-A disconnect the blade damper attachment assy P/N 3G6410A00831 from the blade assy (without removing the lag damper from the damper attachment assy).

- The Scotch Brite must be used only in the direction of the circumference of each bracket eyelet (ref. to Fig. 2 “polishing direction”);
  - The Scotch Brite must be used only with your hands.
6. If no cracks are found, but suspected evidences of corrosion signs are found, gently polish the interested area with a very light Scotch Brite (C015).
  7. After polishing, examine the bracket:
    - 7.1 If, after polishing, the suspected signs of corrosion are no longer evident, treat the component with alodine or equivalent in accordance with CSRP DM CSRP-A-51-21-06-00A-644A-D.
