## **ERRATA CORRIGE**

**SERVICE BULLETIN**

**N° 189-295**

**ATA 34 – GLIDE SLOPE ANTENNA INSPECTION**

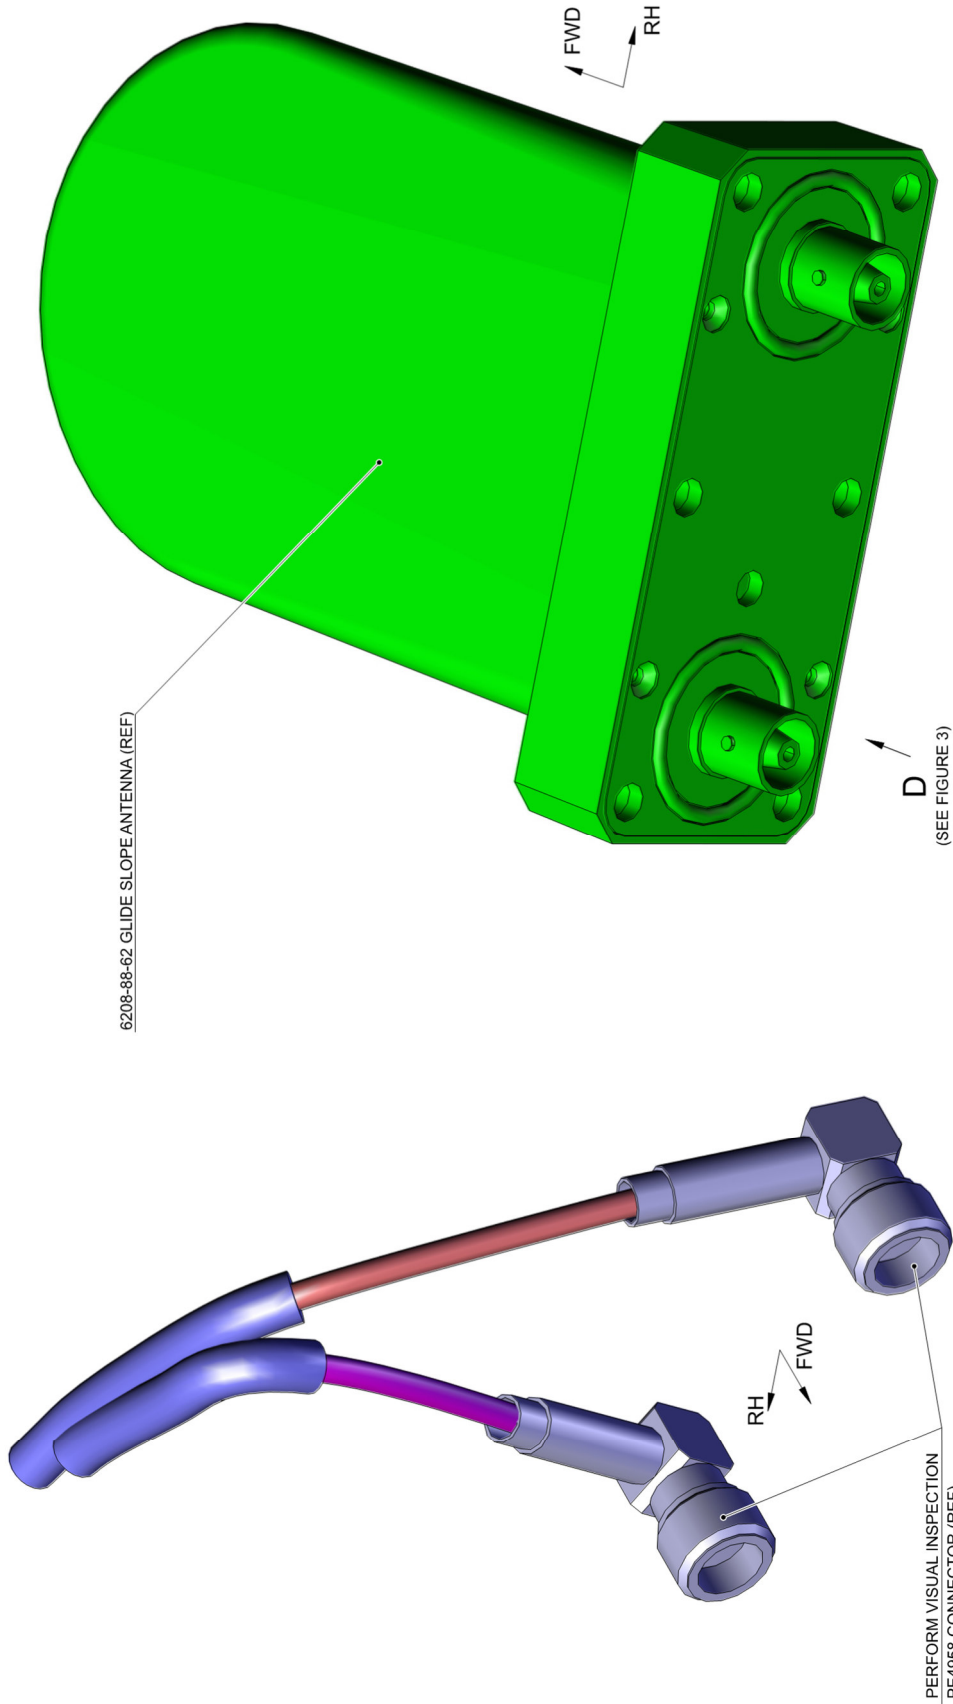
**Figure 2**

4. With reference to Figures 1 thru 3, perform a visual inspection looking for any evidence of sealant on the following components:
  - n°2 coaxial connectors P/N PE4958

- Antenna Support Assy P/N 8G5315A30231.
5. With reference to Figures 1 thru 3, perform a visual inspection looking for any evidence of sealant around the connectors of the Glide Slope Antenna P/N 6208-88-62.

- 6.3 With reference to Figures 1 thru 3, carefully remove the sealant on all affected components by means of a plastic scraper and a lint-free cloth (C011) moistened with isopropyl alcohol (C039).
- 6.4 After the sealant removal, check that the connector plating is not damaged and that no residue remains inside the RF connectors.

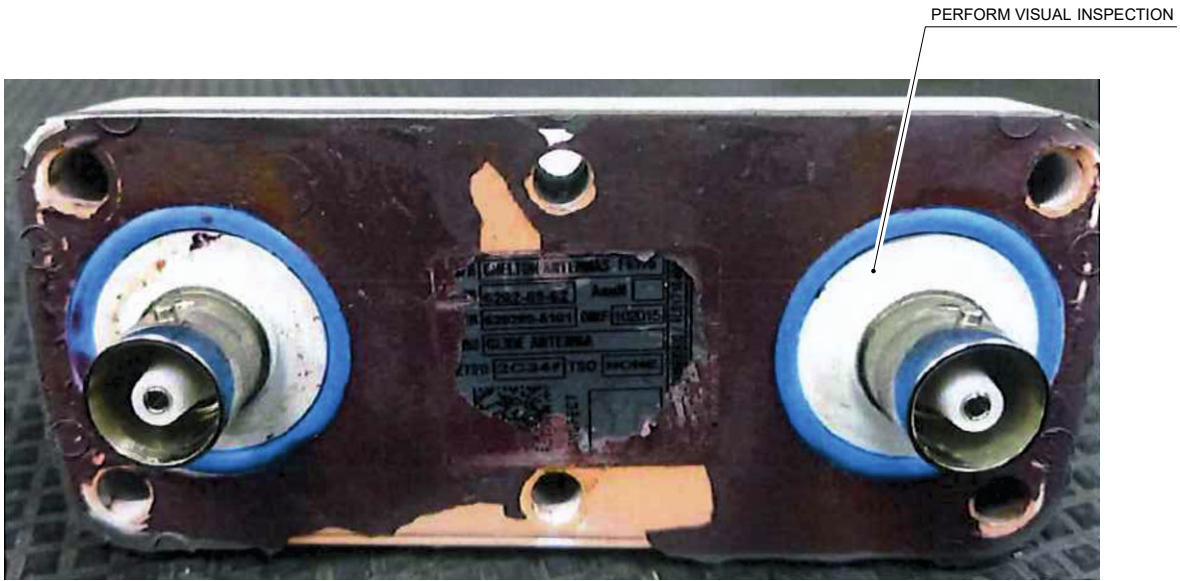
**VIEW D**  
**CORRECT ASSEMBLY PRACTICE**

GLIDE SLOPE ANTENNA P/N 6208-88-62. ANTENNA CORRECTLY MOUNTED, PRESENCE OF SEALANT IS NOT FOUND.  
(REFER TO FIGURE 2)

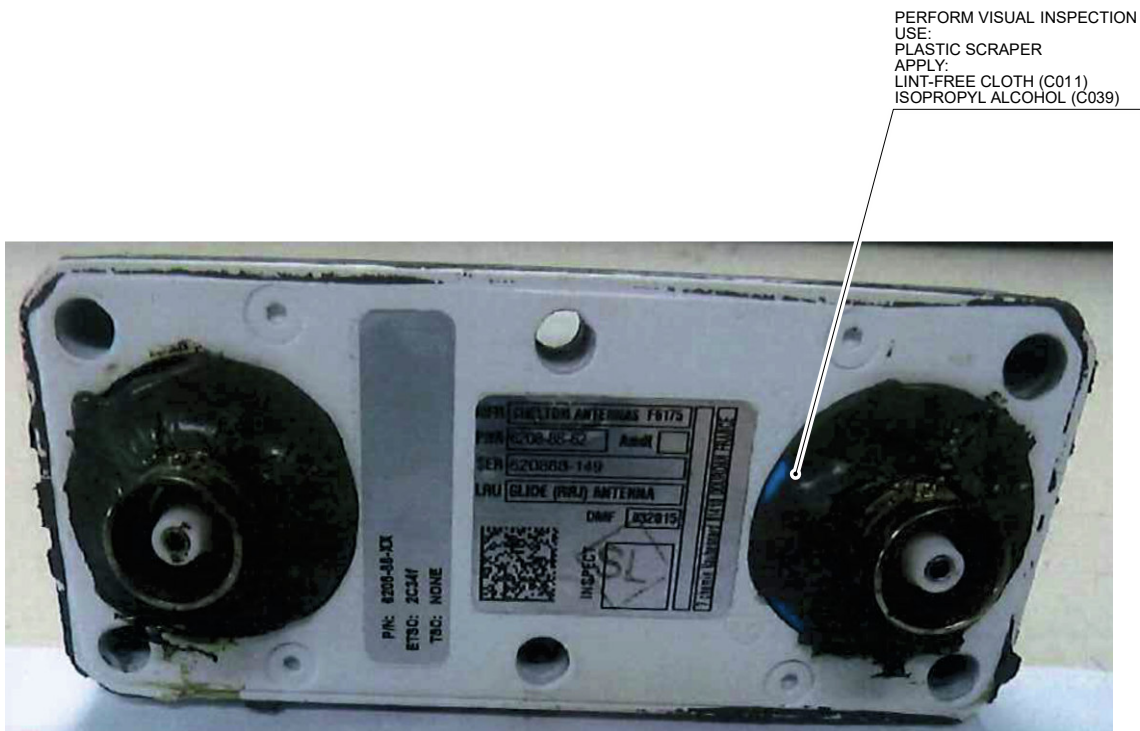
**VIEW D**  
**INCORRECT ASSEMBLY PRACTICE**

The description of the bottom picture “VIEW D – INCORRECT ASSEMBLY PRACTICE” has been changed.

“GLIDE SLOPE ANTENNA P/N 6208-88-62, ANTENNA INCORRECTLY MOUNTED, PRESENCE OF SEALANT IS FOUND”

A deeper investigation performed by the antenna supplier concluded that the root cause of the event were the two coaxial connectors isolated from their ground plane by the presence of grey mastic.

GLIDE SLOPE ANTENNA P/N 6208-88-62. ANTENNA INCORRECTLY MOUNTED, PRESENCE OF SEALANT IS FOUND.  
(REFER TO FIGURE 2)

- 6.5.1 If presence of sealant is not found after cleaning, go to step 7.
  - 6.5.2 If presence of sealant is still found, either on the antenna or on the coaxial connector(s), even after cleaning, record the persistent presence of sealant in the report in ANNEX B.
