SERVICE BULLETIN

N° 189-295

DATE: November 29, 2021

ATA 34 – GLIDE SLOPE ANTENNA INSPECTION

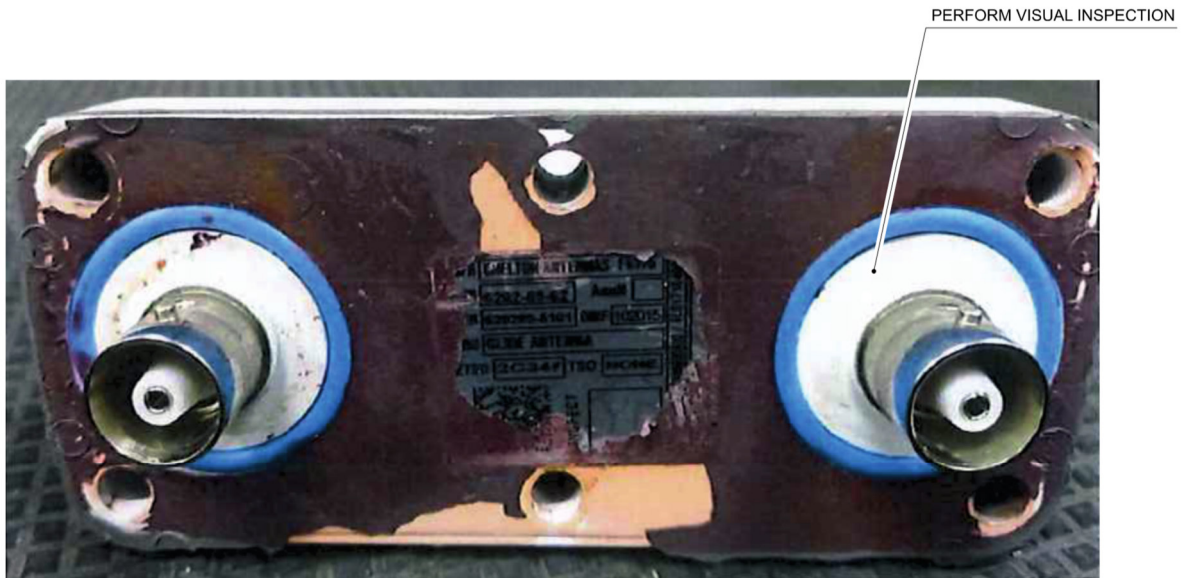
VIEW D
CORRECT ASSEMBLY PRACTICE

GLIDE SLOPE ANTENNA P/N 6208-88-62. ANTENNA CORRECTLY MOUNTED, PRESENCE OF SEALANT IS NOT FOUND.
(REFER TO FIGURE 2)

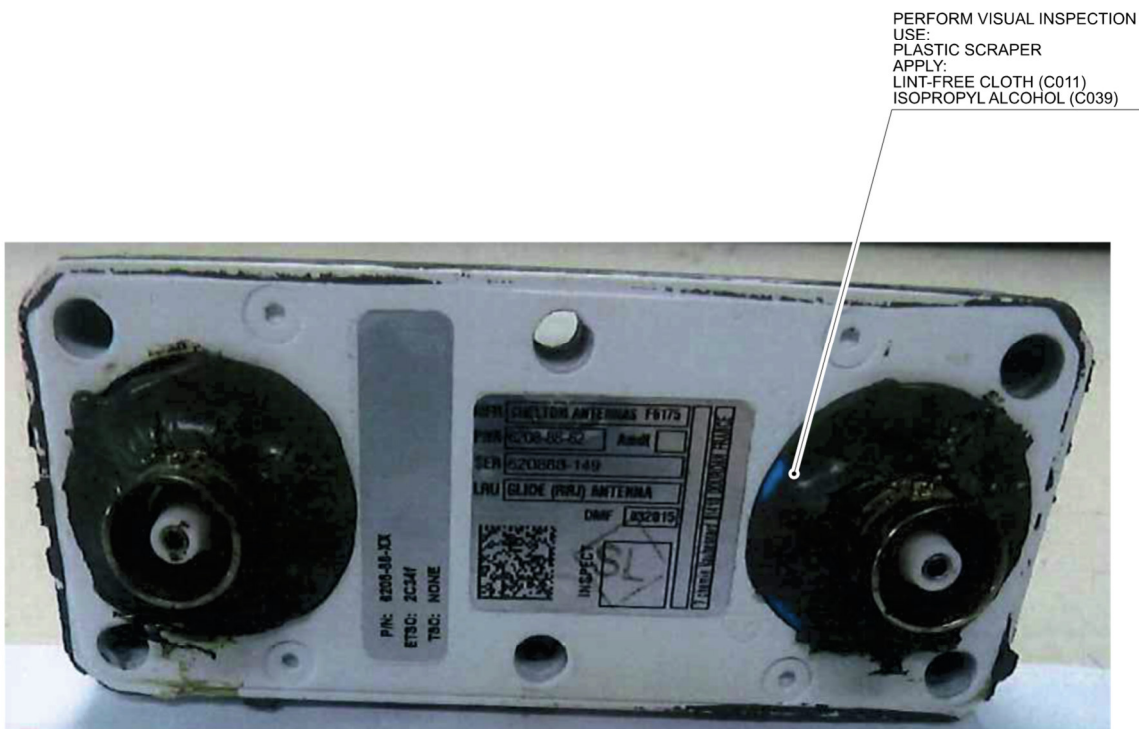
VIEW D
INCORRECT ASSEMBLY PRACTICE

A deeper investigation performed by the antenna supplier concluded that the root cause of the event were the two coaxial connectors isolated from their ground plane by the presence of grey mastic.

GLIDE SLOPE ANTENNA P/N 6208-88-62. ANTENNA CORRECTLY MOUNTED, PRESENCE OF SEALANT IS NOT FOUND.
(REFER TO FIGURE 2)

- 6.3 With reference to Figures 1 thru 3, carefully remove the sealant on all affected components by means of a plastic scraper and a lint-free cloth (C011) moistened with isopropyl alcohol (C039).
- 6.4 After the sealant removal, check that the connector plating is not damaged and that no residue remains inside the RF connectors.
