**SERVICE BULLETIN**

**N° 189-315**

**DATE:** October 20, 2022

**ATA 25 - EMERGENCY LIFE-RAFT SYSTEM, ACTUATION CABLE INSTALLATION**

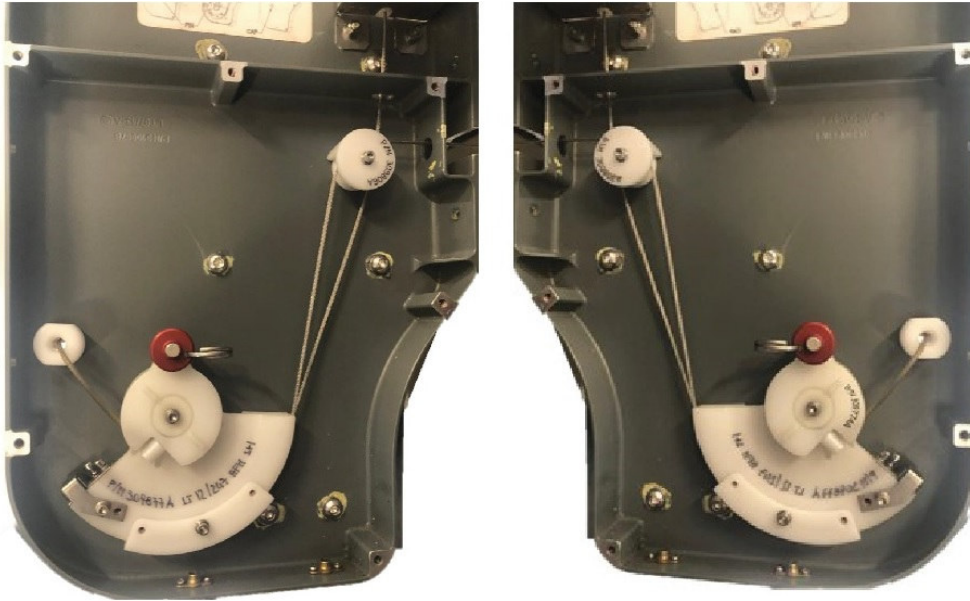
Control cable on RH ELS

Control cable on LH ELS

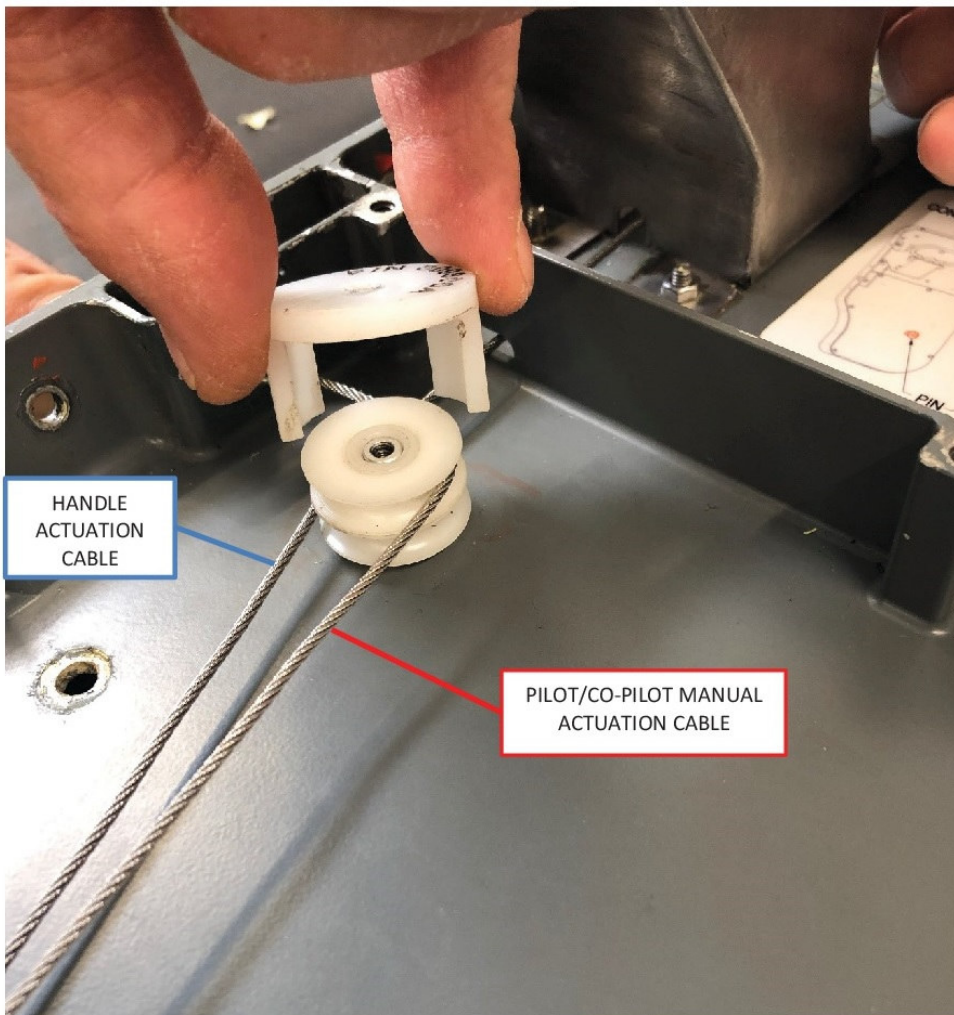
**Figure 1**

- 3.4.2 Make sure that the pulley cover is correctly installed. Check if the P/N stamped on the pulley cover is in the position shown in Figure 1.
  - 3.4.3 Make sure that the control cable is correctly installed as showed in Figures 1 and 2. The control cables must go into the pulley cover through the smallest opening and come out through the largest one.

Pulley cover installation

- 3.4.1 Inspect the pulley cover for condition. No damage / wear to pulley cover is permitted. In case it's not possible to properly inspect the whole cover, its removal is required (in this case, steps 3.4.2 and 3.4.3 have to be skipped). In case of any damages, take pictures of the pulley cover and fill the Inspection report in Figure 5. Then replace the pulley cover P/N 309806A with a new one.

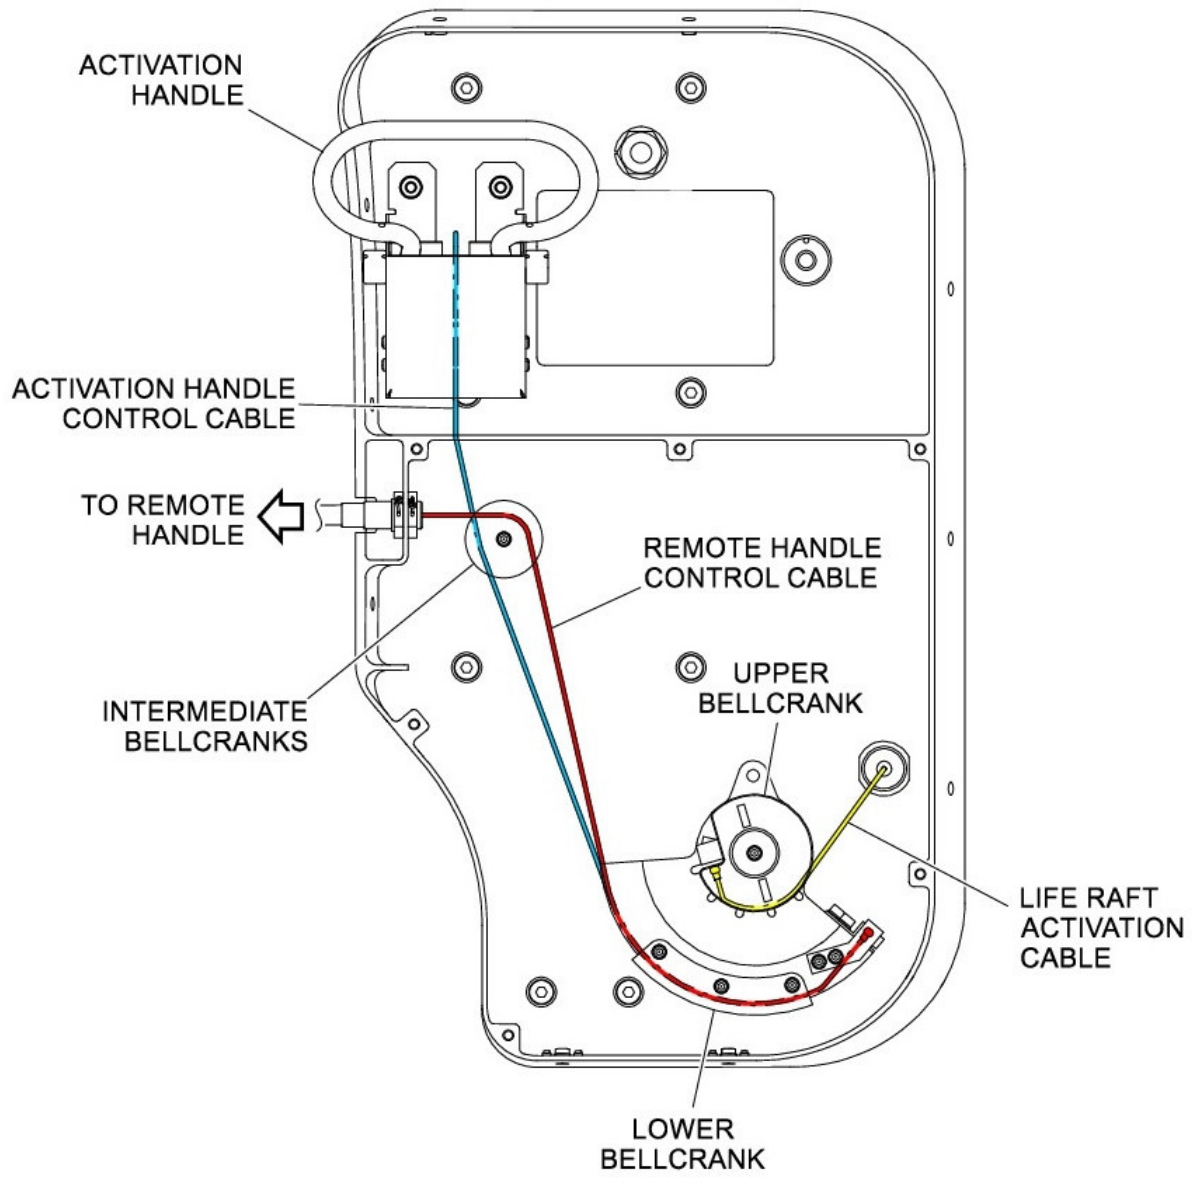
Figure 2

CONTROL CABLE PATHS

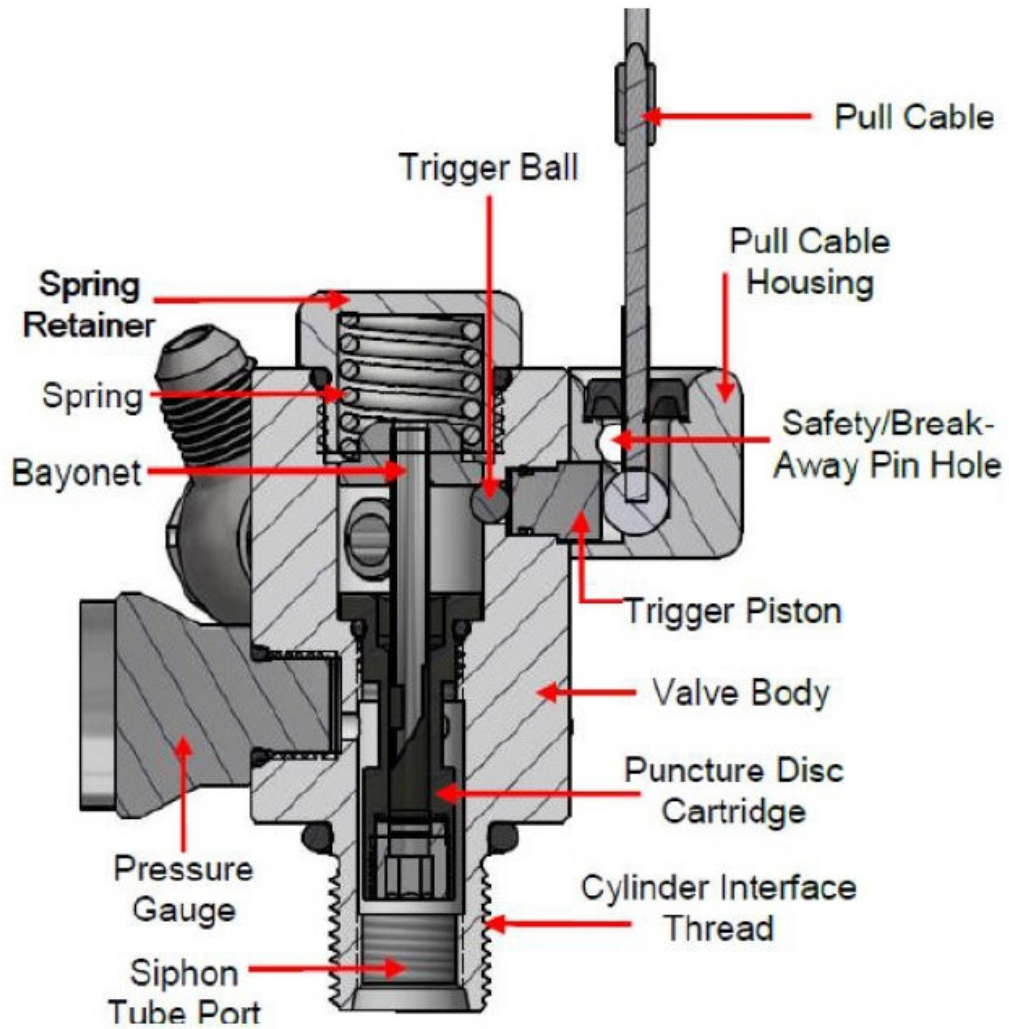
Figure 3

- 3.3.4 Install the safety pin and then gently push the activation cable inside the valve. Make sure that the trigger ball end on the inflation valve does not move.
- 3.3.5 In case the condition reported in Step 3.3.4 is not verified, fill the Inspection report in Figure 5. Then perform Part II of this Service Bulletin to immediately replace the life raft, or go to next step 3.3.6. Otherwise go to Step 3.3.7.

CYLINDER INFLATION VALVE
