**SERVICE BULLETIN**

**N° 189-384**

**ATA 78 – EJECTOR DUCT INSPECTION**

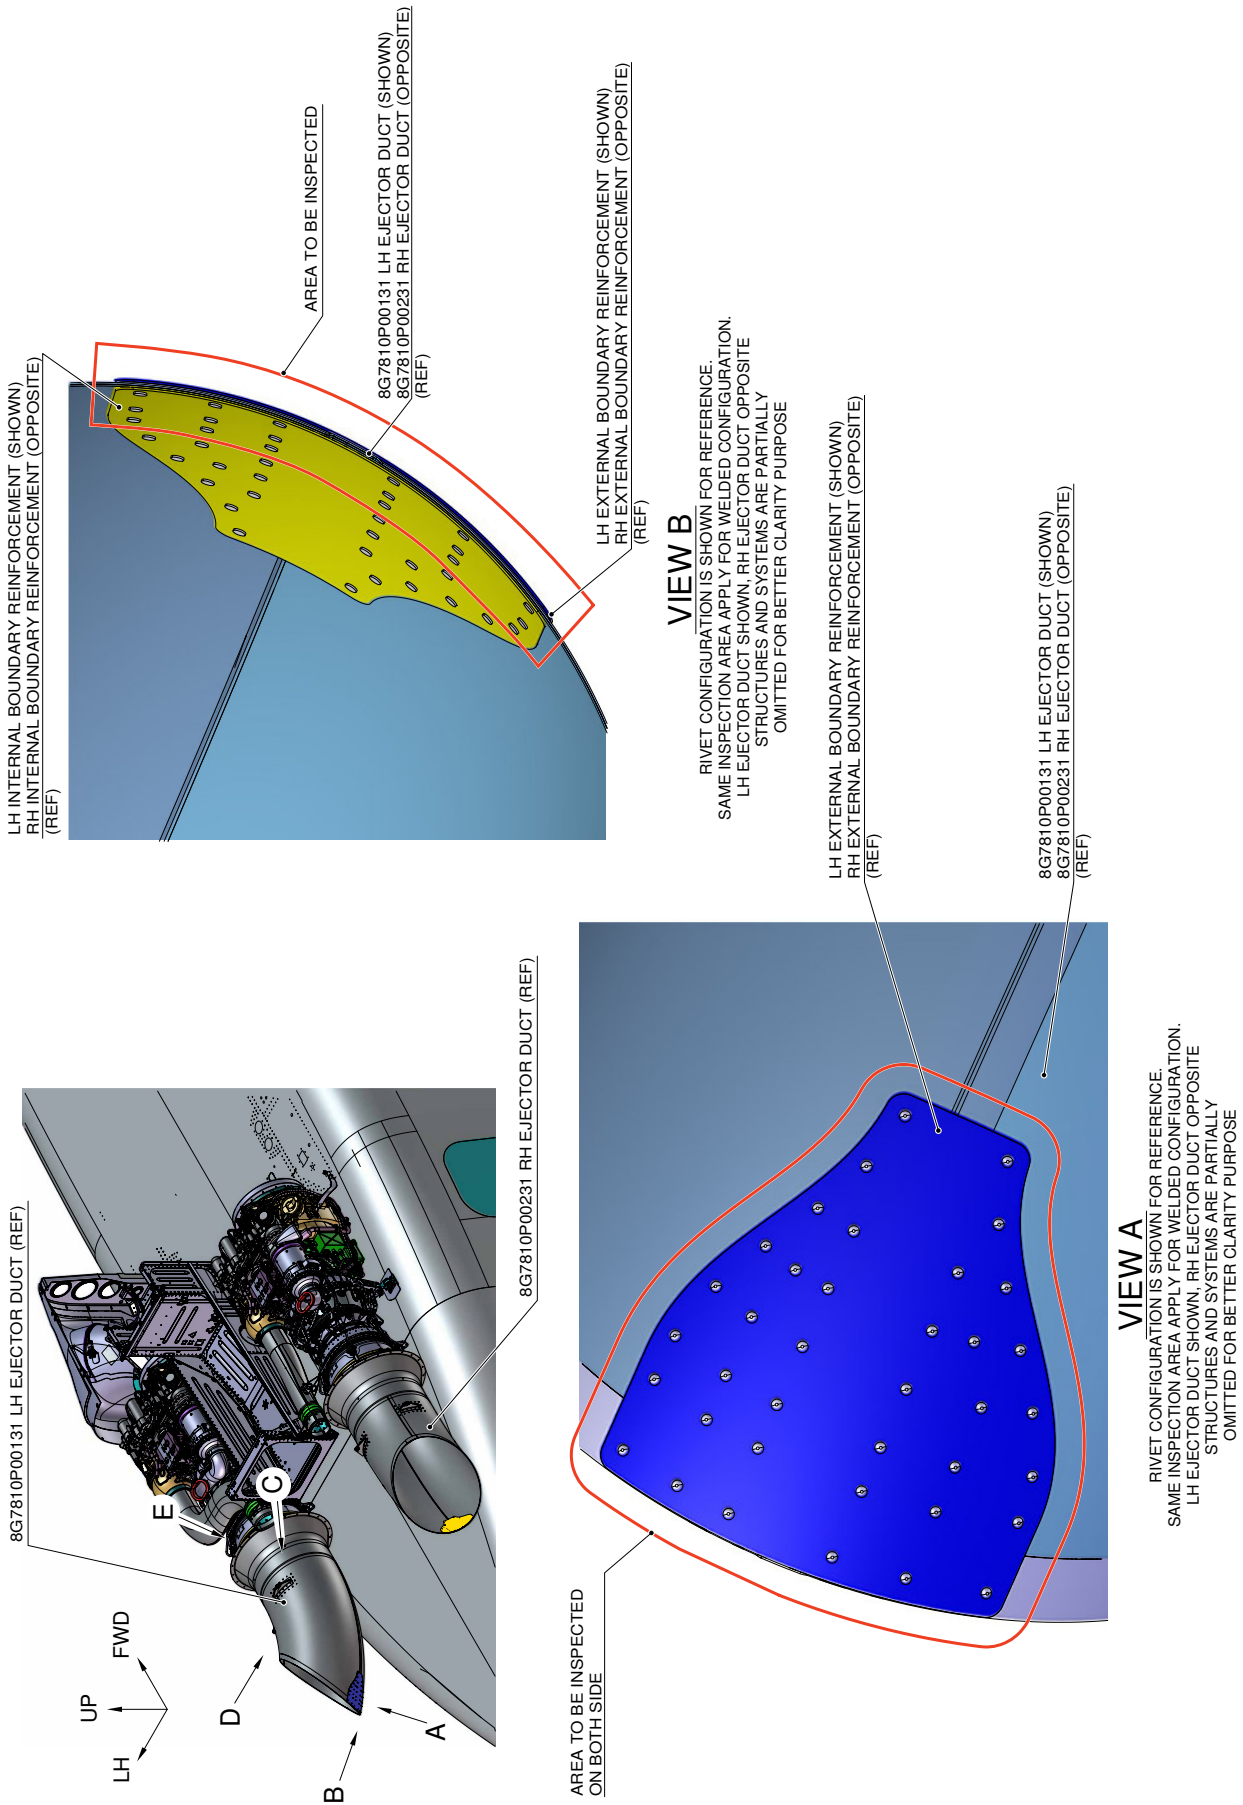
**Figure 1**

Leonardo Helicopters received reports about damages on the ejector ducts LH P/N 8G7810P00131 in the area of the boundary reinforcement plate. In some cases, if the crack is not detected, the damage could lead to the detachment of the reinforcement plates area.

- 2.2 With reference to Figure 1, perform a detailed visual inspection of the area highlighted in figure for cracks, missing rivets or condition of welding points, firstly referring to the trailing edge of the duct (see View A) (through-thickness) and secondly to the border of the reinforcement plates (see View B) both inboard and outboard sides. Use a light source and a magnifier. Make sure that the reinforcement is correctly installed (no missing rivets or welding not damaged) and that it does not move with respect to the ejector.
- 2.3 In case of no findings, skip to Step 3. Otherwise, take a picture of the crack and the damaged reinforcement and fill the report in Figure 2. Send pictures and report to Leonardo Helicopters at the following mail box:  
[engineering.support.lhd@leonardo.com](mailto:engineering.support.lhd@leonardo.com).

- 3.2 With reference to Figure 1, perform a detailed visual inspection of the area highlighted in figure for cracks missing rivets or condition of welding points, firstly referring to the trailing edge of the duct (see View A) (through-thickness) and secondly to the border of the reinforcement plates (see View B) both inboard and outboard sides. Use a light source and a magnifier. Make sure that the reinforcement is correctly installed (no missing rivets or welding not damaged) and that it does not move with respect to the ejector.
- 3.3 In case of no findings, skip to Step 4. Otherwise, take a picture of the crack and the damaged reinforcement and fill the report in Figure 2. Send pictures and report to Leonardo Helicopters at the following mail box: [engineering.support.lhd@leonardo.com](mailto:engineering.support.lhd@leonardo.com).

- 2.4 Replace the damaged ejector duct in accordance with the following procedure:
  - 2.4.1 In accordance with AMP DM 89-A-78-10-01-00A-520A-B, remove and return to Leonardo Helicopters the damaged LH ejector duct for investigation.
  - 2.4.2 In accordance with AMP DM 89-A-78-10-01-00A-720A-B, install a serviceable ejector duct LH P/N 8G7810P00131.
3. In accordance with AMP DM 89-A-06-41-00-00A-010A-A and with reference to Figure 1, get access to the ejector duct RH P/N 8G7810P00231 and perform the inspection as described in the following procedure:
  - 3.1 With reference to Figure 1, clean the surface of the ejector duct by means of a cleaning solvent (C010) and a soft lint-free cloth (C011).

- 3.4 Replace the damaged ejector duct in accordance with the following procedure:
  - 3.4.1 In accordance with AMP DM 89-A-78-10-02-00A-520A-B, remove and return to Leonardo Helicopters the damaged RH ejector duct for investigation.
  - 3.4.2 In accordance with AMP DM 89-A-78-10-02-00A-720A-B, install a serviceable ejector duct RH P/N 8G7810P00231.
4. Return the helicopter to flight configuration and record for compliance with this Service Bulletin on the helicopter logbook.
5. Gain access to My Communications section on Leonardo WebPortal and compile the "Service Bulletin Application Communication".
