SERVICE BULLETIN

TITLE: Shafts - Internal inspection of the rear section of the rear transmission shaft

| Model: | AS350 |
| Component affected: | 350A34-0210-XX |

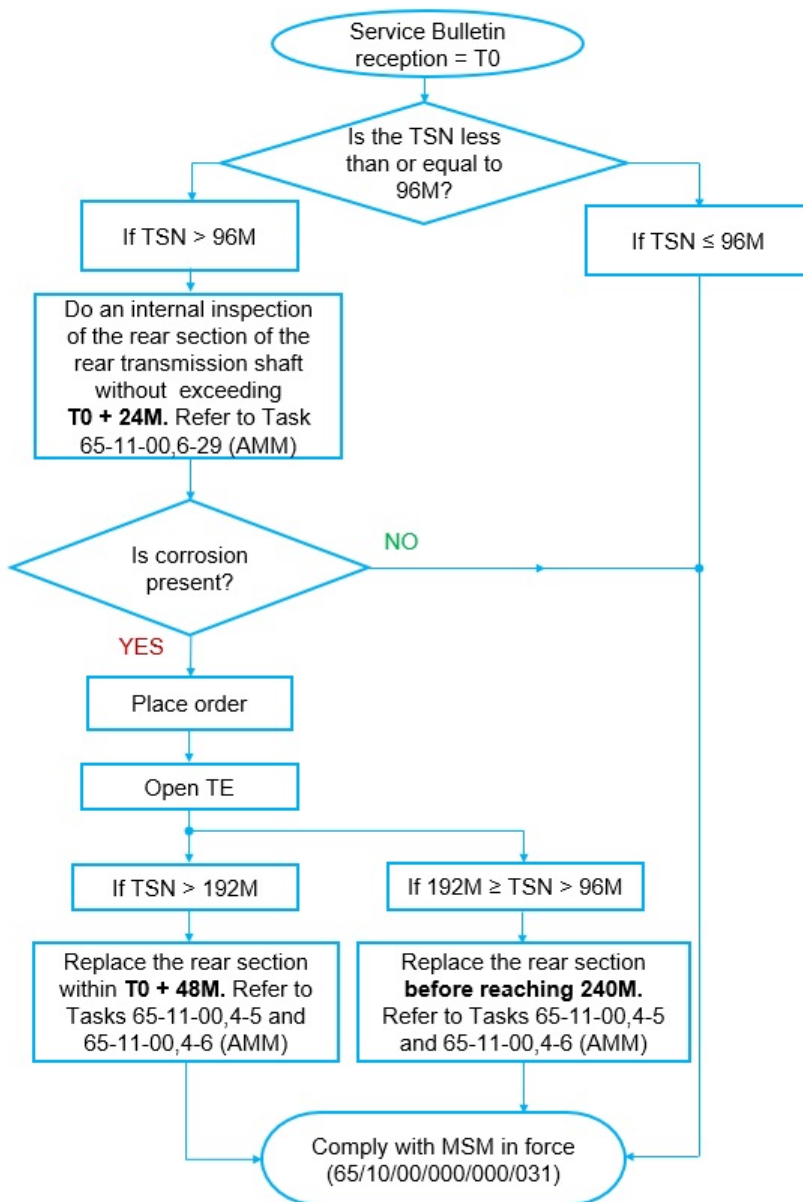
Airbus Helicopters recommends that you comply with the limits of the flowchart below to do the first internal inspection of the rear section of the rear transmission shaft:

- Do a check of the TSN of the rear transmission shaft
- Do the inspection given in the AMM (within a time limit that depends on the TSN of the shaft).
 - If there is no corrosion, resume flights.
 - Depending on the result of the inspection, replace the shaft (within a time limit that depends on the TSN of the shaft).

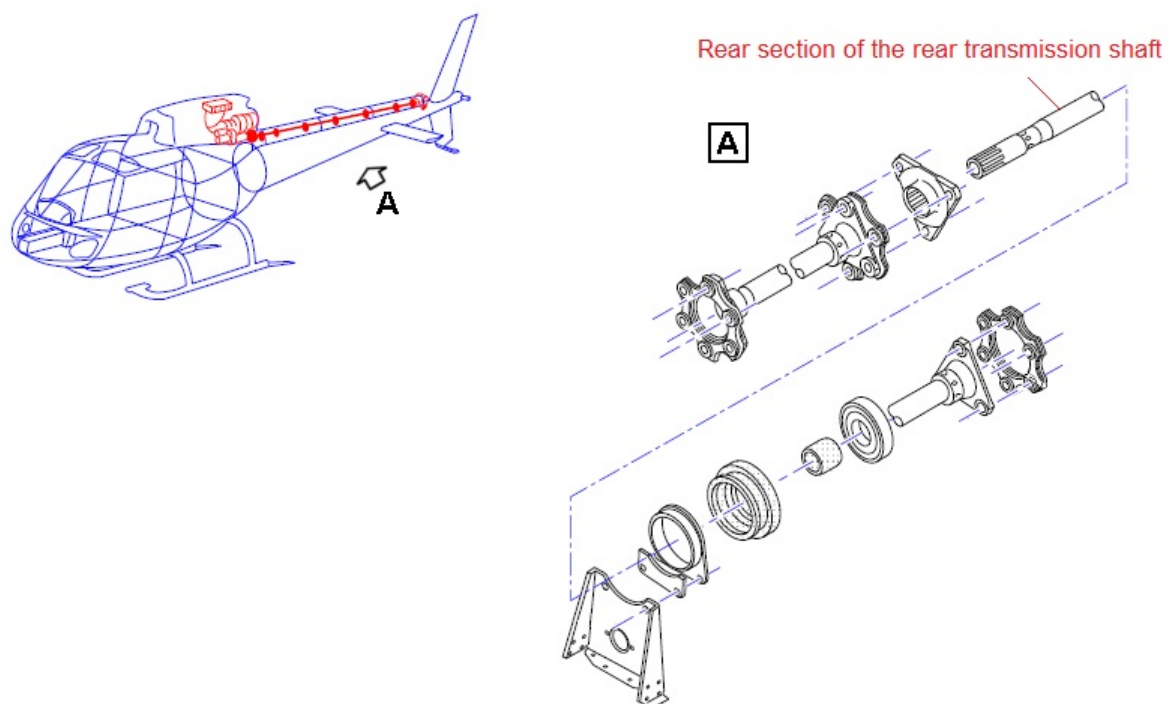
GENERAL ILLUSTRATION

Airbus Helicopters has been informed of the discovery of corrosion marks inside the rear section of the rear transmission shaft on the Ecureuil family.
