SERVICE BULLETIN

TITLE: TIME LIMITS - SCHEDULED-UNSCHEDULED MAINTENANCE
- Inspection of the mounting bushings of the horizontal stabilizer

Model:	AS365
Version:	N , N1 , N2 , N3 , F , Fs , K , K2

The purpose of this Service Bulletin is to identify the configuration of the horizontal stabilizer and to do a periodic condition check of the mounting bushings of the horizontal stabilizer PRE MOD 074545.

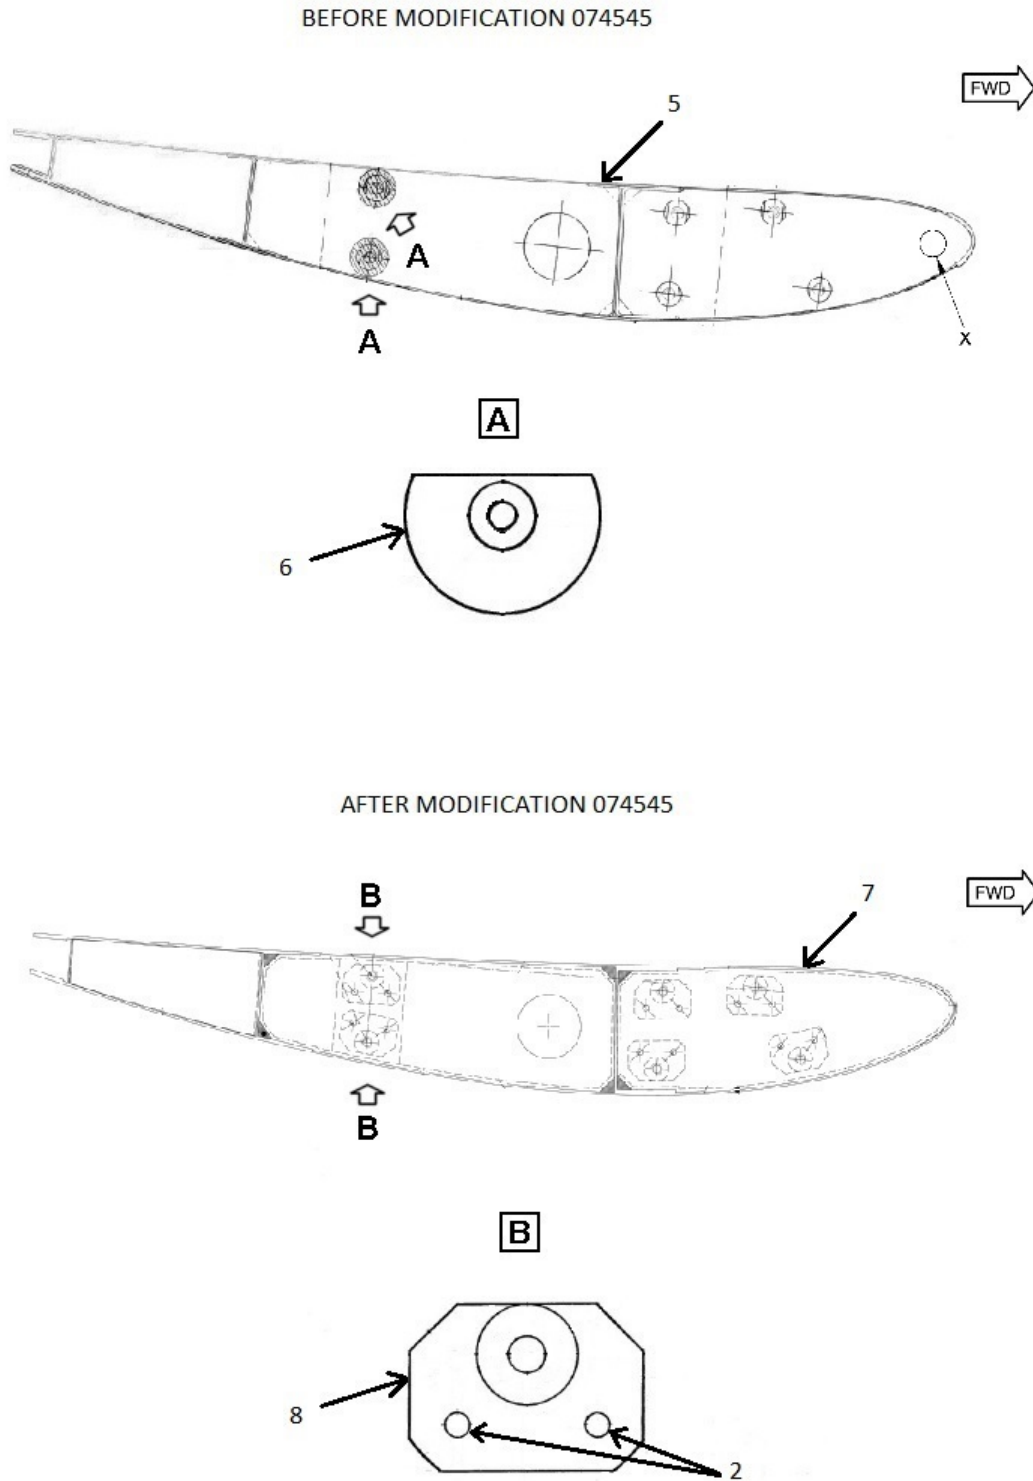
Figure 1

4.2.2. Do a visual check of the attachment of all the bushings (6) or (8) to identify the configuration of the horizontal stabilizer (PRE or POST MOD 074545) ([\(Figure 1\)](#)):

4.2.2.1. If the horizontal stabilizer (7) is equipped with a bushing (8) and two rivets (2), refer to Detail B, Figure 1:

4.2.2.2. If the horizontal stabilizer (5) is equipped with a bushing (6), refer to Detail A, Figure 1:

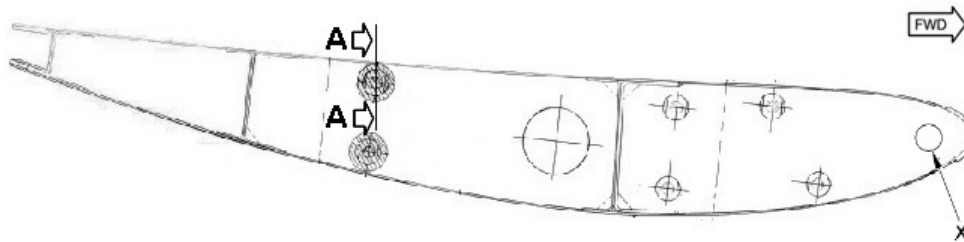
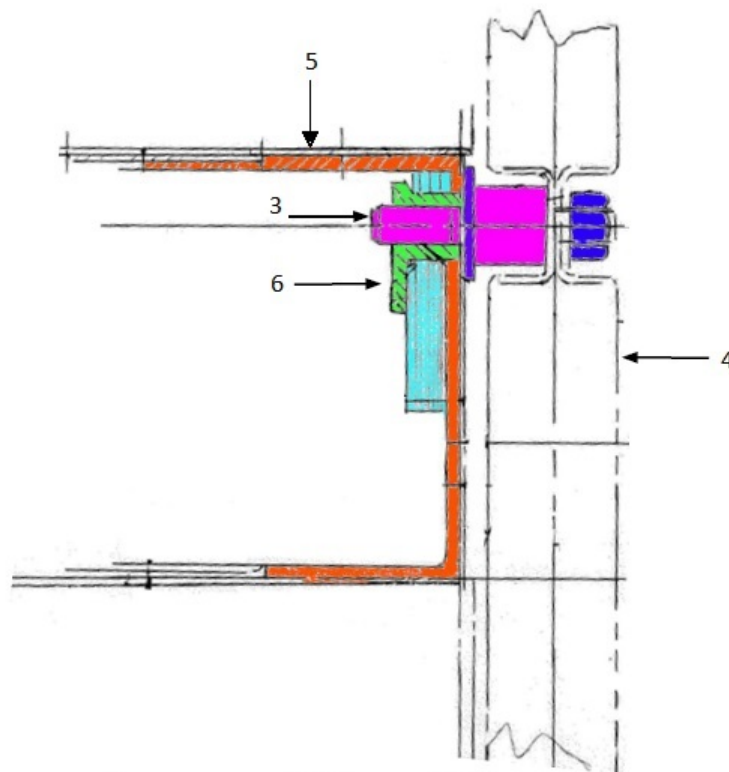
Figure 2

The investigation revealed that the half of the shoulder of the bushing had separated from the internal reinforcement of the horizontal stabilizer, at the rear of the right side spoiler attachment studs. The two rear studs were held in place but the shoulder of bushings inside the horizontal stabilizer were missing.

The four bushings were in place and showed some corrosion.

The presence of corrosion can lead to the failure of the bushings of the internal reinforcement of the horizontal stabilizer.

4.2.1. If necessary, remove the studs (3) (Section A-A, [\(Figure 2\)](#)).

- 4.3.2. Do an endoscopic inspection with the Borescope assembly (1) (not shown) on the inner surface of all the bushings (6) (Figure 2) to make sure that there is no corrosion or crack. Refer to [MTC 20-90-03-103](#).

- Comply with paragraph 5. CLOSE UP.
 - 4.3.3.2. If there is corrosion and/or a crack at least one bushing (6):
 - Replace all the bushings (6). Refer to Work Card [MRM 55-10-10-777](#).
