SERVICE BULLETIN

N° **139-725**

DATE: July 25, 2022

ATA 64 – TAIL ROTOR DUPLEX BEARING INSPECTION AND REPLACEMENT

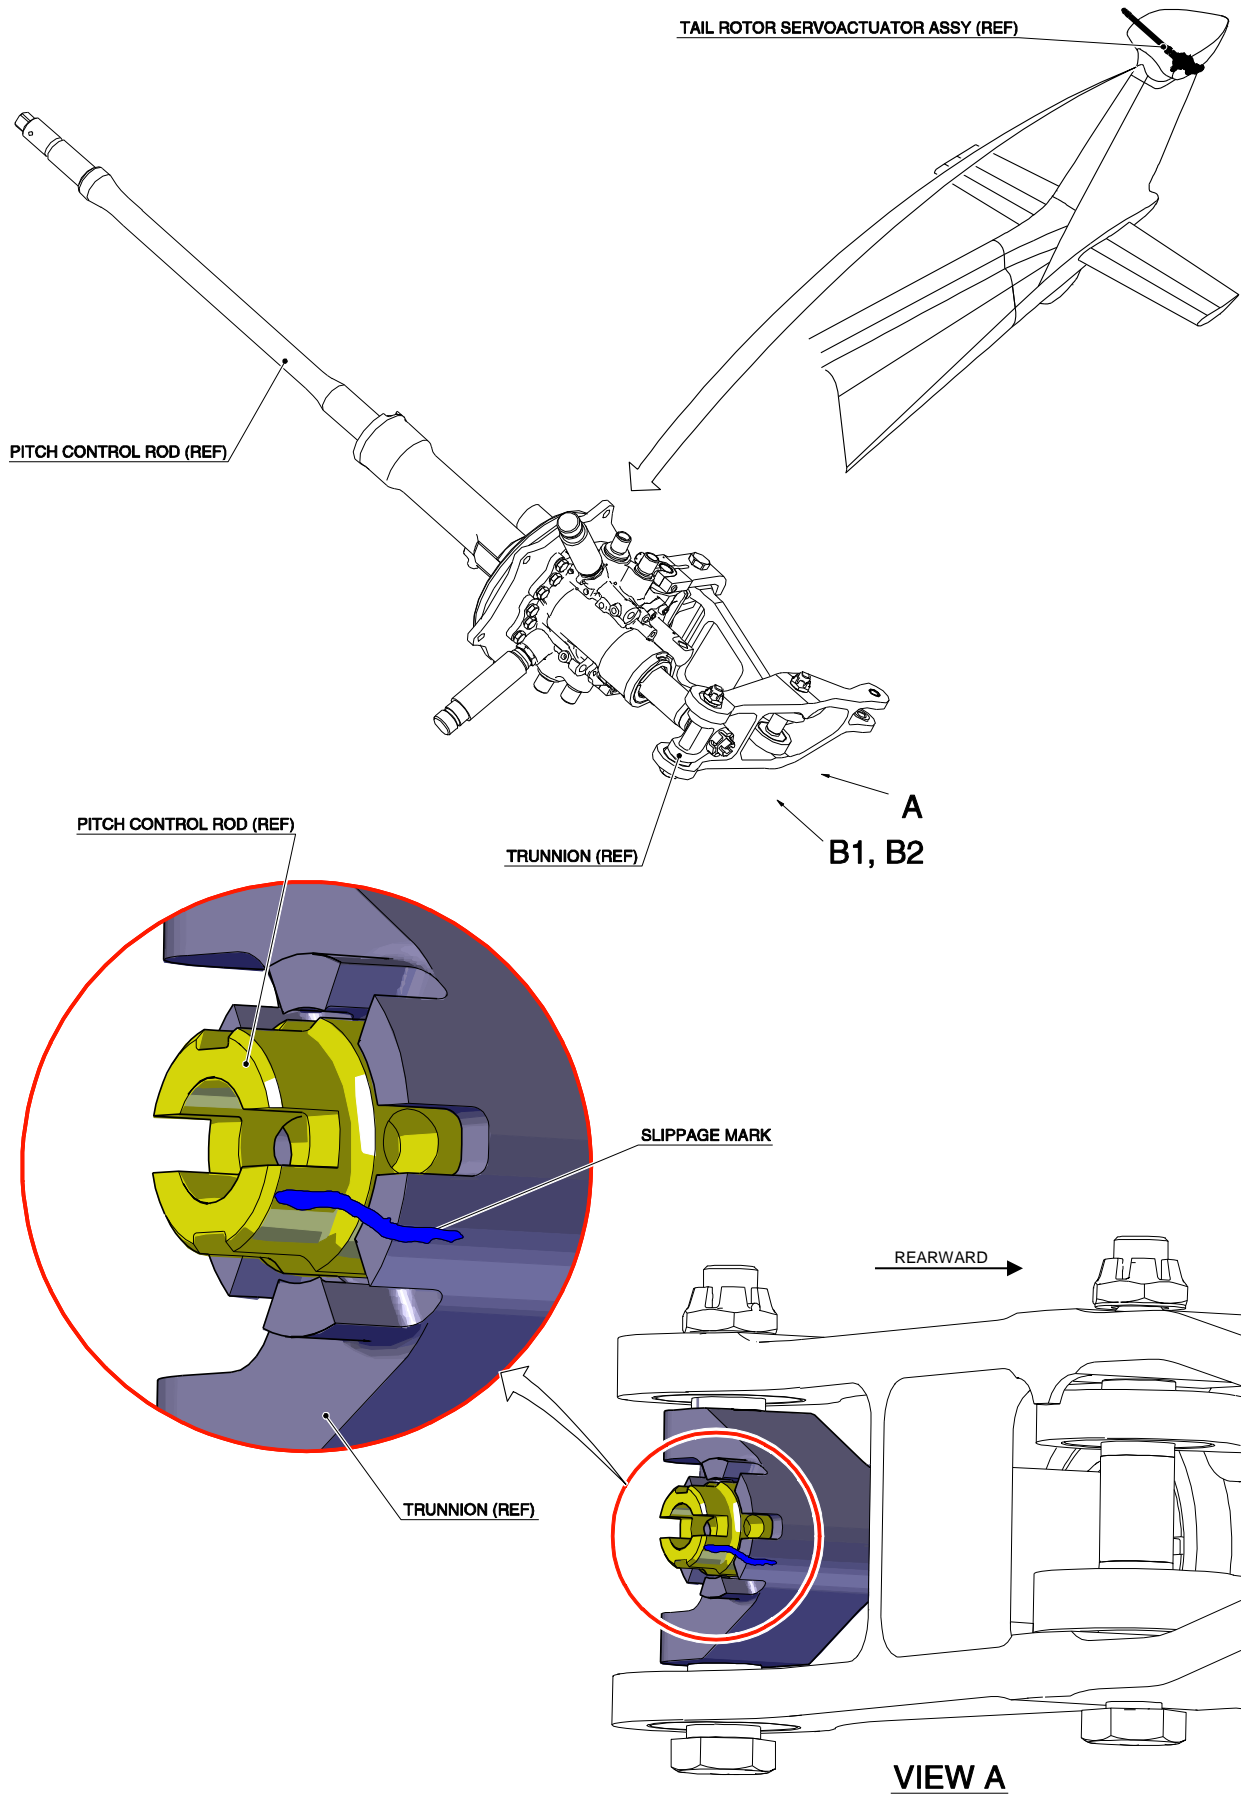
- 3.1.2 With reference to Figure 1 view A and in accordance with the applicable steps of AMP DM 39-A-20-00-00-00A-69CA-A apply a slippage mark on the mating edge between the trunnion and the pitch control rod on the rearward facing side, near the cotter pin.

- 3.2 If Part I has already been applied before, with reference to Figure 1 view A, check for the alignment of the slippage mark. If rotation is found proceed to step 4, otherwise skip to step 5.

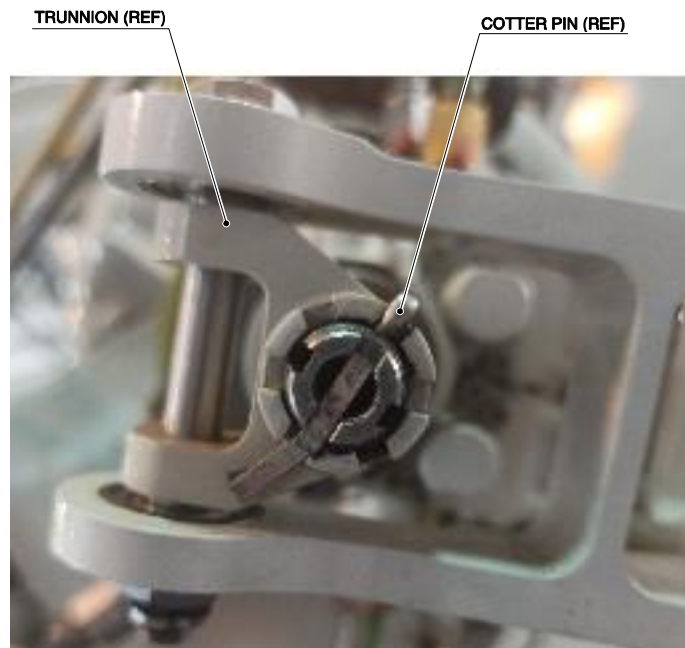
- 3.1.1 With reference to Figure 2 views B1 and B2, check that the castellated holes of the trunnion are aligned with those of the pitch control rod that goes thru it and check that the cotter pin is perfectly straight and not bended by a rotation movement. If rotation is found skip to step 4.

CORRECT COTTER PIN INSTALLATION WITH NO SIGN OF ROTATION
VIEW B1

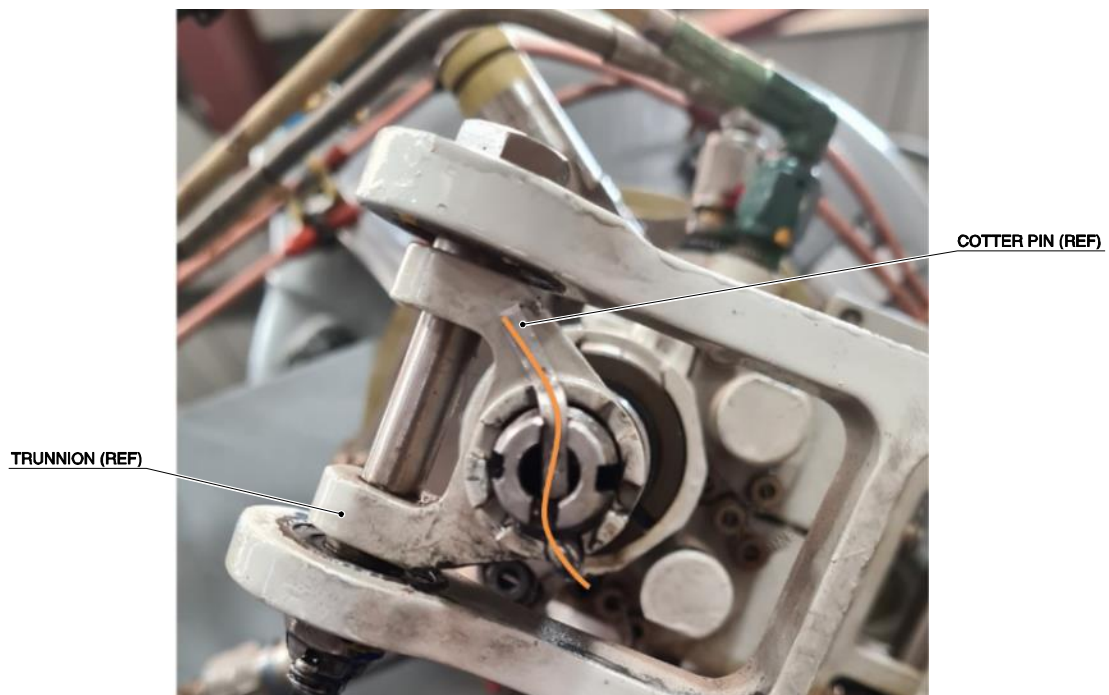
Leonardo Helicopters has developed this Service Bulletin following a reported occurrence of a tail rotor duplex bearing found damaged on an AW139. The investigation found that the bearing was removed and reinstalled on another sliding control assembly, even though AMP procedures do not allow reinstallation of a previously removed bearing.

5. With reference to Figure 2 views B1 and B2, perform the inspection for rotation between the parts by checking that the castellated holes of the trunnion are aligned with those of the pitch control rod that goes thru it and checking that the cotter pin is perfectly straight and not bended by a rotation movement. If rotation is found proceed to step 6, otherwise skip to step 7.

EVIDENCE OF ROTATION OF THE PITCH CONTROL ROD
VIEW B2

4. Replace the duplex bearing in accordance with the following procedure:
 - 4.1 In accordance with AMP DM 39-A-64-31-04-00A-520A-A and with reference to Figure 3, remove the sliding control assembly from the helicopter.

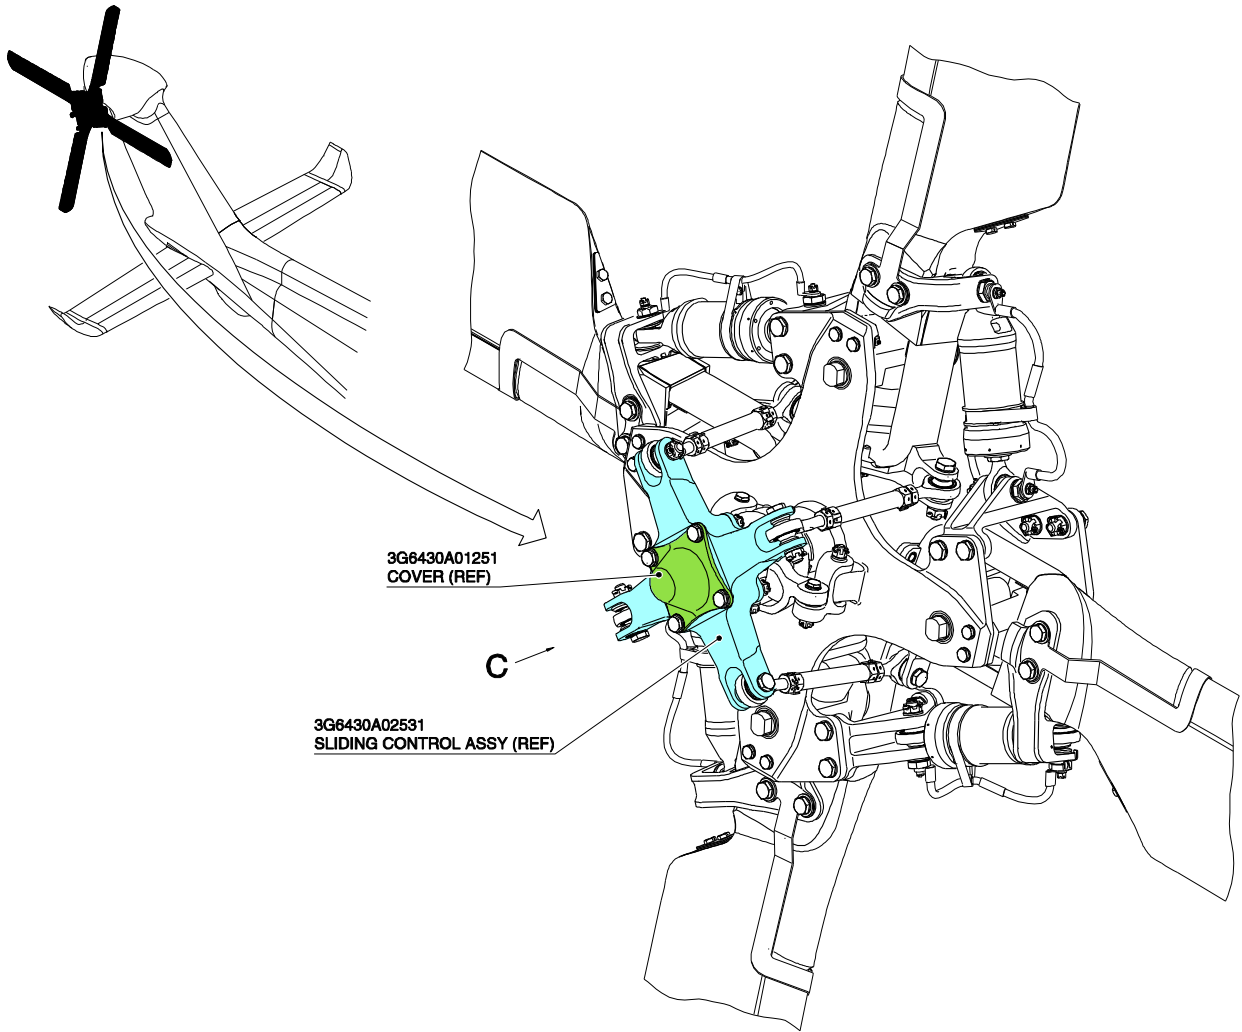
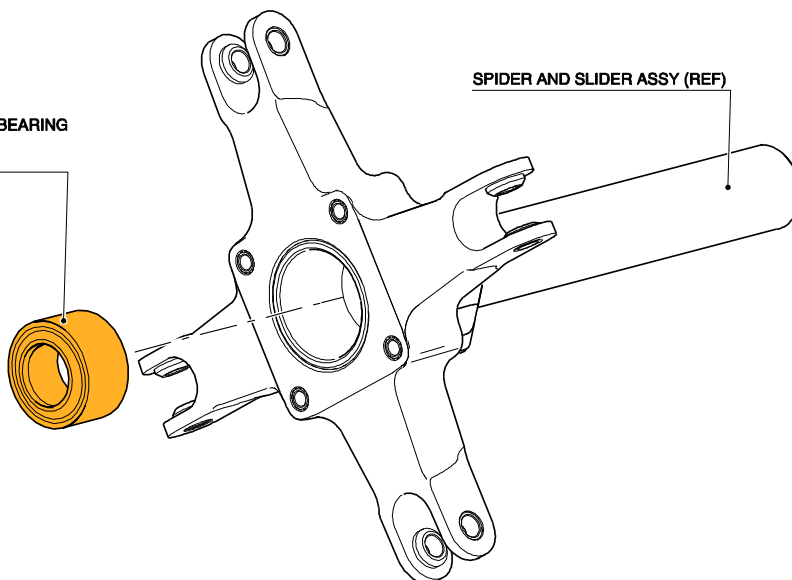
Figure 3

REMOVE:
TAIL ROTOR DUPLEX BEARING
INSTALL:
NEW ITEM

- 4.2 In accordance with AMP DM 39-A-64-31-04-01A-921A-B and with reference to Figure 3, replace the tail rotor duplex bearing with a new item and discard the removed one.

4. In accordance with AMP DM 39-A-64-31-04-00A-520A-A and with reference to Figure 3, remove the sliding control assembly from the helicopter.
5. In accordance with AMP DM 39-A-64-31-04-01A-921A-B and with reference to Figure 3, replace the tail rotor duplex bearing with a new item and discard the removed one.
