SERVICE BULLETIN

N° **139-731**

ATA 00 – FORWARD CABIN ROOF CEILING HARNESS INSPECTION

This Service Bulletin is issued in order to prescribe one-off inspections of the Forward Cabin Roof Ceiling Harnesses and their installation in the area between STA 3120 and 3900 to identify potential chafing conditions.

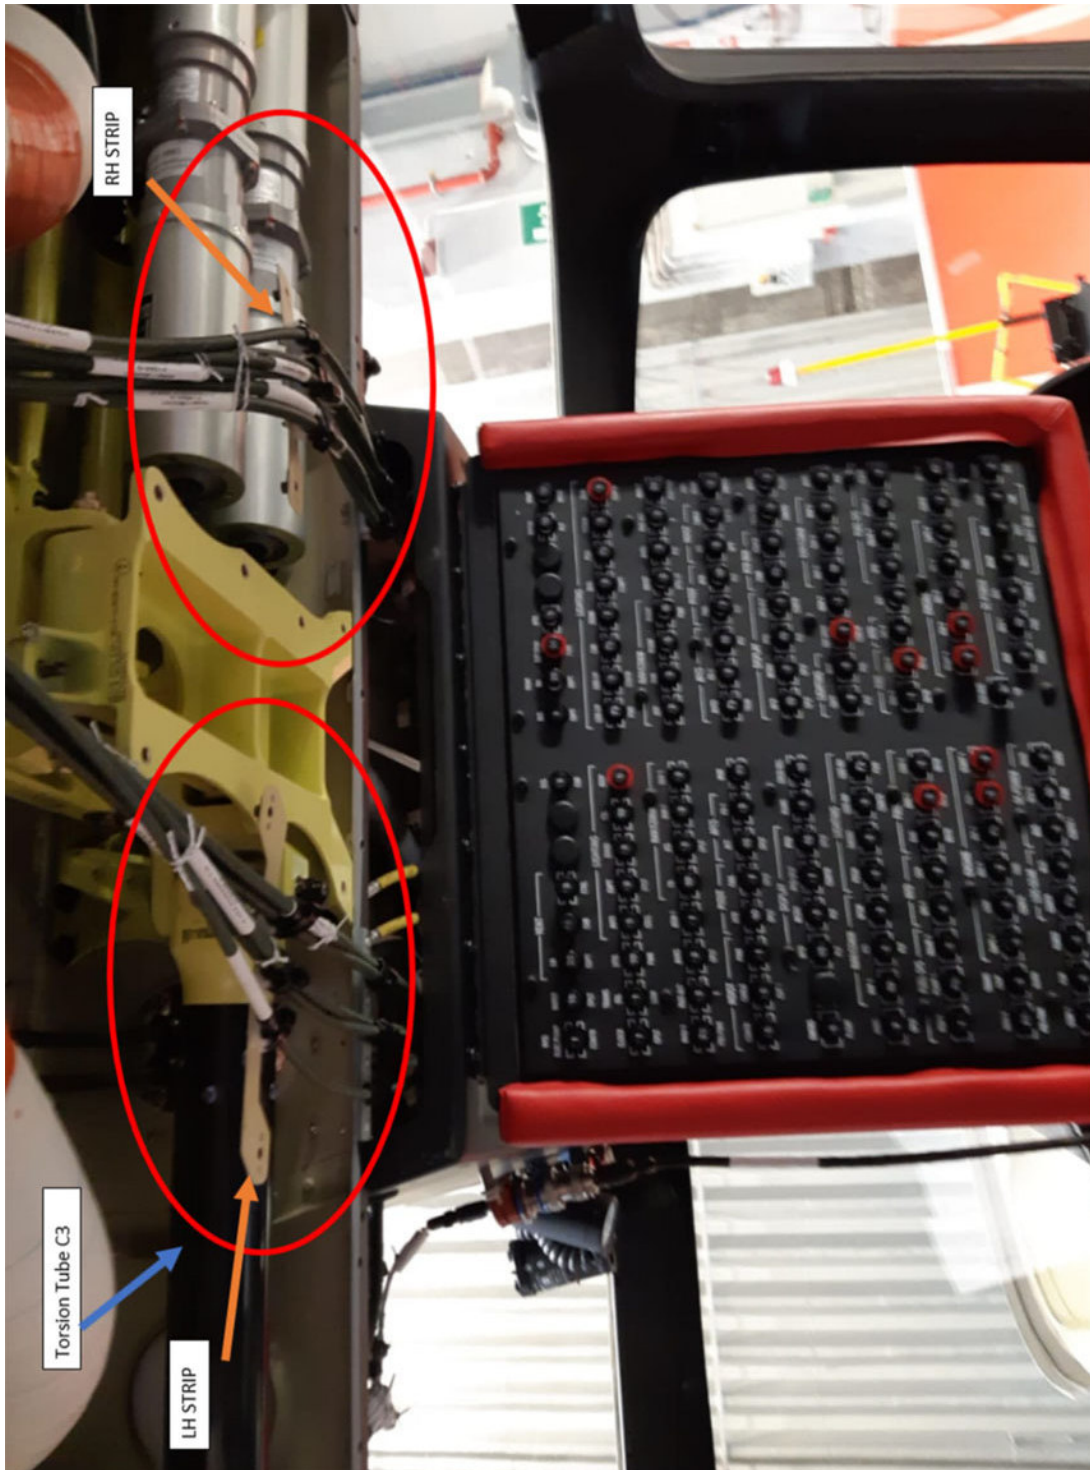
Figure 2

- 3.2 With reference to Figure 2, perform a visual inspection of the Torque Tube C3 P/N 3E6711A00433. Make sure that there is no damage on the tube. If damage is found, contact Product Support Engineering (engineering.support.lhd@leonardo.com) in order to receive further instruction.

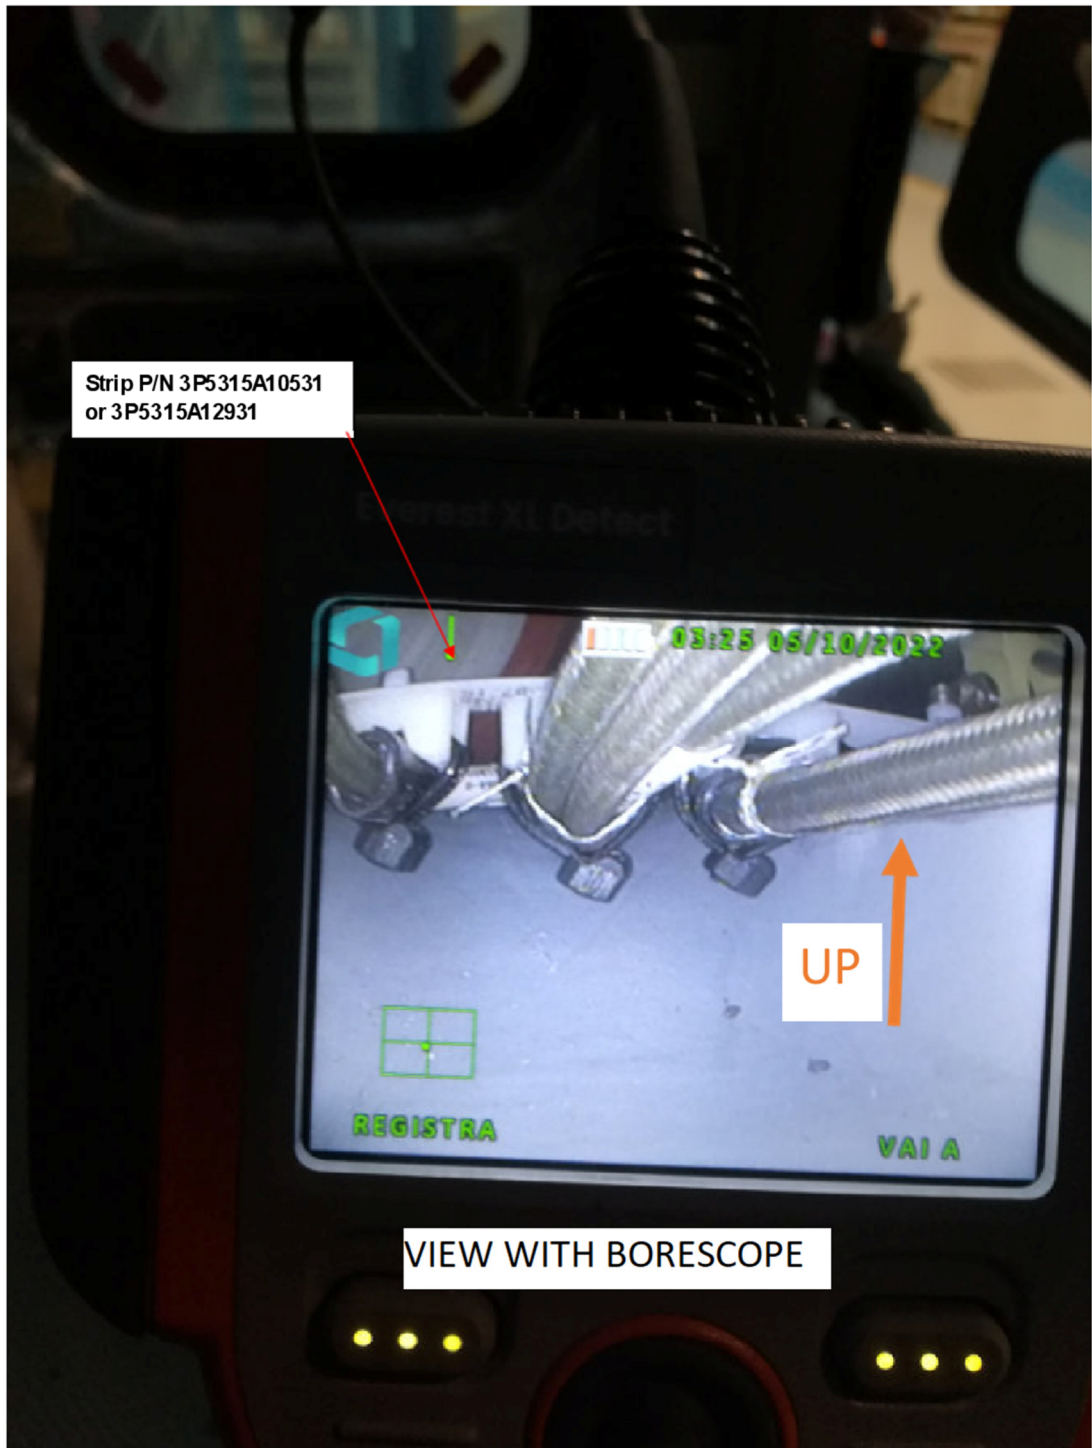
Figure 3

When C/A installation is correct, C/A are installed below the RH/LH strips P/N 3P5315A10531 and P/N 3P5315AA12931, as shown in Figure 3.

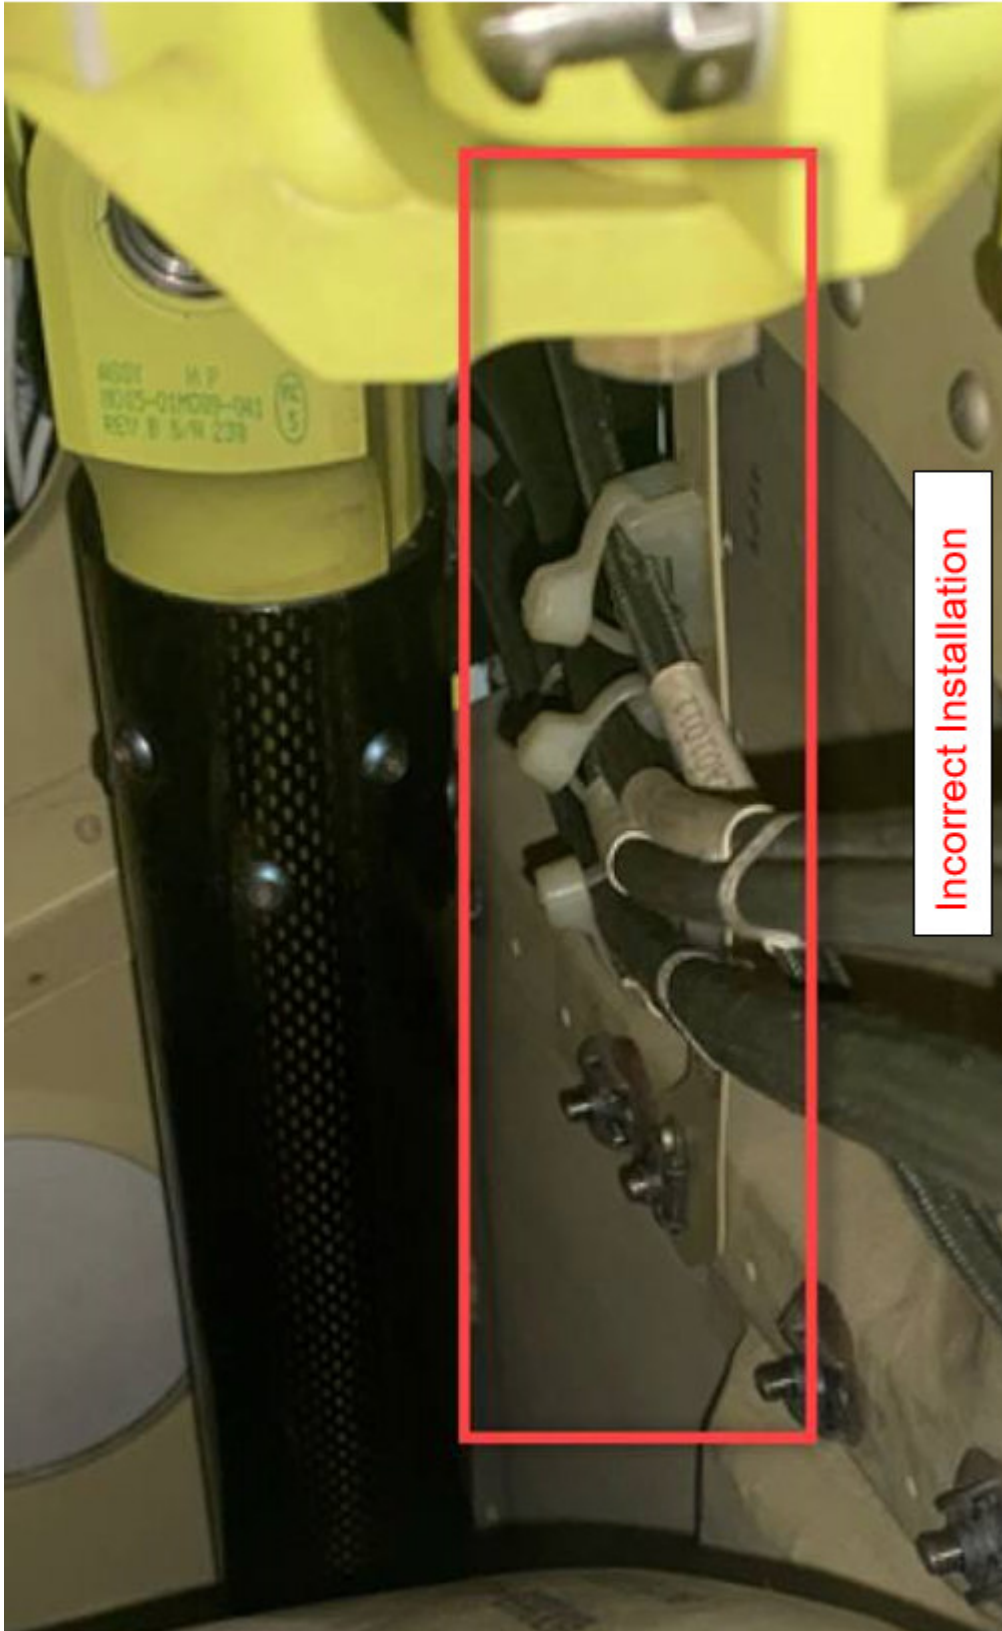
- 2.1.4 If C/As are installed above the strips P/N 3P5315A10531 and/or P/N 3P5315A12931 as per Figure 4 “Incorrect Installation”, go to step 3.
- 2.1.5 If C/As are installed correctly as shown in Figure 3, go to step 5 and close SB Part I application.

- 3.3 With reference to Figure 4 and to Figure 6 thru 9 perform strip installation adjustment as described in the following procedure:
 - 3.3.1 With reference to Figure 4, remove C/A from supports AW001CL504B-N6 installed on strips P/N 3P5315A10531 and/or P/N 3P5315A12931.

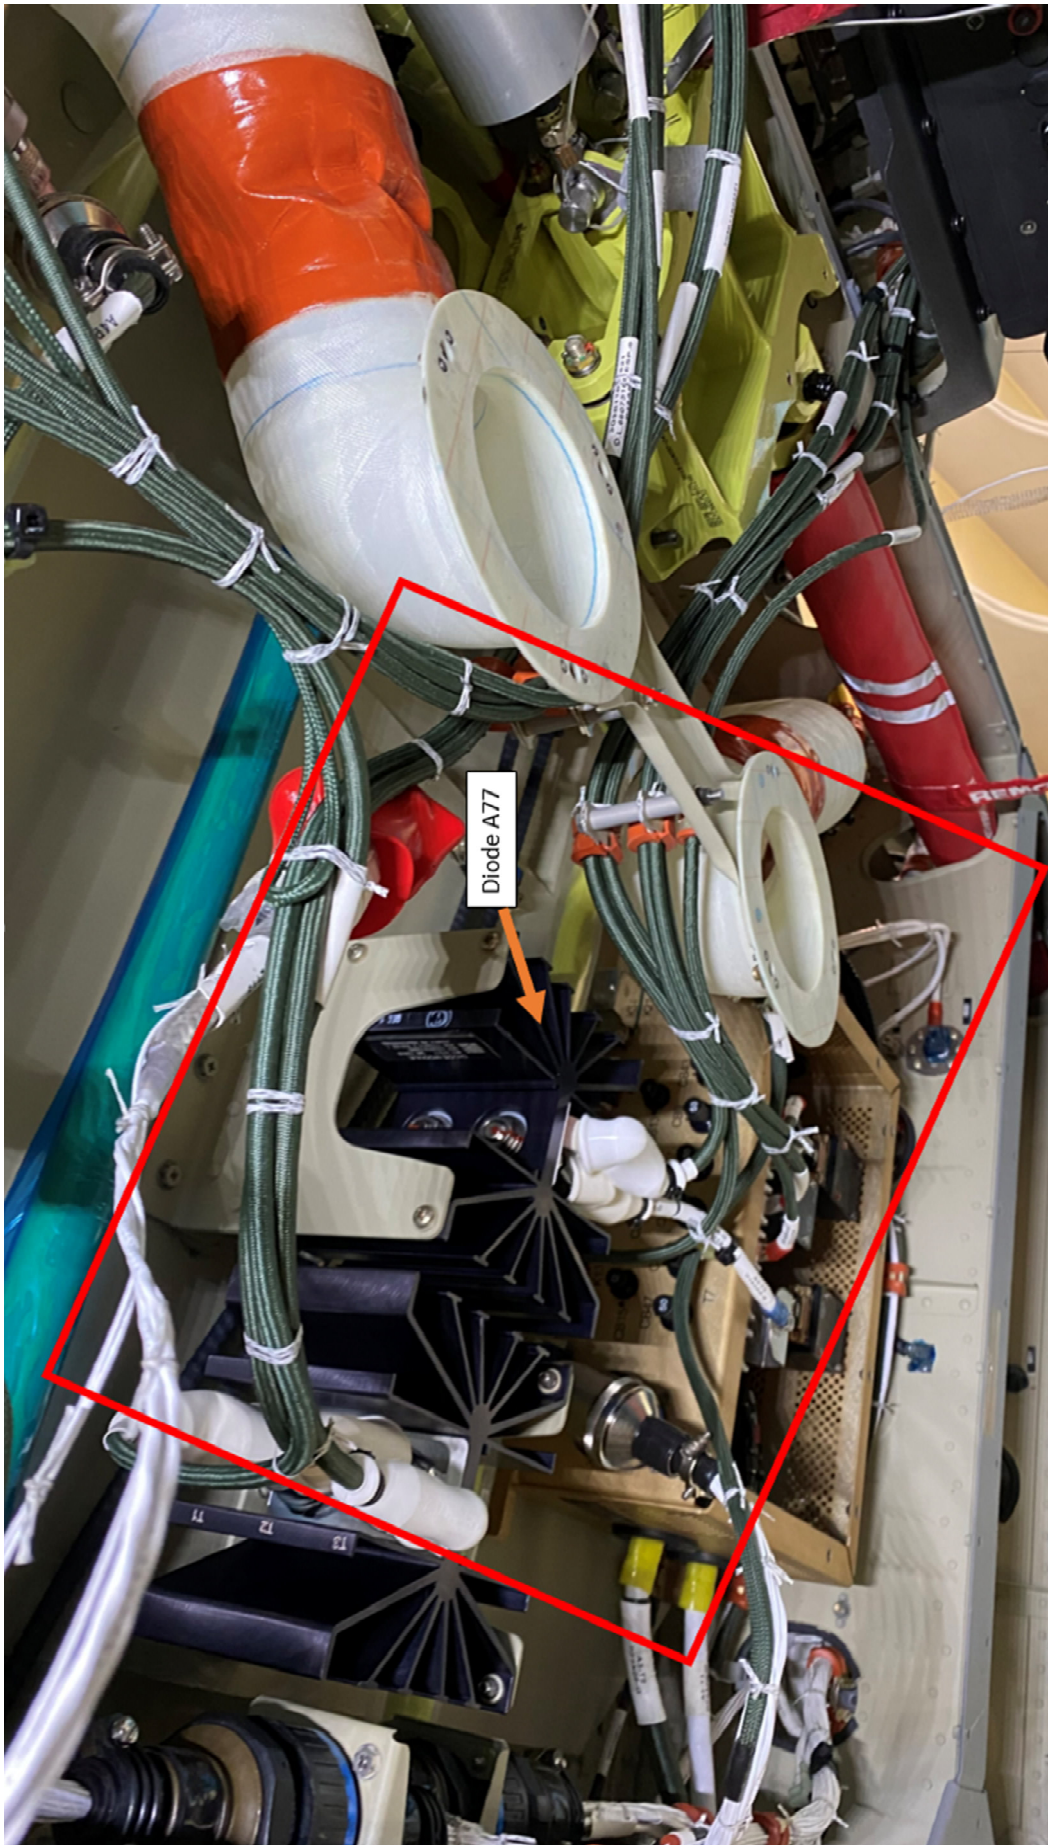
- 2.1.1 With reference to Figure 10, check for chafing or damage on the cable harness in the area showed.
 - 2.1.2 In case of any finding, contact Product Support Engineering (engineering.support.lhd@leonardo.com) in order to receive further instruction.

- 2.1.4 If necessary, in accordance with Figure 10 and Figure 11, re-route the cable harnesses (using if needed also lacing cord to fix the cables with each other) in order to respect the clearance of at least 10.0 mm from the diode or any other surrounding structure or component.

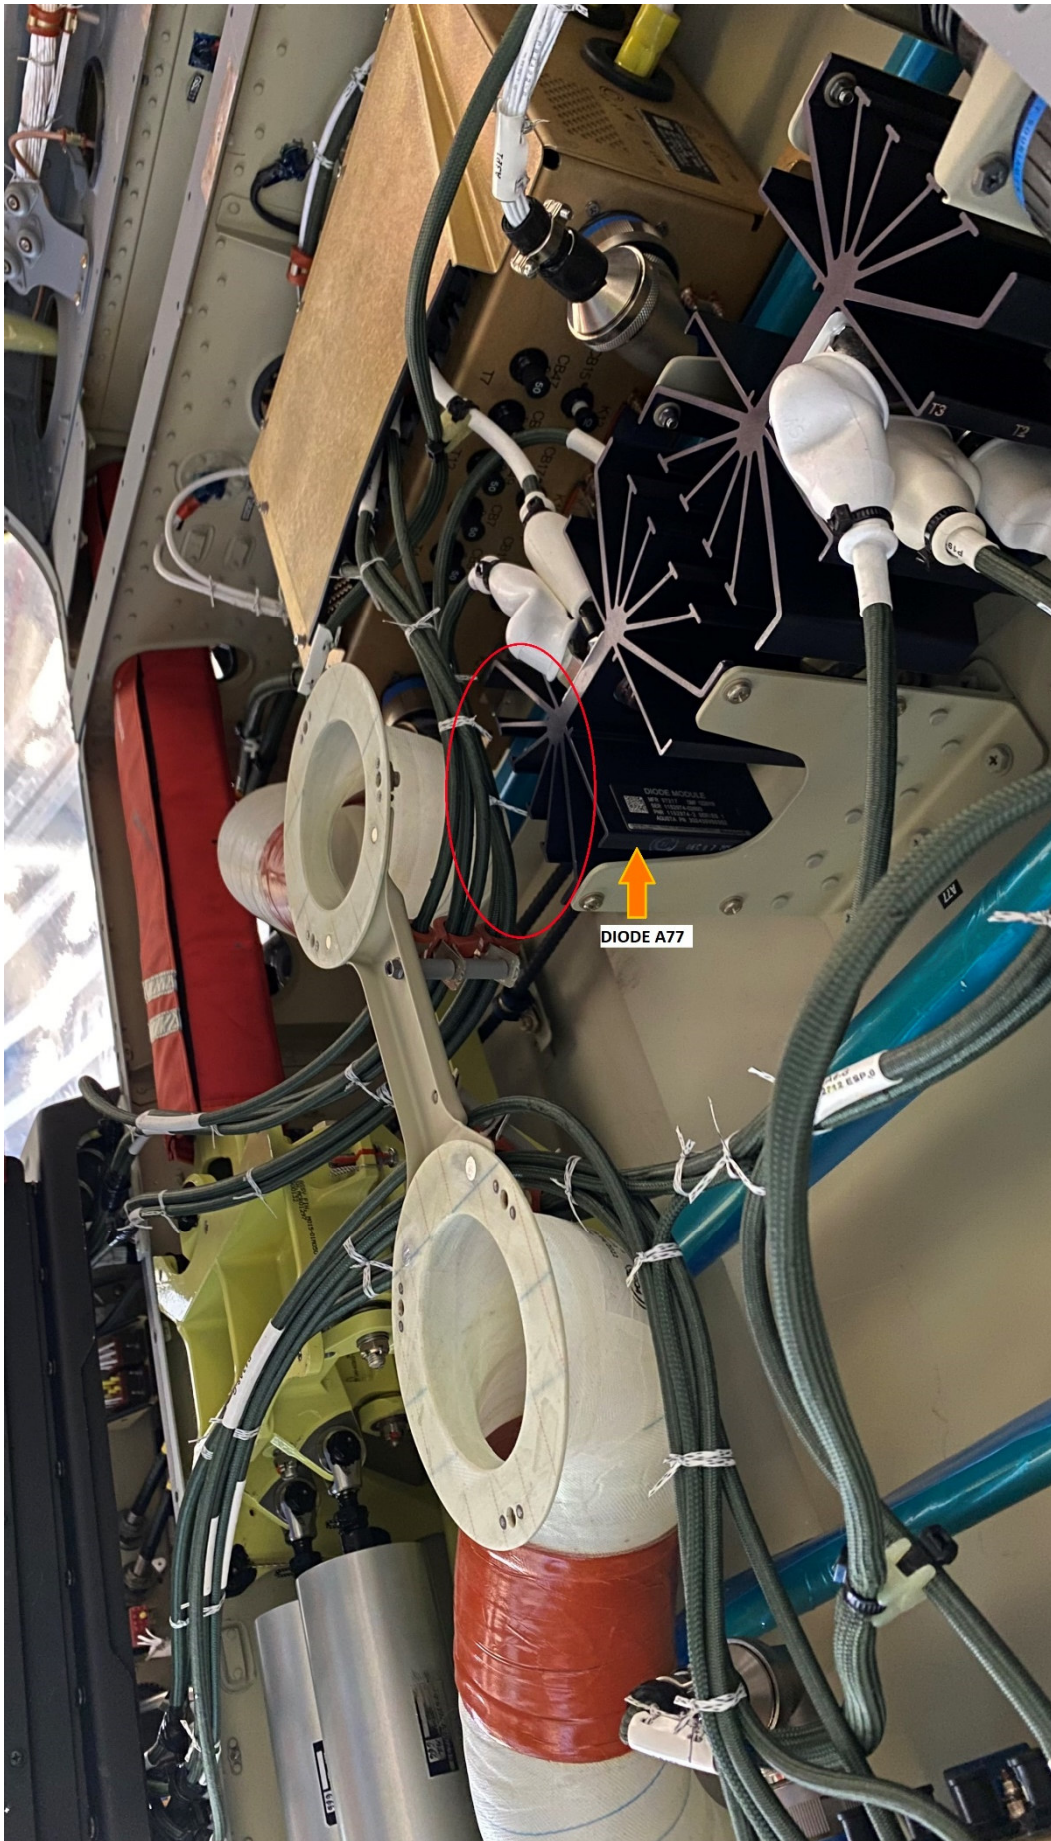
Figure 11

- 2.1.3 With reference to Figure 10 and Figure 11, ensure that clearance of at least 10.0 mm exists in the area inside the red circle shown in Figure 11, between the cable harness and Diode A77 P/N 3G2430V00352.
