No. EC120-52-021

SERVICE BULLETIN

DOORS - CARGO DOOR AND REAR ACCESS DOOR
New EC120 door lock key

The purpose of this Service Bulletin is to replace the lock key of the RH cargo door and the rear access door due to obsolescence.

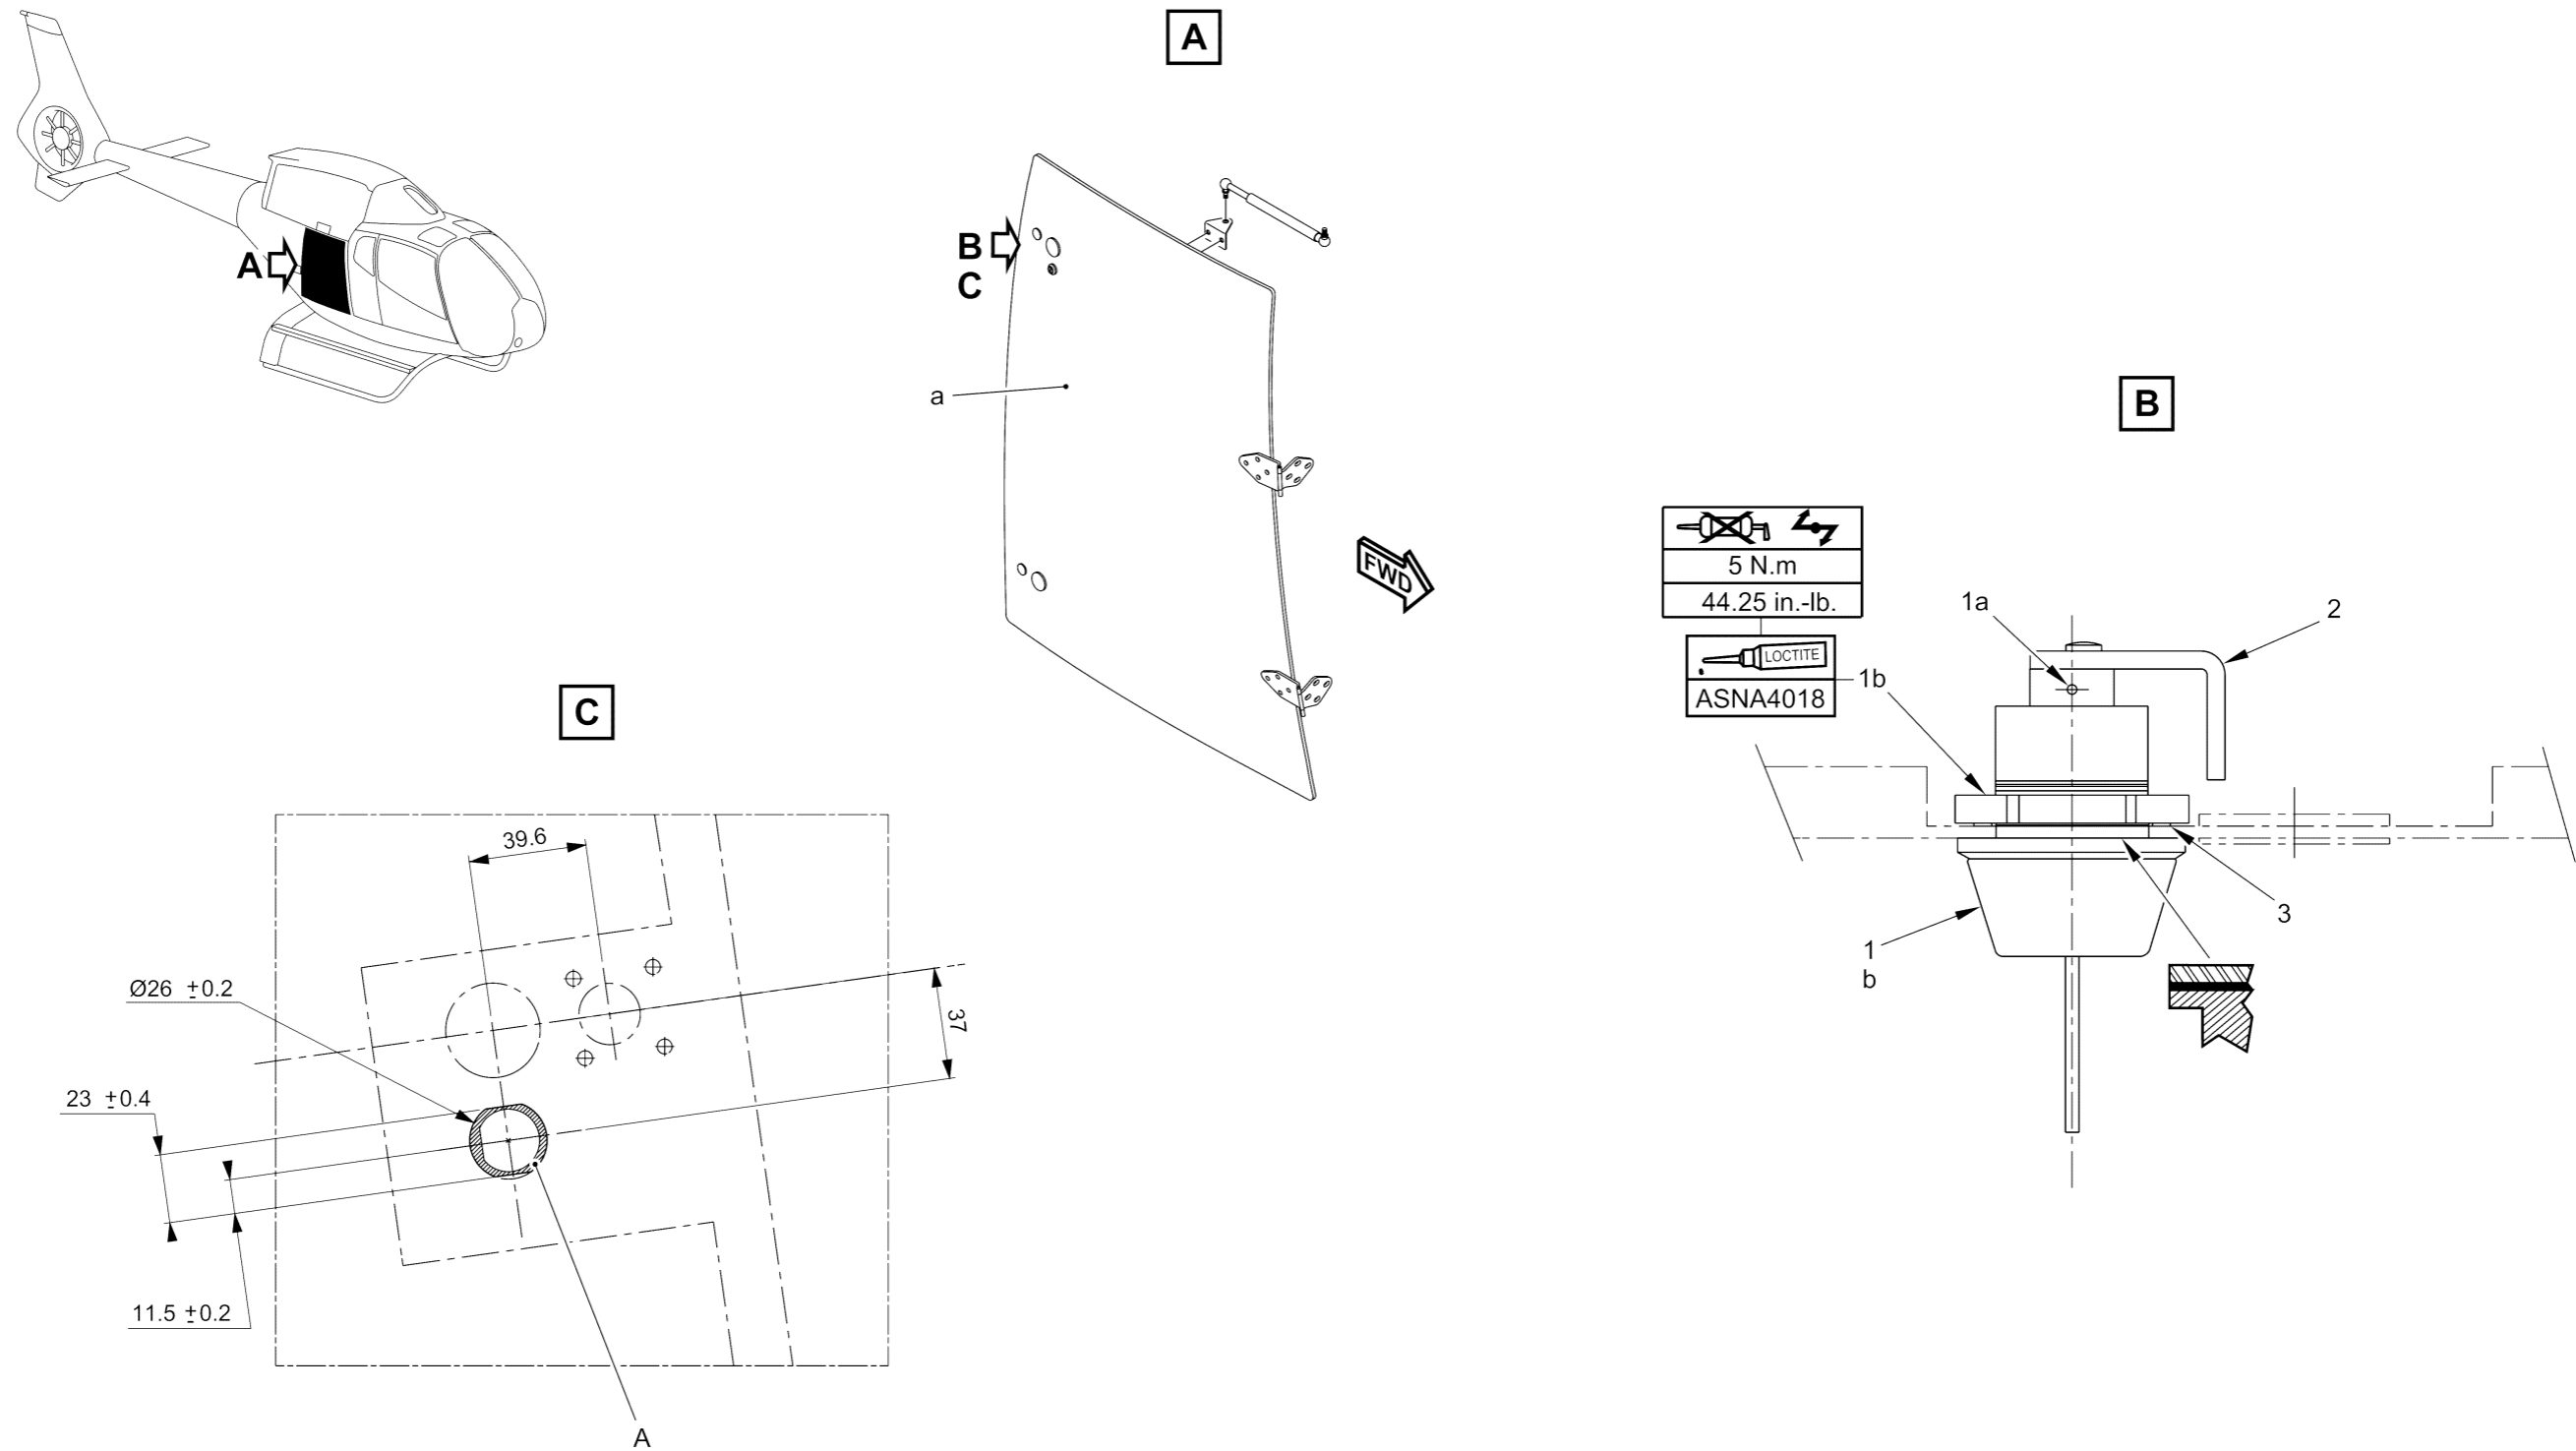
Figure 1

3.B.2.a. Modification of the RH cargo door and rear access door (Figure 1, Figure 2)

- Remove the RH cargo door (a) as per Task 52-30-00,4-1 (AMM).
- On the cargo door RH (a) (Details A and B):
 - . Remove the lock key (b).
 - . Discard the lock key (b).
 - . Identify the cutout (A) as per dimensions (Detail C).
 - . Do the cutout (A).
 - . Apply adhesive (4) in the nut (1b).
 - . Install the lock key (1) with interposition of sealing compound (5) (Detail B) with:
 - .. A washer (3)
 - .. The nut (1b).
 - . Torque the nut (1b) to the indicated torque value.
 - . Install the pin locking (2) on the lock key (1) with the split pin (1a) (Detail B).
 - . Identify again the RH cargo door (a) as per paragraph [3.C.](#) (Detail A).

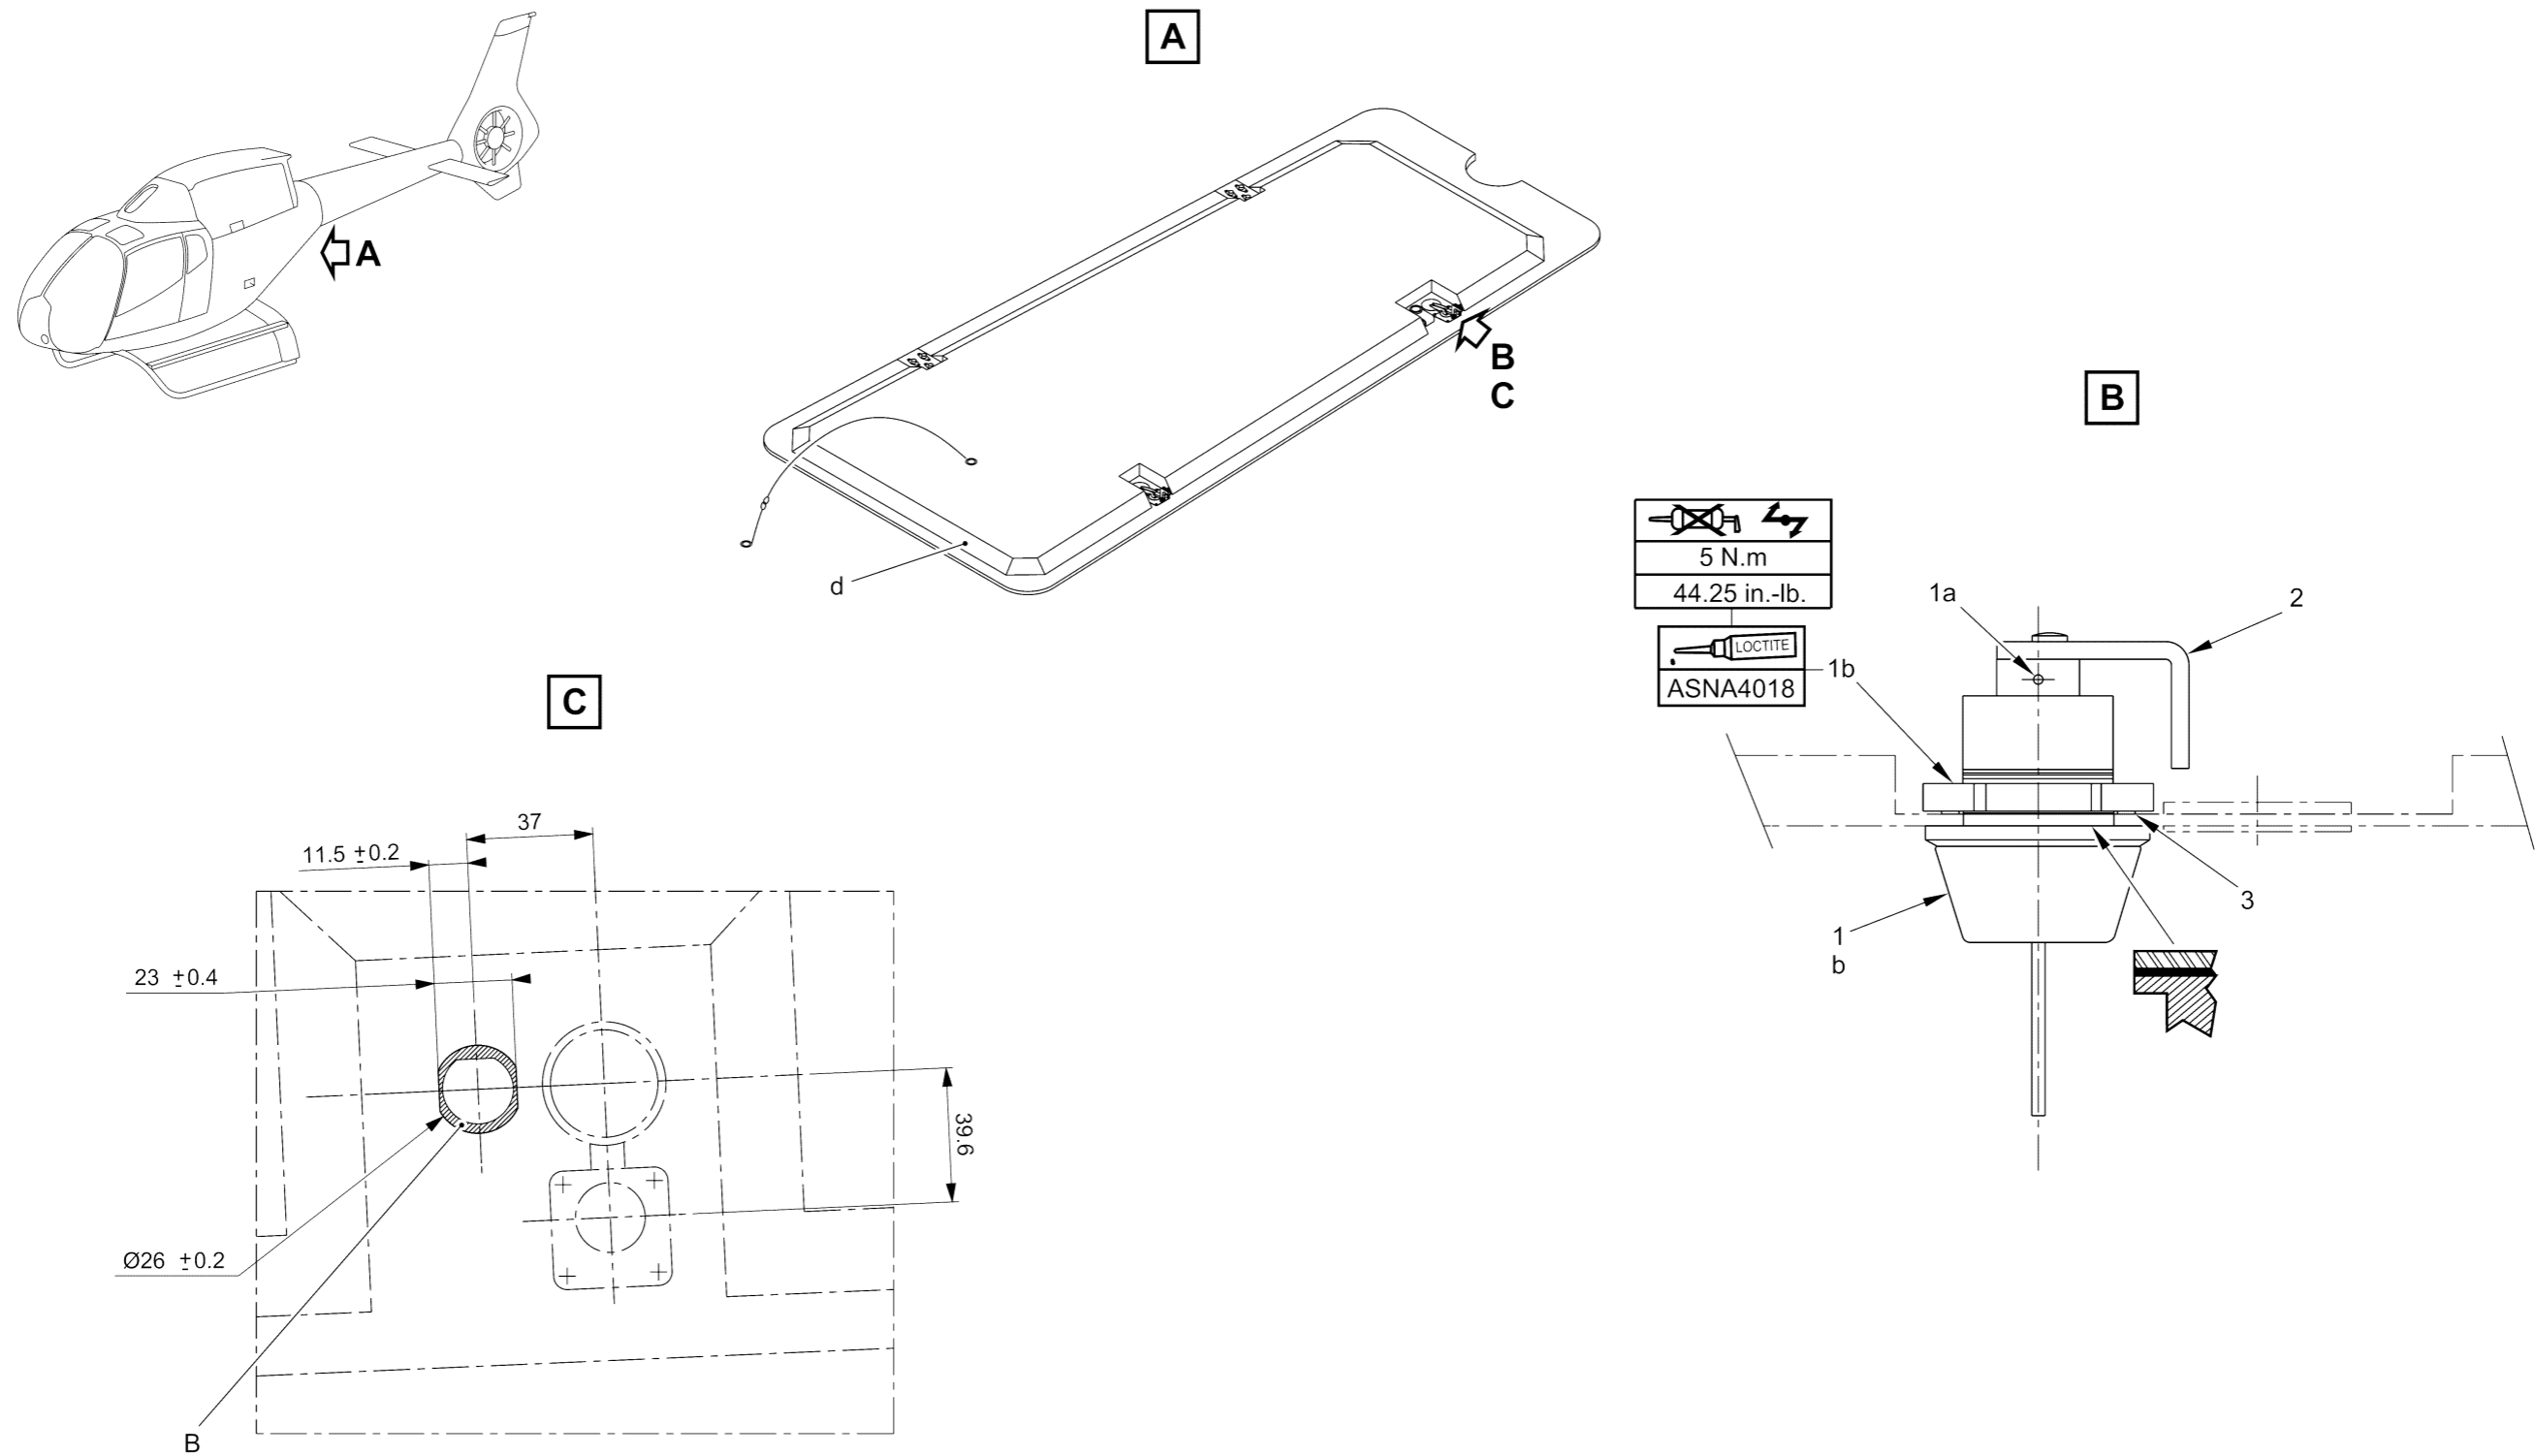
Figure 2

Only the assembly for the RH cargo door (a) is given. Do the same procedure for the rear access door (d) with the cutout (B) and as per Task 52-30-00,4-3 (AMM) ([Figure 2](#)).
