No. EC155-05-040

SERVICE BULLETIN

TIME LIMITS – MAINTENANCE CHECKS - Electrical hoist
Introduction of complementary maintenance of the electrical hoist

4.A. GOODRICH SERVICE BULLETIN No. 763XX-25-12

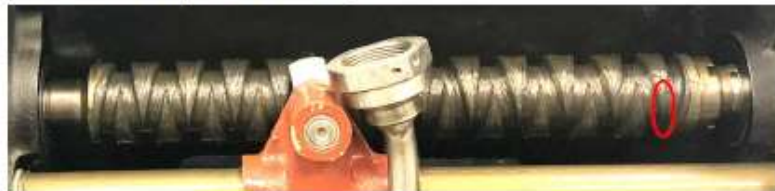
Figure 1

A 76368-240-D hoist jam occurred due to premature wear of the winding screw caused by the presence of sand in the lubricating grease. Wear on the threads of the screw weakened the tips at the intersection of the left and right threads and, as a result, one of the tips bent - see Figure 1.

Localization of tips at the intersection of the left and right threads of a winding screw

This Service Bulletin is edited to provide additions to second level maintenance CMM to prevent damage to the winding screw due to pollution.

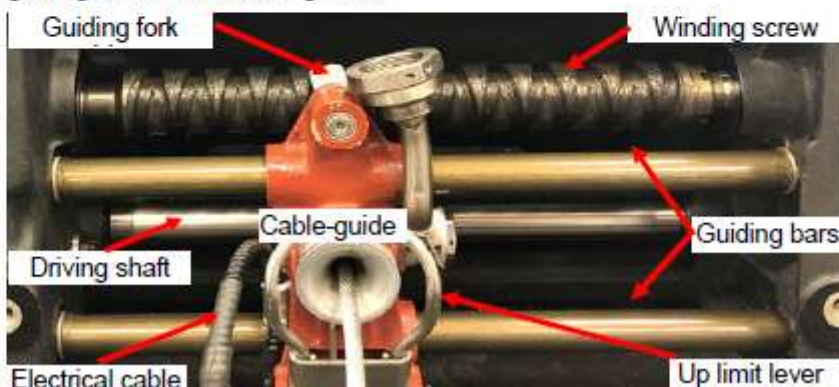
Figure 2

Cable-guide area including winding screw and guiding fork

- (1) Cleaning of cable-guide device and winding screw – see figures 2 and 3.

Clean metallic components other than the ball bearings with a non-metallic brush and/or a lint-free cloth using Starnet or isopropyl alcohol.

Clean especially the winding screw, the guiding fork, the cable-guide, the guiding bars and the driving shaft.

Move the cable-guide, reeling out up to 5 m (16.4 ft) of cable in order to completely clean the winding screw. Make sure there is no more grease, sand or dust deposit.

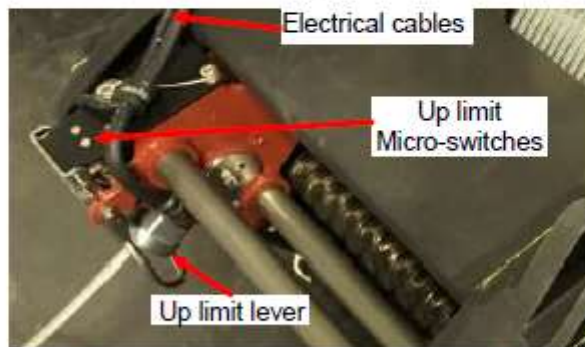
Figure 4

Location of the two up limit micro-switches

- (2) Cleaning of electrical components – see figure 4

Clean with a lint-free cloth soaked in isopropyl alcohol the electrical cables and the external portion of the two up limit micro-switches which are located at the interface level with the up limit lever.

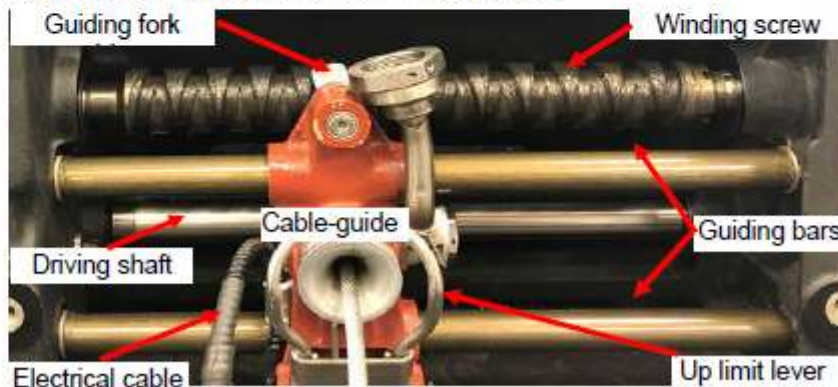
- (1) Check for pollution deposits (salt, sand, dust or other particles) on the hoist, in particular on the winding screw, the guiding fork, the cable-guide, the guiding bars and the driving shaft – see Figure 5.

Cable-guide area including winding screw and guiding fork
 Figure 5

If there is pollution, clean up in accordance with paragraph 3.C.(1) of this Service Bulletin.

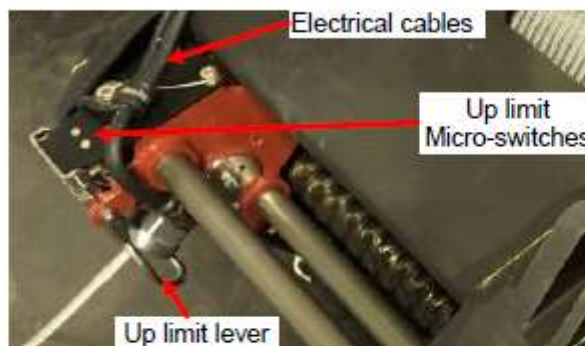
- (2) Check for pollution deposits on the electrical cables and the two up limit micro-switches which are located at the interface level with the up limit lever – see figures 5 and 6.

Location of the two up limit micro-switches
 Figure 6

If there is pollution, clean up in accordance with paragraph 3.C.(2) of this Service Bulletin.

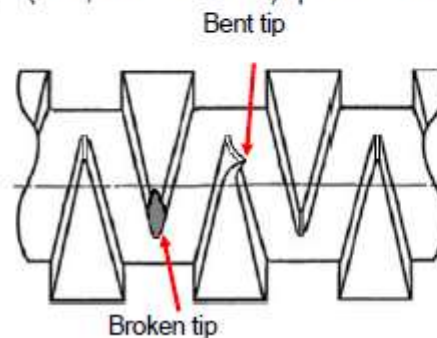
Check for damaged (bent, broken or worn) tips on the winding screw - see figure 7.

Example of a winding screw with damaged tips
 Figure 7

This check of all the tips is to be performed over the entire length of the winding screw

If there is one or several bent, broken or worn tips on the winding screw, the hoist must be sent for repair to Goodrich Actuation Systems, Hoist & Winch, requesting first a RMA (*) at Desk-customer.Stouen@collins.com).

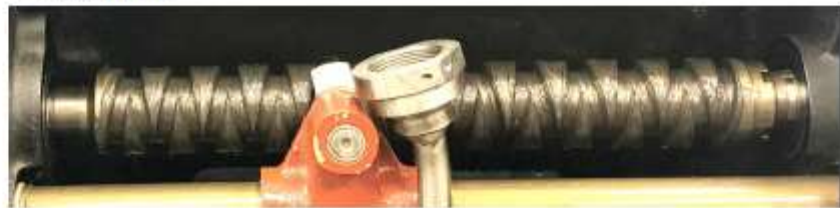
Figure 9

Correct application of grease to the winding screw

CAUTION: COAT GREASE MODERATELY ON THE WINDING SCREW (SEE FIG. 9). DO NOT APPLY GREASE TO THE CABLE AND SURROUNDING PARTS OF THE EXTRACTING DEVICE, IN PARTICULAR ON THE EXTRACTING ROLLERS.

Lubricate the winding screw with about 1 cm³ (0.06 in³) of grease AIR 4217 (NATO G-353), using a brush. Roll up 5 meters of cable to move the cable guide to evenly apply the grease on the threads of the entire winding screw – see figure 9.
