SERVICE BULLETIN

TITLE: Service and miscellaneous - New battery door compensator rod

Model:	EC155
Version:	B, B1
Helicopters PRE MOD:	0752C81

SB EC155-52-41-0001

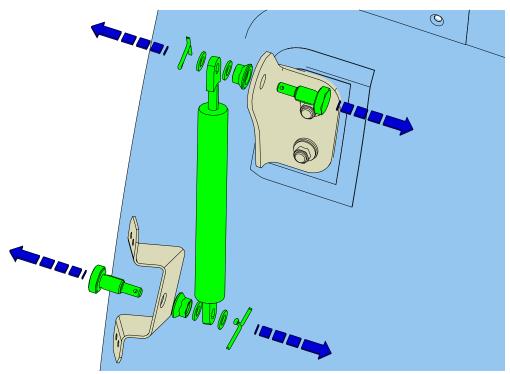
Figure 1

The purpose of this Service Bulletin is to replace the compensator rod which is no longer supplied, with a new compensator rod.

- 4.1. Removal of the compensator rod
- 4.1.1. Remove and discard pins, self-locking nuts and flat washers from the compensator rod on both sides according to (Figure 1).
- 4.1.2. Remove the compensator rod according to (Figure 1).

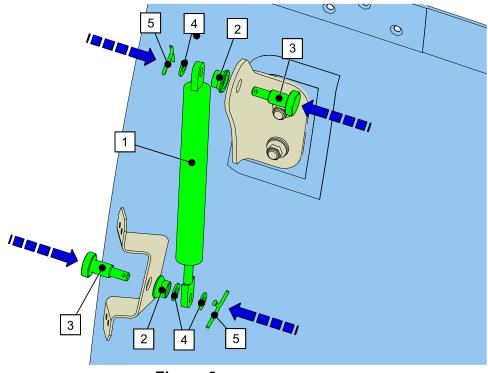
Figure 3

The mounting orientation of the new compensator rod is changed to allow for better lubrication and performance.

The connecting rod should be installed with the connecting rod body up (battery door side) and the connecting rod down (structure side).

- 4.3.1. Install on the door side (top in (Figure 3)):
 - The SHOULDER PIN 365A61671120 (3)
 - The SELF-LOCKING HEX NUT ASN52320BH060N (2), dry tightening torque refer to <u>MTC 20-02-05-404</u>
 - The COMPENSATOR ROD IG6004-40052 (1)
 - The FLAT WASHER 23111AG040LE (4)
 - The SPLIT PIN 23310CA015012 (5).
- 4.3.2. Install on the structure side (bottom in (Figure 3)):
 - The SHOULDER PIN 365A61671120 (3)
 - The SELF-LOCKING HEX NUT ASN52320BH060N (2), dry tightening torque refer to <u>MTC 20-02-05-404</u>
 - The COMPENSATOR ROD IG6004-40052 (1)
 - The two FLAT WASHER 23111AG040LE (4)
 - The SPLIT PIN 23310CA015012 (5).
