**No. EC155-67-013**

# SERVICE BULLETIN

### ROTOR FLIGHT CONTROLS

#### Washer under the screw head of trim lever assembly

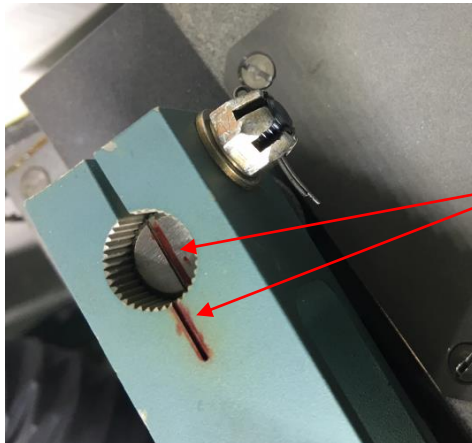
*When MOD 0722B80 is embodied, the end of the bolt does no longer protrude beyond the end of the castellated hex. nut and is now positioned as shown below. This assembly is only acceptable for the assembly of trim levers.*

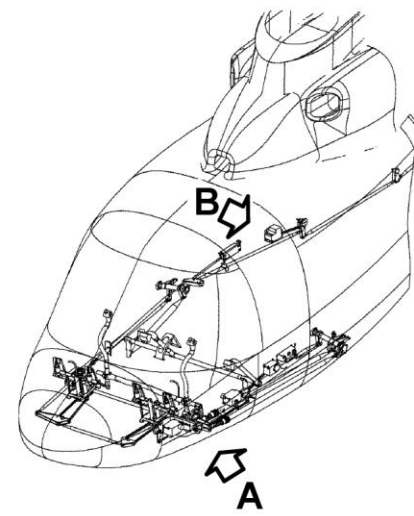
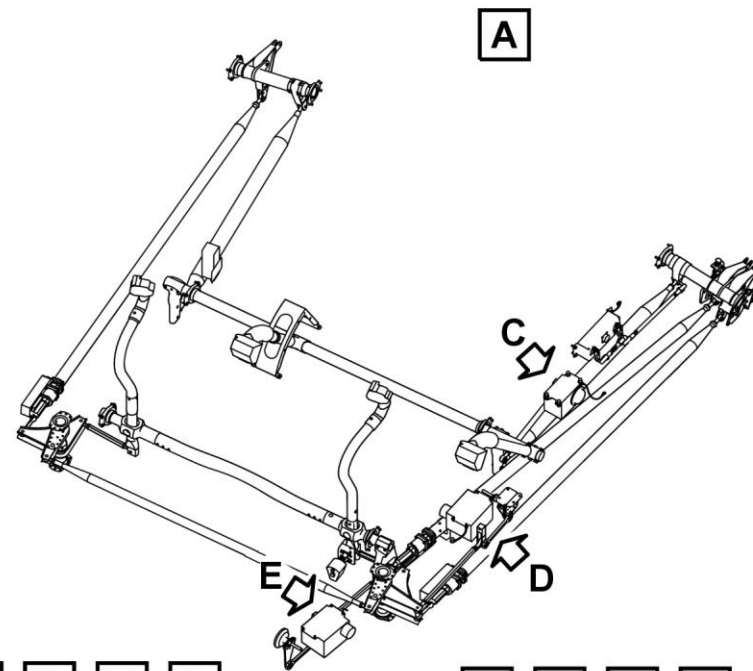
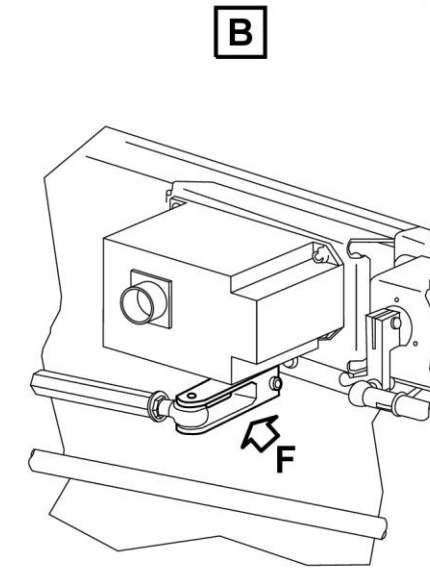
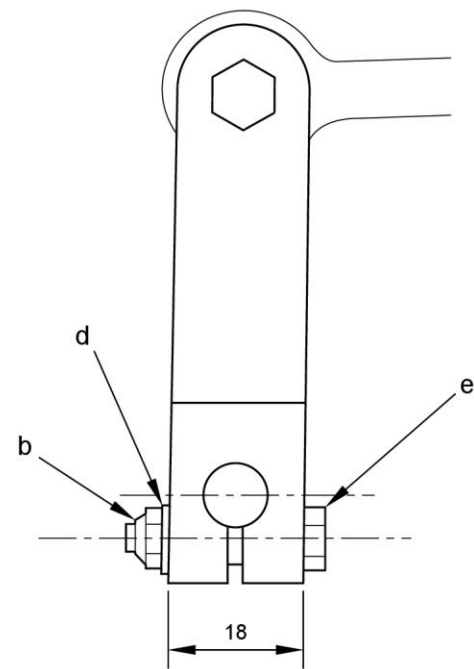
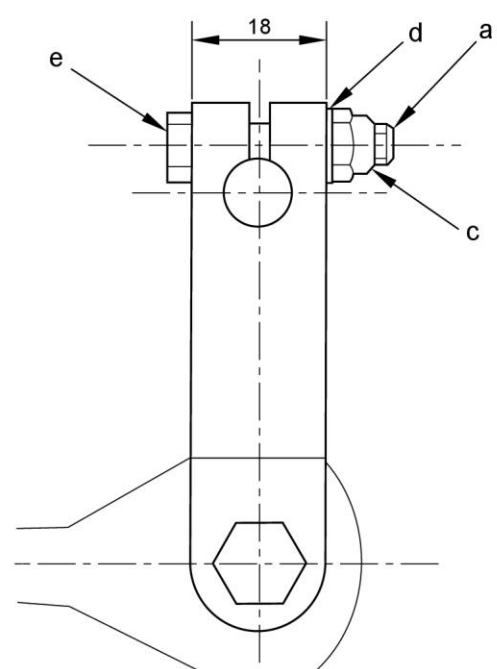
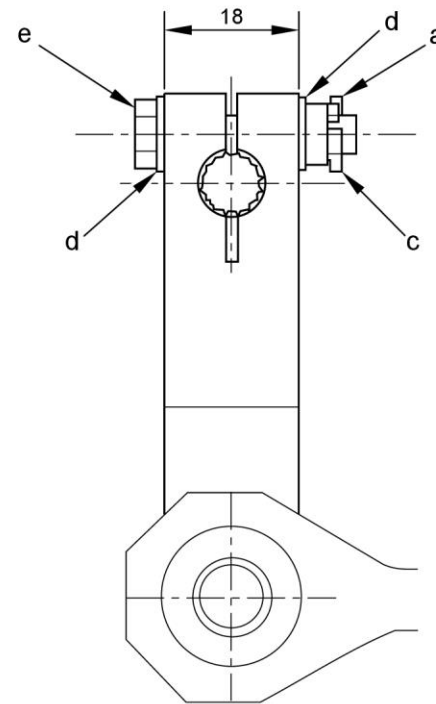
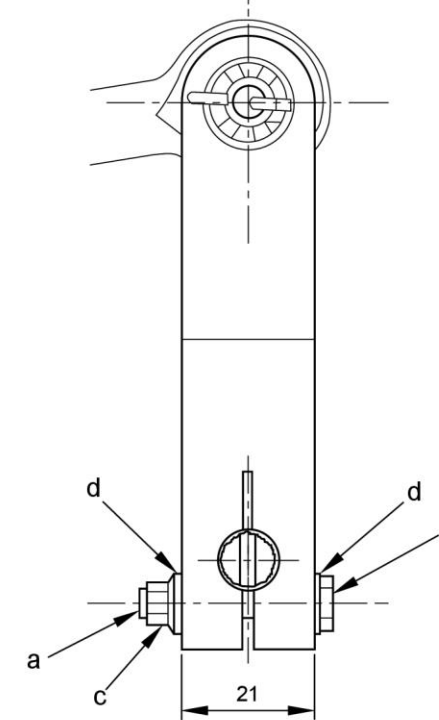
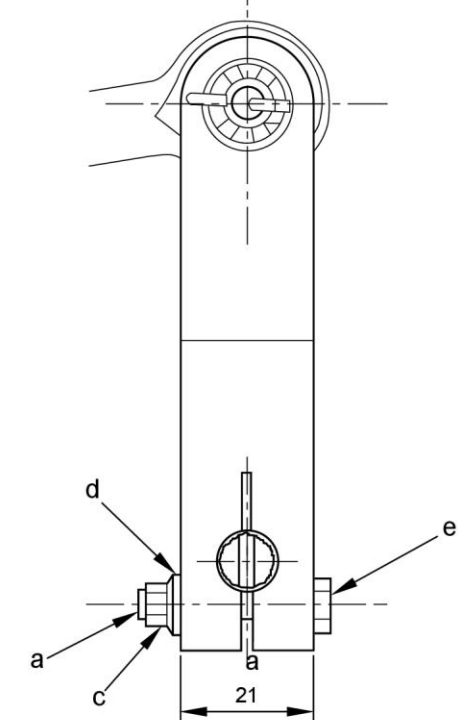
Figure 1

An occasional play between the roll trim lever and the roll trim shaft has been identified in operation. If so, this can cause a play in the cyclic control, which leads to oscillation due to the autopilot.

- Remove and discard ([Figure 1](#)):
  - . The pin (a)
  - . The self-locking nut (b)
  - . The castellated hex. nut (c)
  - . The washer (d)
  - . The screw (e).
