SERVICE BULLETIN

N° **189-387**

ATA 21 - HEATING DUCT REAR AVIONIC BAY MODIFICATION

**70688A010001 (BWT33906-1) PART
MODIFICATION****1. PLANNING INFORMATION****A. EFFECTIVITY**

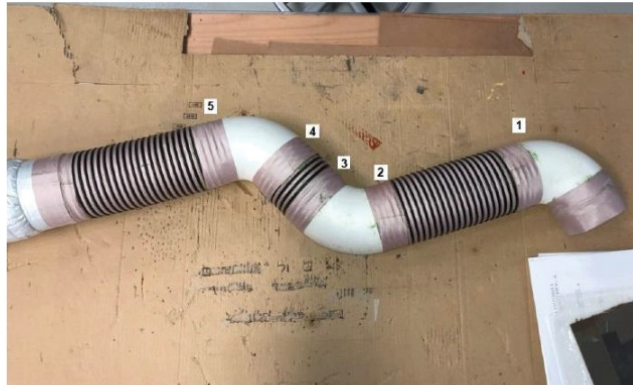
Figure 1 – Duct with the 5 joints to be reinforced.

Step 1 - Carefully remove the insulation between the top clamping position of the long flexible length and the jet pump cuffed end, in one complete piece cutting along the length between these 2 points. Preserve for reuse if possible subject to in-service degradation. [See Figure 1.](#)
