SERVICE BULLETIN

_{N°} 139-778

DATE: June 12, 2024

ATA 55 - TAIL PLANE ROD ASSY INSTALLATION INSPECTION

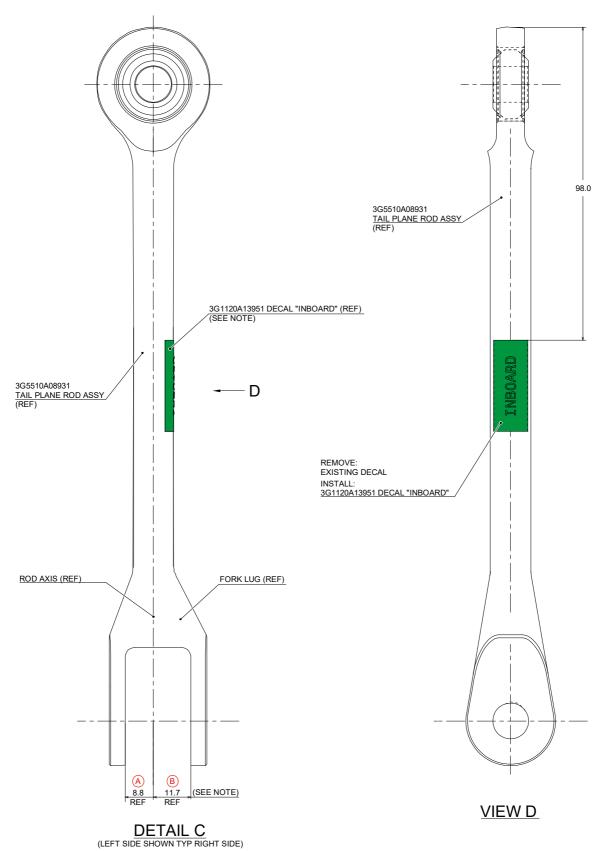
Leonardo Helicopters issued this Service Bulletin as consequence of some in-service reports and a Quality Alert from MAG: it has been identified a batch of potentially non-conformant tail plane rod assy P/N 3G5510A08931 because of the incorrect placement of the "INBOARD" decal P/N 3G1120A13951.

The decal "INBOARD" P/N 3G1120A13951 must be installed on the same side where fork lug is located 11.7 mm from rod axis (Ref. Figure 2 Detail C).

NOTE:
INSTALL DECAL INBOARD TAKING CARE TO BOND IT ON THE SAME SIDE WHERE FORK LUG IS LOCATED 11.7 MM FROM ROD AXIS.

8. In accordance with AMP DM 39-A-11-00-01-00A-520A-A and with reference to Figure 2 View D, remove the existing decal from the wrong position on the tail plane rod assy P/N 3G5510A08931.

- 9. In accordance with AMP DM 39-A-11-00-01-00A-720A-A and with reference to Figure 2, install the new decal "INBOARD" P/N 3G1120A13951 to the indicated position on the tail plane rod assy P/N 3G5510A08931.
- 10. In accordance with AMP DM 39-C-55-11-02-00A-720A-A (LH side) or DM 39-C-55-11-03-00A-720A-A (RH side) and with reference to Figure 1, install the left or right tail plane rod assy P/N 3G5510A08931 on the helicopter, as necessary.

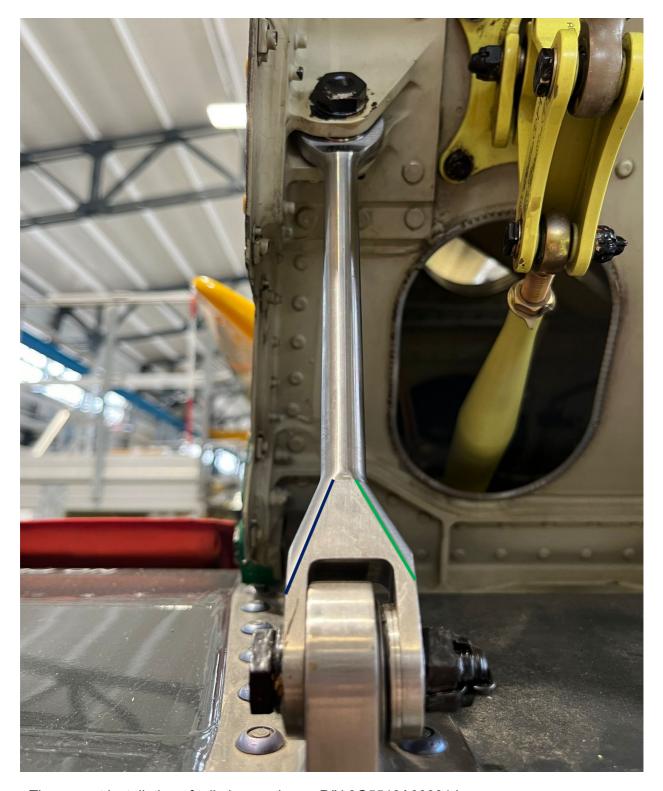
Figure 3

The correct installation of tail plane rod assy P/N 3G5510A08931 has:

- the longer highlighted side of the fork end (blue) on the **OUTBOARD** side of the installation;
- the shorter highlighted side of the fork end (green) on the INBOARD side of the installation.

LH tail pane rod assy shown. RH tail plane rod assy is opposite.

- the longer highlighted side of the fork end (blue)
 on the OUTBOARD side of the installation;
- the shorter highlighted side of the fork end (green) on the INBOARD side of the installation.
- 3.1 Using a caliper gauge, take the dimension "A" and "B" on the fork lug of the tail plane rod assy P/N 3G5510A08931 and verify that the larger dimension is on the inboard side of the tail plane rod assy installation.
- 3.2 In case of findings, compile and send the Inspection Report Form in Figure 4 and proceed with step 6; otherwise proceed with the following step.
- 4. In accordance with Figure 1 View B, check if the decal "INBOARD" P/N 3G1120A13951 facing the inboard side of the helicopter.
 - In case of not compliant decal installation, compile and send the Inspection Report Form in Figure 4 and proceed with step 6; otherwise proceed with step 11.
