SERVICE BULLETIN

N° **189-371**

DATE: June 25, 2024

ATA 71 - ENGINE FLOOR INSPECTION

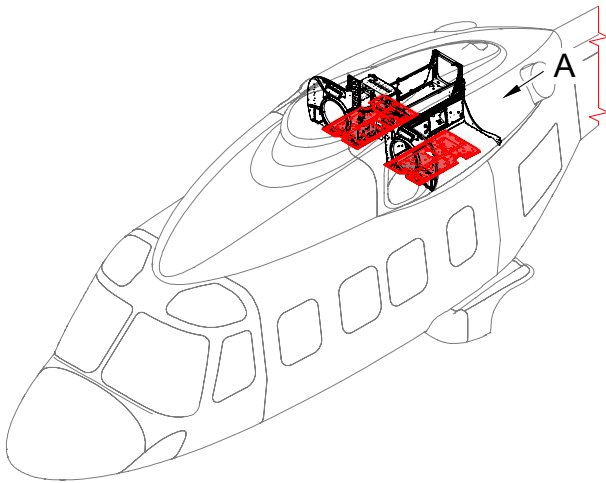
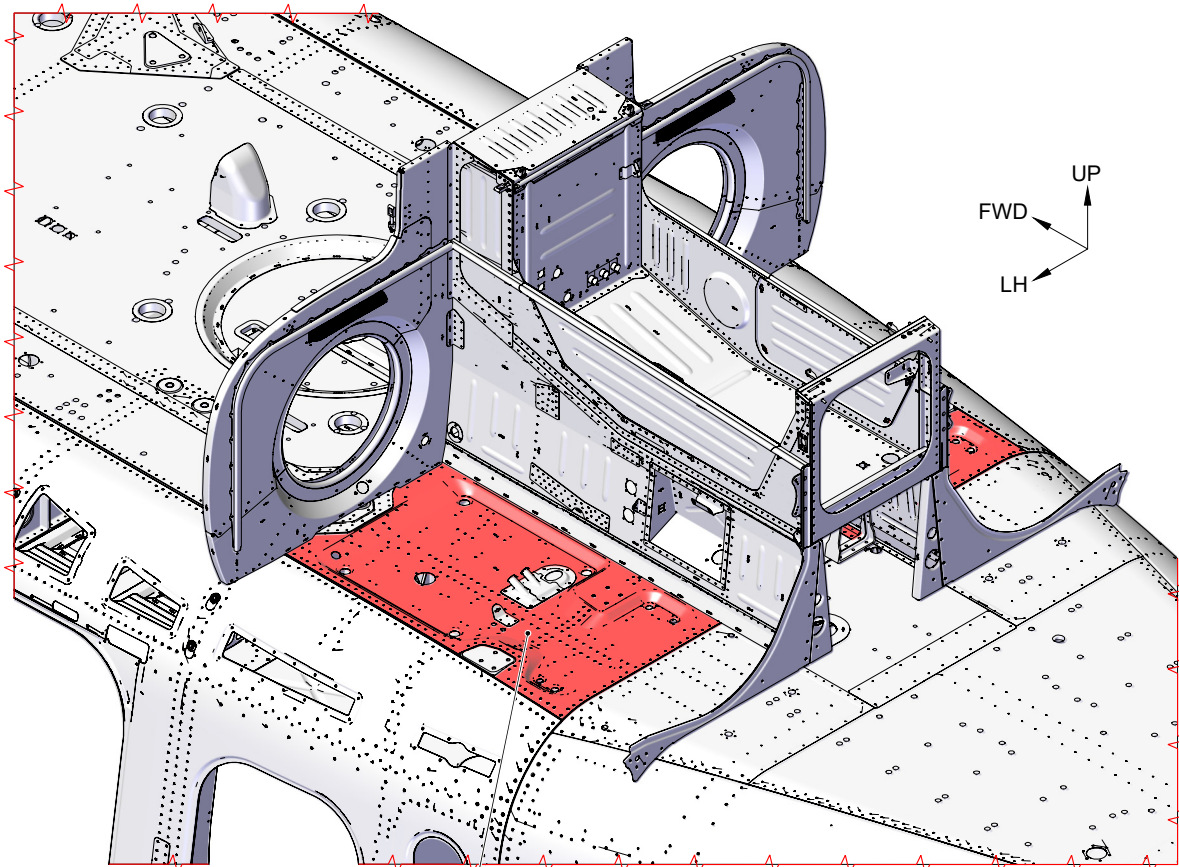
Figure 1

Leonardo Helicopters received a report of a crack on the LH engine floor in correspondence of a rivet hole.

- 2.2 With reference to Figure 1, properly clean the engine floor and the area under the engine from any type of dirt and perform a visual inspection of the area highlighted in Figure in order to correctly detect any cracks. Use a borescope to inspect the forward part of the area.
If case of findings, proceed with next Step 2.3. Otherwise skip to Step 3.

If case of findings, proceed with next Step 3.3. Otherwise skip to Step 4.
 - 3.3 In accordance with the applicable steps of AMP DM 89-A-71-01-02-00A-520A-A, remove the Number 2 engine from the helicopter. Take pictures of the damaged area and measure the dimension of the crack:

- 2.3 In accordance with the applicable steps of AMP DM 89-A-71-01-01-00A-520A-A, remove the Number 1 engine from the helicopter. Take pictures of the damaged area and measure the dimension of the crack:

- if the crack found is less than or equal to 55.0 mm in length, contact LH for repair instructions. Send pictures and the “Inspection Report” filled (refer to Figure 2) to Leonardo Engineering Dept. at the following mail box: engineering.support.lhd@leonardo.com.

- if the crack found is more than 55.0 mm in length, contact LH for damage assessment. Send pictures and the “Inspection Report” filled (refer to Figure 2) to Leonardo Engineering Dept. at the following mail box: engineering.support.lhd@leonardo.com.
