SERVICE BULLETIN

N° **189-376**

**ATA 06 – ENGINE CABLE ASSY RE-ROUTING**

This Service Bulletin is issued in order to provide the necessary instruction on how to perform the “engine 1/2 CTRL & IND C/A installation retromod” P/N 8G0630P09011.

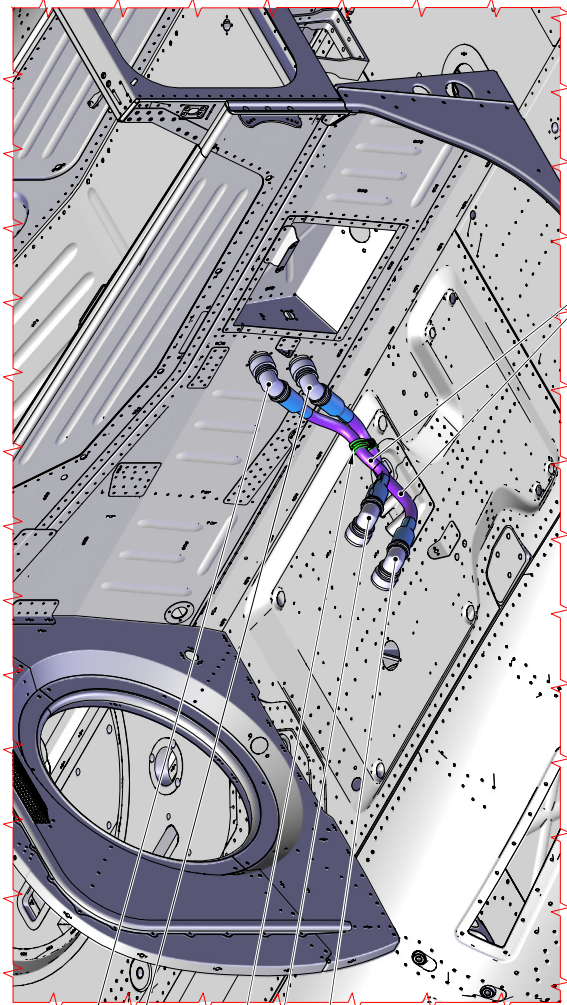
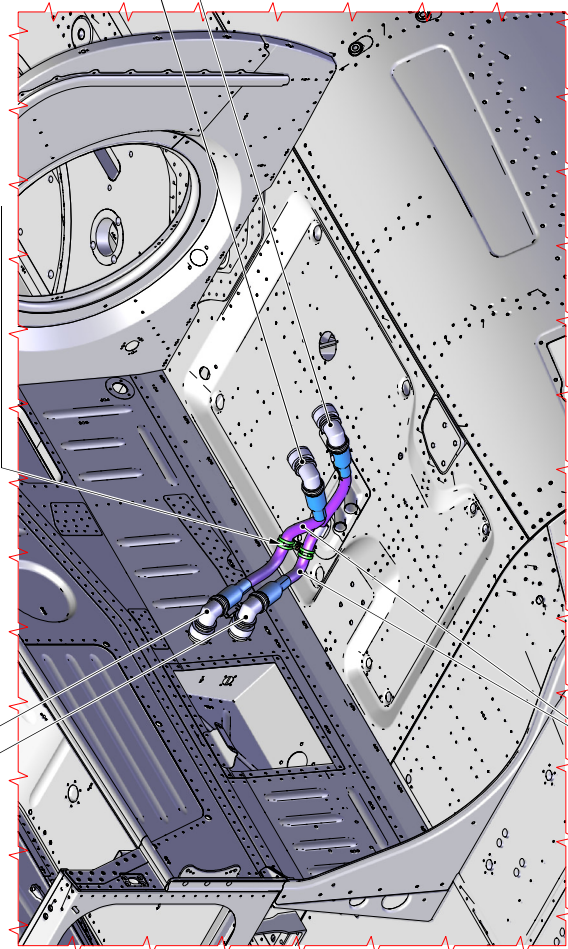
**VIEW A**

This Service Bulletin provides instruction on how to install fixing points on the C/As in the upper deck engine area to modify the routing in order to avoid possible interference between the harnesses connecting the engine FADEC and the firewall.

- 2.1 With reference to Figure 1 View A and in accordance to AMP DM 89-A-71-01-01-00A-520A-A, remove the Number 1 engine to gain access to the LH upper deck.

- 2.2 With reference to Figure 1 View A, re-route the engine 1 CTRL & IND cable assemblies as shown.
  - 2.3 With reference to Figure 1 View A, install n°2 clamps P/N AW001CB11H on the engine 1 CTRL & IND cable assemblies and fix by means of one screw P/N NAS1802-3-8, n°2 washers P/N NAS1149C0316R and the nut P/N MS21043-3.

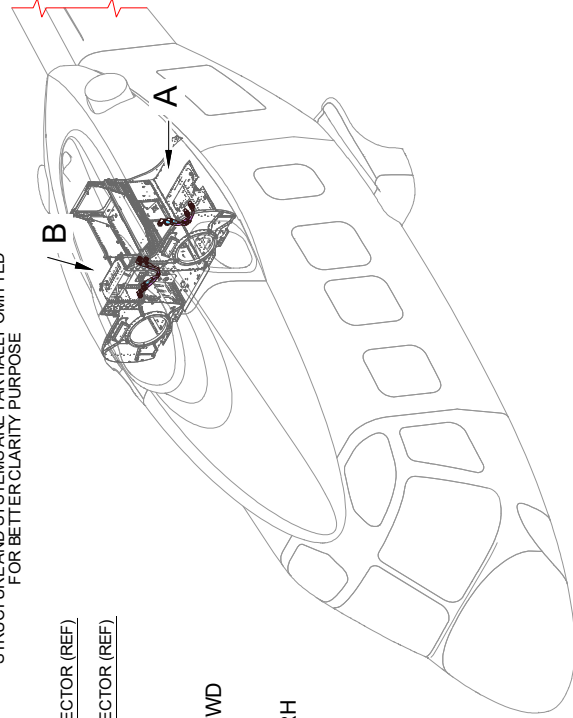
**VIEW B**

RE-ROUTE AS SHOWN,  
ENGINE 2 CTRL & IND C/A

- 2.4 In accordance to AMP DM 89-A-71-01-01-00A-720A-A, re-install the Number 1 engine.
  - 2.5 With reference to Figure 1 View B and in accordance with AMP DM 89-A-71-01-02-00A-520A-A, remove the Number 2 engine to gain access to the RH upper deck and repeat steps 2.2 and 2.3 for the RH upper deck to re-route the engine 2 CTRL & IND cable assemblies.
