SERVICE BULLETIN

N° **189-382**

ATA 71 - FUEL AND D1 DRAINAGE LINES INSPECTION

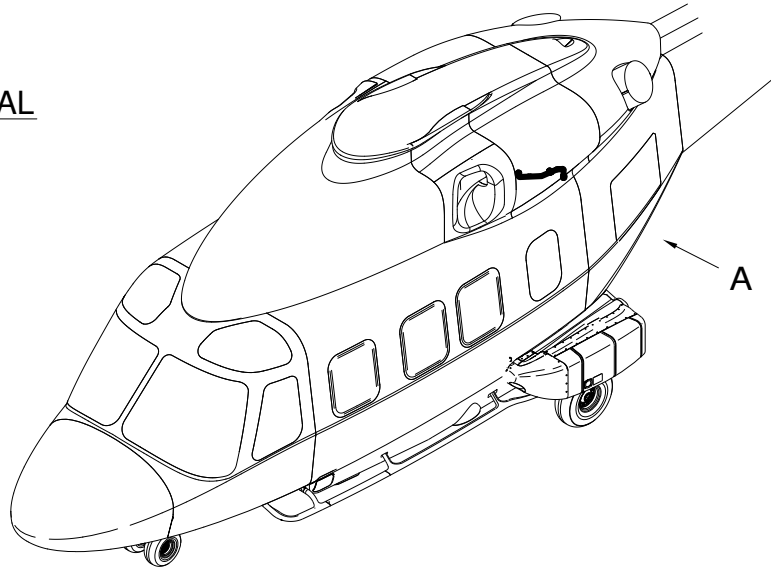
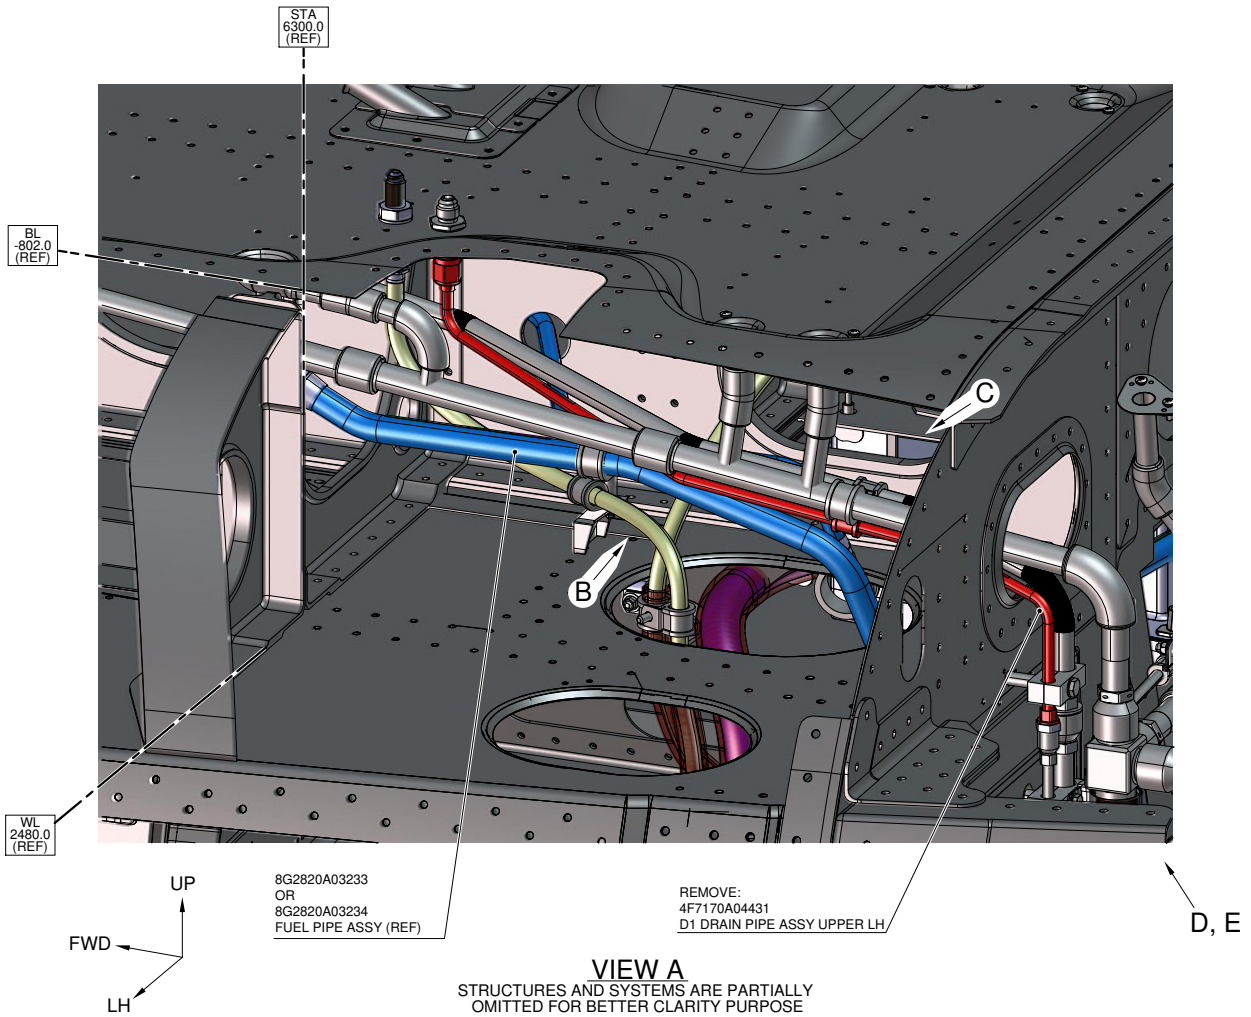
Leonardo Helicopters received a report of marginal clearance between the "engine D1 drain LH" P/N 4F7170A04431 and the fuel pipe assy (return line) P/N 8G2820A03234 or P/N 8G2820A03233. In case of contact, wear on the pipes could occur resulting, in the worst case scenario, in a fuel leakage in a drained area.

3. With reference to Figure 1 and Figure 2 View B, using a borescope and a bright light source, visually inspect the whole zone of intersection between the “D1 drain pipe assy upper LH” P/N 4F7170A04431 and the fuel pipe assy P/N 8G2820A03234 or P/N 8G2820A03233, for evidence of chafing. In case of no findings, skip to Step 6. Otherwise, perform the following Step.
4. In case of damage on “D1 drain pipe assy upper LH” P/N 4F7170A04431 only, no action is required. Proceed to Step 6.
5. In case of damage on fuel pipe assy P/N 8G2820A03234 or P/N 8G2820A03233, perform the following procedure:
 - 5.1 Measure the depth of the damage found. Use the borescope with measurement feature. Take a picture of the damaged pipe and fill the report in Figure 4. Send pictures and report to Leonardo Helicopters at the following mail box: engineering.support.lhd@leonardo.com.

- 4.1 With reference to Figure 1, using a bright light source, visually inspect the fuel pipe assy for evidence of damage.
 - 4.2 In case of findings, take a picture of the damaged pipe and fill the report in Figure 4. Send pictures and report to Leonardo Helicopters at the following mail box: engineering.support.lhd@leonardo.com. Then perform Step 5.

- 4.3 In case of no findings, skip to Step 6.
5. In accordance with CSPP DM CSPP-A-20-20-02-00A-663A-D, repair the fuel pipe with spare P/N 8G2820A03253.

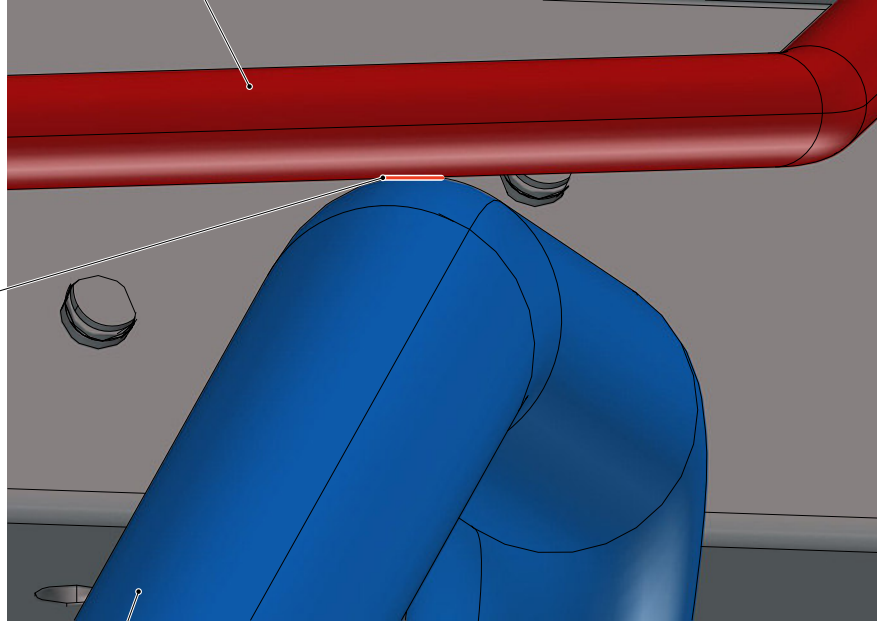
VIEW B

CHAFING
