SUBJECT: RR300-73-007, ENGINE FUEL AND CONTROL -
 TECS ENGINE DRIVEN FUEL PUMP INTERNAL SPLINE INSPECTION

ENGINE, FUEL AND CONTROL - TECS ENGINE DRIVEN FUEL PUMP INTERNAL SPLINE INSPECTION

RR300-73-007

Triumph Engine Control Systems Models MFP-262, MFP-263, MFP-264 Main Fuel Pump Inspection of Main Drive Shaft for Backlash

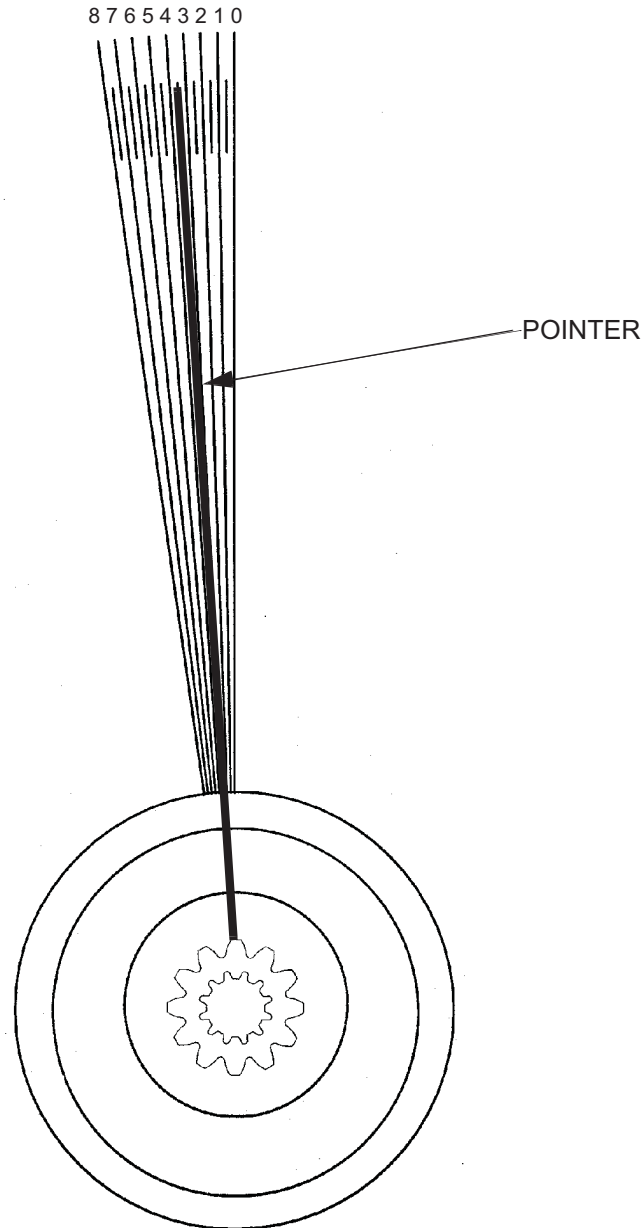
Figure 3B. Pointer Alignment

NOTE: The example shown in Figure 3B indicates a backlash of 3.25 degrees.

- F. Rotate the shaft counterclockwise until a firm stop is reached. Record the angular travel (backlash) to the nearest 0.25 degree increment measured with the pointer and template (see Figure 3B).

- G. If the measured backlash is less than 6.0 degrees, the pump may be returned to service. If the reading is greater than or equal to 6.0 degrees, replace the pump with one that is new, newly overhauled, or that meets the backlash requirements of this bulletin. Pumps requiring repair may be sent to a Triumph authorized maintenance center. Standard warranty conditions apply.
