No. EC155-25-154

SERVICE BULLETIN

EQUIPMENT AND FURNISHINGS - Electrical hoist
One time verification for no damage on cable hook side and preventive actions

Revision No.	Date of issue
Revision 0	2021-07-29

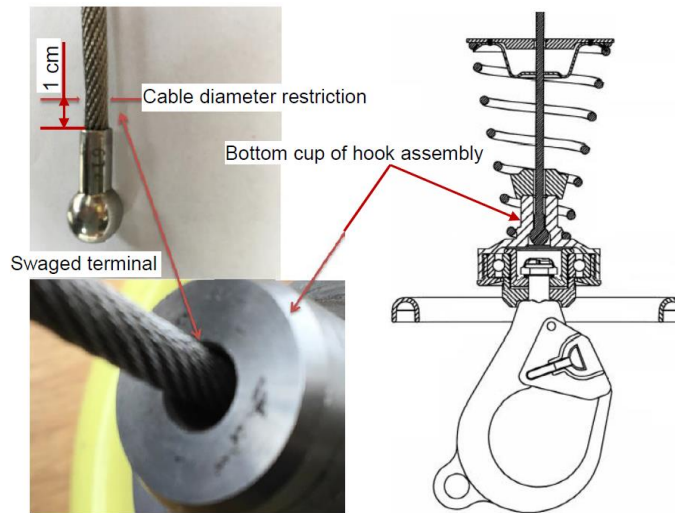
Customers reported cases of cable diameter restriction, found at the edge of the bottom cup of the hook assembly. The cable diameter restriction was found at about 1 cm from the swaged terminal. This restriction with interactions between the cable and the bottom cup of the hook assembly (back and forth motion) could cause damage during flights.

Figure 1: Cable diameter restriction located at edge of bottom cup of the hook assembly

Pending investigations, Goodrich wrote the Service Bulletin No. 76378-25-13, which has the objectives that follow:

- Do a one time verification for no damage on cable hook side
- Add precision on the procedure to make sure correct hook assembly stowage at the up limit
- Add an additional precision for the periodical check of the cable.

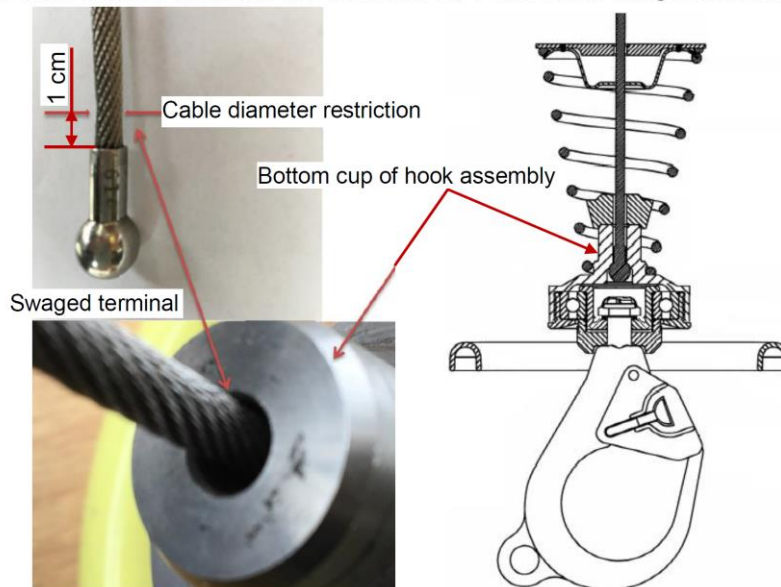
The cable diameter restriction was located about 1 cm from the swaged terminal.

Figure 1: Cable diameter restriction located at edge of bottom cup of the hook assembly.

- (2) Improper hook assembly stowage combined with interactions between the cable and the bottom cup of the hook assembly (back and forth motion) could induce such damages during flights.

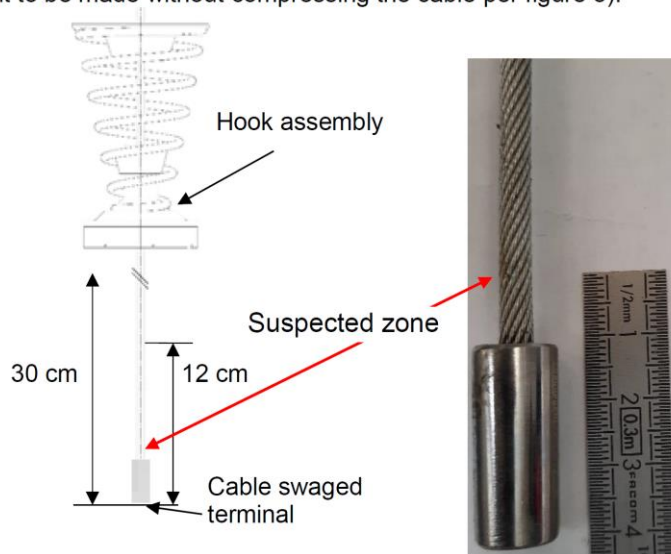
Figure 2

Check for cable damages as written in para 4.D.(2) and 4.D.(3) of chapter CHECK of the CMM. Verify especially if there is a cable diameter restriction at about 1 cm from the cable swaged terminal - cable minimum diameter must be ≥ 4.50 mm (0.181 in) (measurement to be made without compressing the cable per figure 3).

Part of the cable to be checked

- (7) If the cable checked in para 3.A.(6) is compliant:
- (a) Reassemble bottom part of hook assembly on the upper part per para 7.A.(5) of chapter Repair of CMM.

- (8) If the cable checked in para 3.A.(6) is not compliant,
- (a) Reassemble bottom part of hook assembly on the upper part per para 7.A.(5) of chapter Repair of CMM.

- 1 Replace the cable. The hoist can be kept in operation.
 - 2 On the removed cable, measure cable diameter at 2 cm from cable swaged terminal.
 - 3 Send to Goodrich Actuation Systems, Hoist & Winch at desk-customer@collins.com

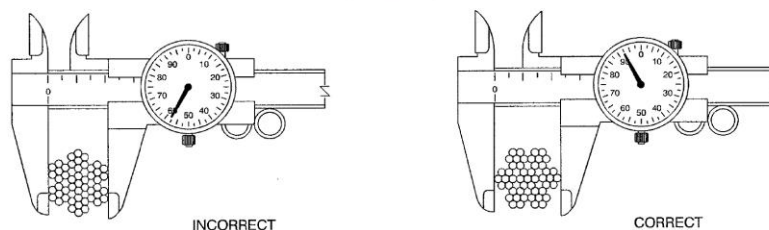
Figure 3

Correct measurement of cable diameter

While checking the 30 mm near the cable crimped end, check for no cable diameter restriction, especially at about 1 cm from the cable swaged terminal - cable minimum diameter must be ≥ 4.50 mm (0.181 in) (measurement to be made without compressing the cable per figure 3 of this Service Bulletin).

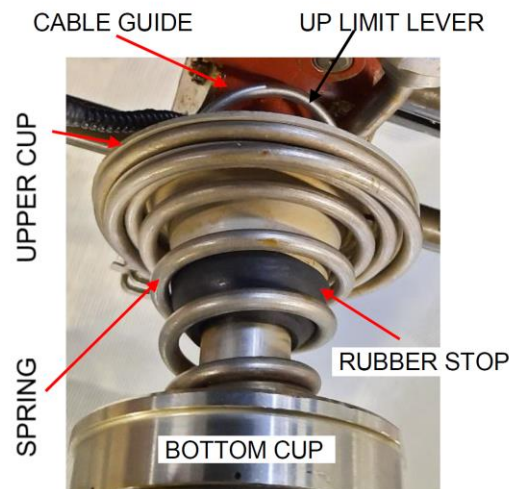
The hook assembly is properly at the stowage position when:

- Proper compression of the spring;
- Bottom cup, rubber and upper cup are steadily pressed together on cable-guide.

Figure 4: Proper stowage of hook assembly at the Up Limit stop

After a first cable reeling-in stop (when upper cup of the hook assembly activates the up limit lever) continue to activate control pendant fully in the up direction. After two seconds (2 s) the cable reeling-in starts again at very low speed. Reel in command at maximum order on the control pendant shall be maintained until cable reeling in completely stops.

This procedure allows proper stowage position of the hook assembly which prevents swinging during flights.

Make sure hook assembly is steadily pressed onto the cable-guide as shown on figure 4.
