No. EC155-67-015

SERVICE BULLETIN

ROTOR FLIGHT CONTROLS Replacement of the Old Generation SEMA by the New Generation 2 SEMA

Corresponds to modification 0722B81

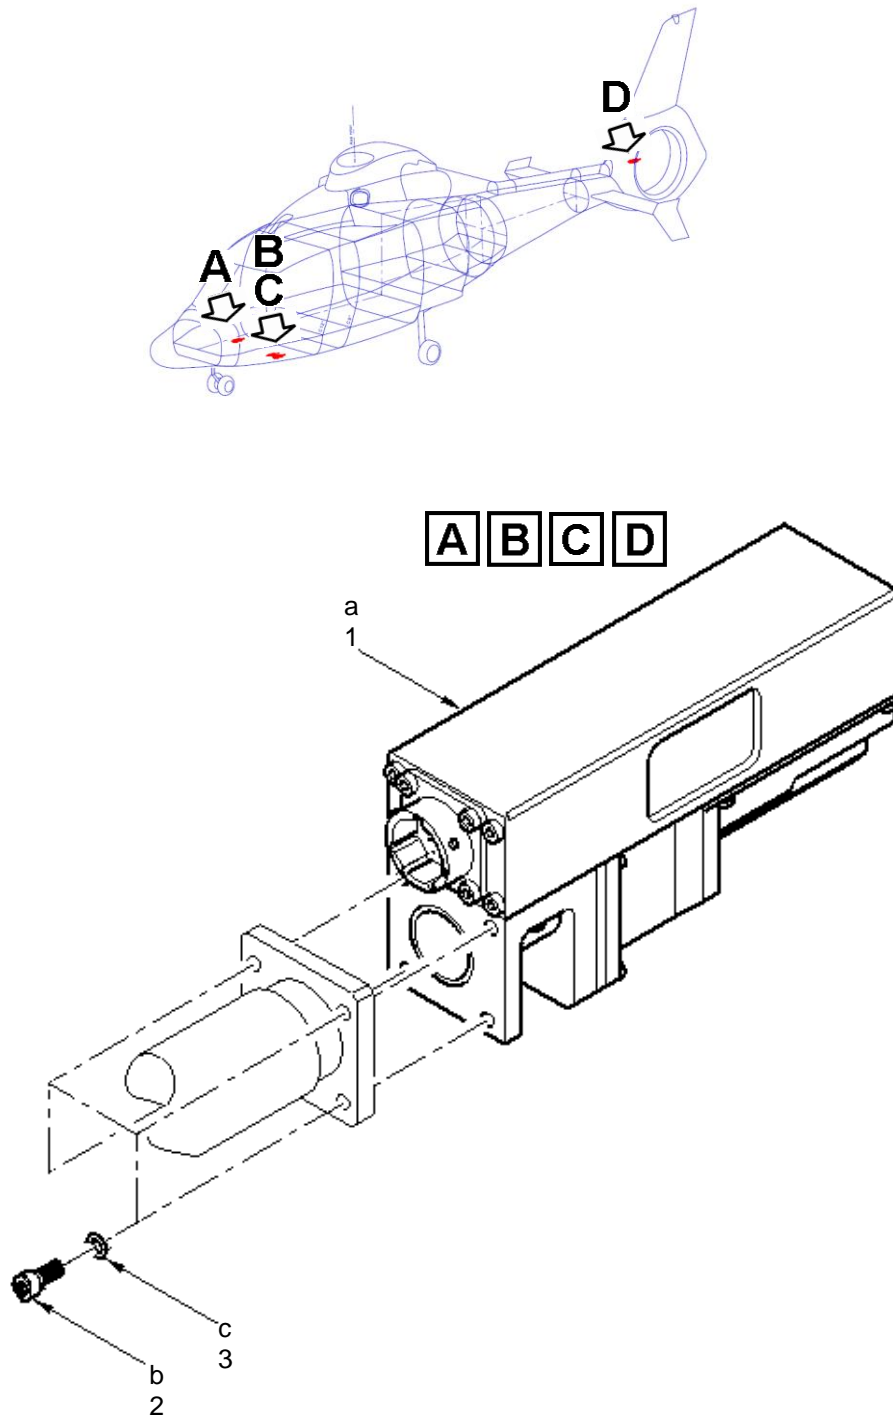
Figure 1

The purpose of this Service Bulletin is to replace the Old Generation (OG) serial actuator SEMA (Smart Electro-Mechanical Actuator) by the New Generation 2 (NG2) SEMA to reduce recurrent maintenance costs, backlash and sealing problems.

- Remove the SEMA (a):
 - . refer to Task 67-11-01-061 (AMM) for the main rotor rod assemblies,
 - . refer to Task 67-20-02-063 (AMM) for the tail rotor rod assembly.
- Store the SEMA (a) with their screws (b) and washers (c).
- Install the new SEMA (1) with the new screws (2) and the new washers (3):
 - . refer to Task 67-11-01-061 (AMM) for the main rotor rod assemblies,
 - . refer to Task 67-20-02-063 (AMM) for the tail rotor rod assembly.
- Do a functional check as per Task 22-10-00-725 (AMM).
