Modification	Recurring action		One-off action
		No.	292 73 2088

ARRIEL 2 B1 - B1A - C2 - C2-CG

Subject: Adjusted hydro-mechanical unit (HMU). Reduced torque of the metering valve emergency control.

Application of modification TU 88A.

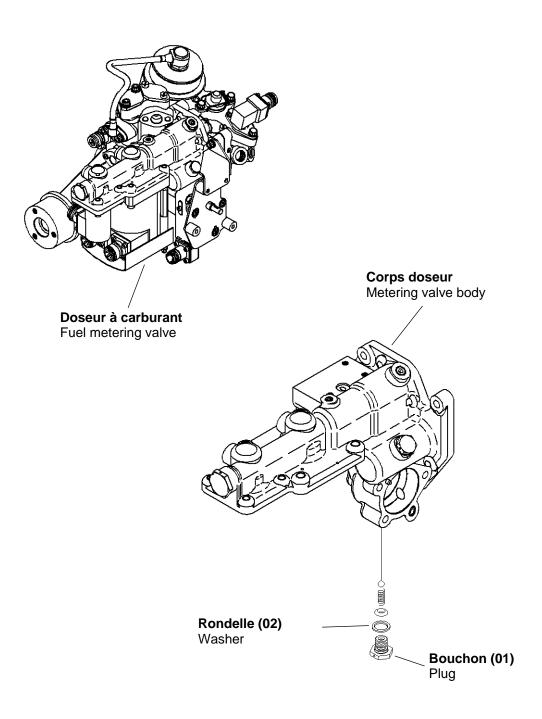
ANNEXE 1 / APPENDIX 1

The purpose of this modification is to reduce the maximum torque for transitioning out of the neutral notch and the continuous friction torque in manual mode.

C. Description (see appendix 1) Torgue reduction is achieved by adding a washer.
