**FEDERAL AVIATION ADMINISTRATION
AIRWORTHINESS DIRECTIVES**

**SMALL AIRPLANES, ROTORCRAFT, GLIDERS,
BALLOONS, & AIRSHIPS**

BIWEEKLY 2021-07

3/15/2021 - 3/28/2021

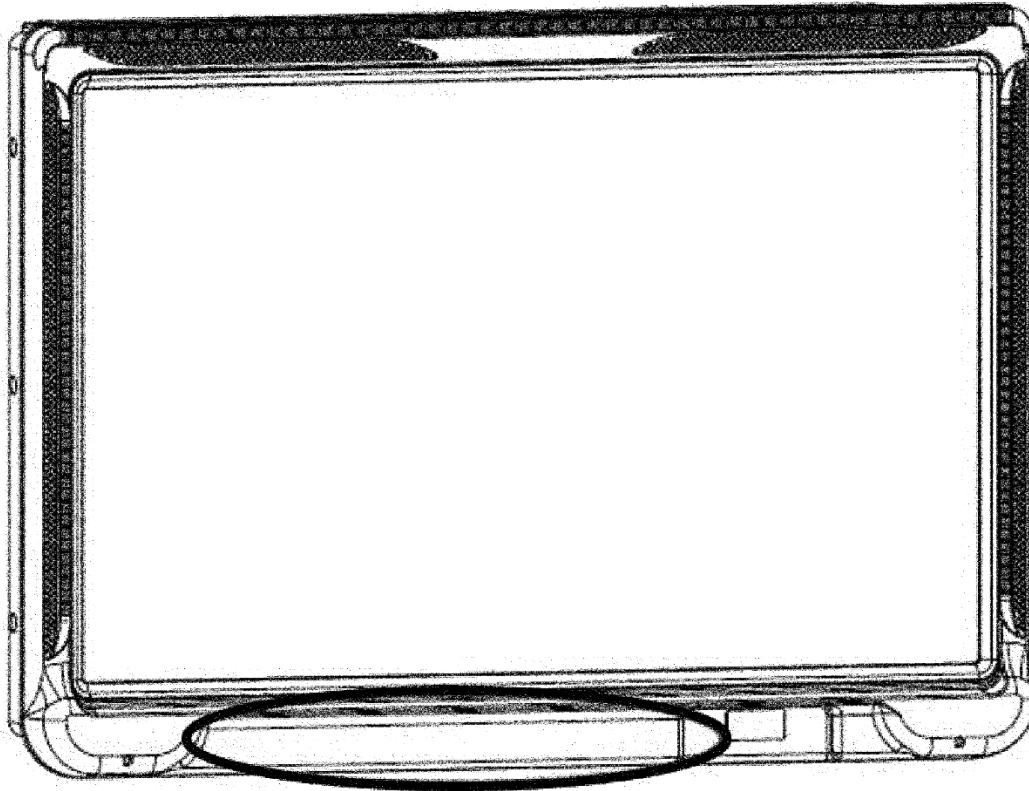
Figure 1 to paragraph (g)(1)(iii); placard location on bezel

This AD was prompted by a conflict between the traffic collision avoidance system (TCAS) primary display indications and aural alerts during a resolution advisory (RA) scenario. The FAA is issuing this AD to prevent conflicting TCAS information, which could result in the pilot under-correcting or over-correcting and may lead to inadequate aircraft separation and a mid-air collision.

(iii) Install the placard on the bottom of each aircraft primary flight display bezel in the area depicted in figure 1 to paragraph (g)(1)(iii) of this AD.
