**FEDERAL AVIATION ADMINISTRATION
AIRWORTHINESS DIRECTIVES**

**SMALL AIRPLANES, ROTORCRAFT, GLIDERS,
BALLOONS, & AIRSHIPS**

BIWEEKLY 2022-01

12/20/2021 - 01/02/2022

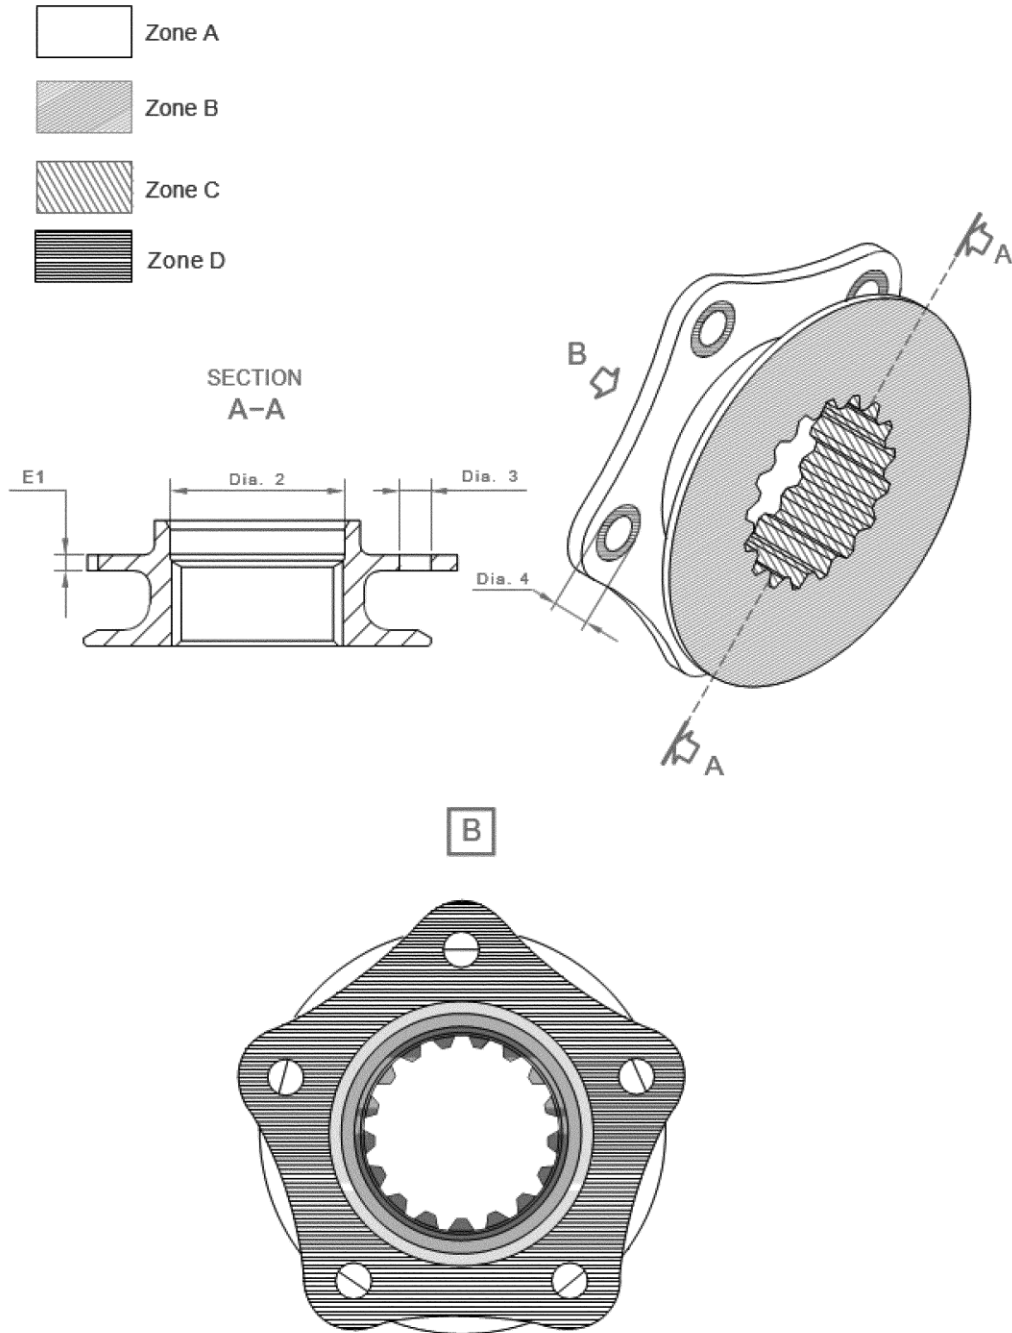
Figure 2 to paragraph (g)(1)(ii) – Inspection Areas of Tail Rotor Splined Flange

This AD was prompted by a report of recurrent loss of tightening torque on several attachment bolts on the tail rotor (TR) hub body. The FAA is issuing this AD to detect cracking and fretting, which if not addressed, could result in potential loss of the TR drive and consequent loss of yaw control of the helicopter.

(ii) Inspect the TR splined flange for corrosion, impacts, fretting, wear, and a crack in the areas identified in Figure 2 to paragraph (g)(1)(ii) of this AD. If the condition of the part (including

corrosion, impacts, fretting, wear, or cracks) exceeds the criteria as specified in Figure 1 to paragraph (g)(1)(ii) of this AD, before further flight, remove the splined flange from service and replace with an airworthy part.

Location as specified in Figure 2 to paragraph (g)(1)(ii) of this AD	Maximum damage, which causes replacement (E1, Dia. 2, Dia. 3, and Dia. 4 are shown in Figure 2 to paragraph (g)(1)(ii) of this AD)
Zone A	Scratch depth > 0.2 mm (0.008 in.). Crack. E1 < 2.75 mm (0.108 in.). Dia. 3 > 6.02 mm (0.2371 in.). Dia. 2 > 33.03 mm (1.3004 in.).
Zone B	Touch-up depth > 0.1 mm (0.004 in.). Crack.
Zone C	Crack. Scratch depth > 0.2 mm (0.008 in.).
Zone D [Dia. 4 = 14 mm +/- 0.1 mm (0.548; 0.555in.)]	Touch-up depth > 0.1 mm (0.004 in.). Crack. E1 < 2.75 mm (0.108 in.).

(i) Remove the TR hub body and each bolt, washer, and nut installed on the TR hub body from service and replace with airworthy parts.
