**FEDERAL AVIATION ADMINISTRATION
AIRWORTHINESS DIRECTIVES**

**SMALL AIRPLANES, ROTORCRAFT, GLIDERS,
BALLOONS, & AIRSHIPS**

BIWEEKLY 2022-03

1/17/2022 - 1/30/2022

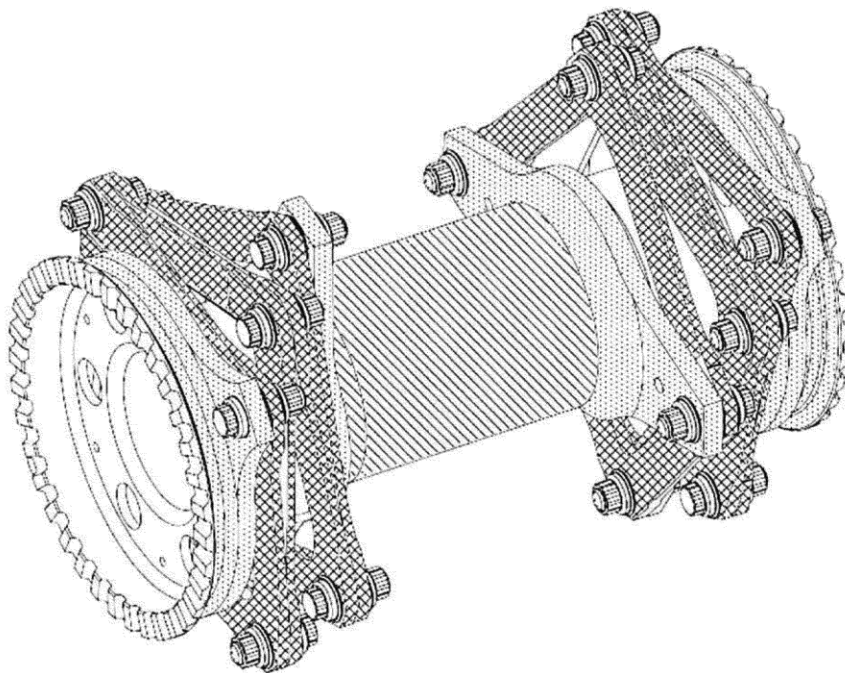
Figure 3 to Paragraph (g)(3)(iv) – Damage Limits

(iv) Inspect the main driveshaft for mechanical damage, corrosion, an edge dent, and nick as shown in Figure 3 to paragraph (g)(3)(iv) of this AD. For the purposes of this inspection, mechanical damage may be indicated by a crack, scratch, or wear; and corrosion may be indicated by corrosion or pitting. If there is a scratch, wear, corrosion, pitting, an edge dent, or a nick within allowable limits, before further flight, repair the main driveshaft in accordance with FAA-approved procedures. If there is a crack, or a scratch, wear, corrosion, pitting, an edge dent, or a nick that exceeds allowable limits, before further flight, replace the main driveshaft. The main drive shaft may be overhauled in accordance with FAA-approved procedures to accomplish the replacement required by this paragraph.

1. No cracks are permitted
2. Repairs must be no less than 1.000 inch apart.
3. Repairs not to be within 0.500 inches of bolt hole.
4. Faying surfaces must be free of any raised metal areas.
5. All repairs to be smooth at maximum depth and smoothly blended with surrounding surface.
6. Exposed bare metal may be touched up with Sermetel Product 1122 or 196. Zinc Chromate, primer color T, even though it does not blend cosmetically with Sermetel coating, can be used if Sermetel touch-up products are unavailable.
