**FEDERAL AVIATION ADMINISTRATION
AIRWORTHINESS DIRECTIVES**

**SMALL AIRPLANES, ROTORCRAFT, GLIDERS,
BALLOONS, & AIRSHIPS**

BIWEEKLY 2022-14

6/20/2022 - 7/3/2022

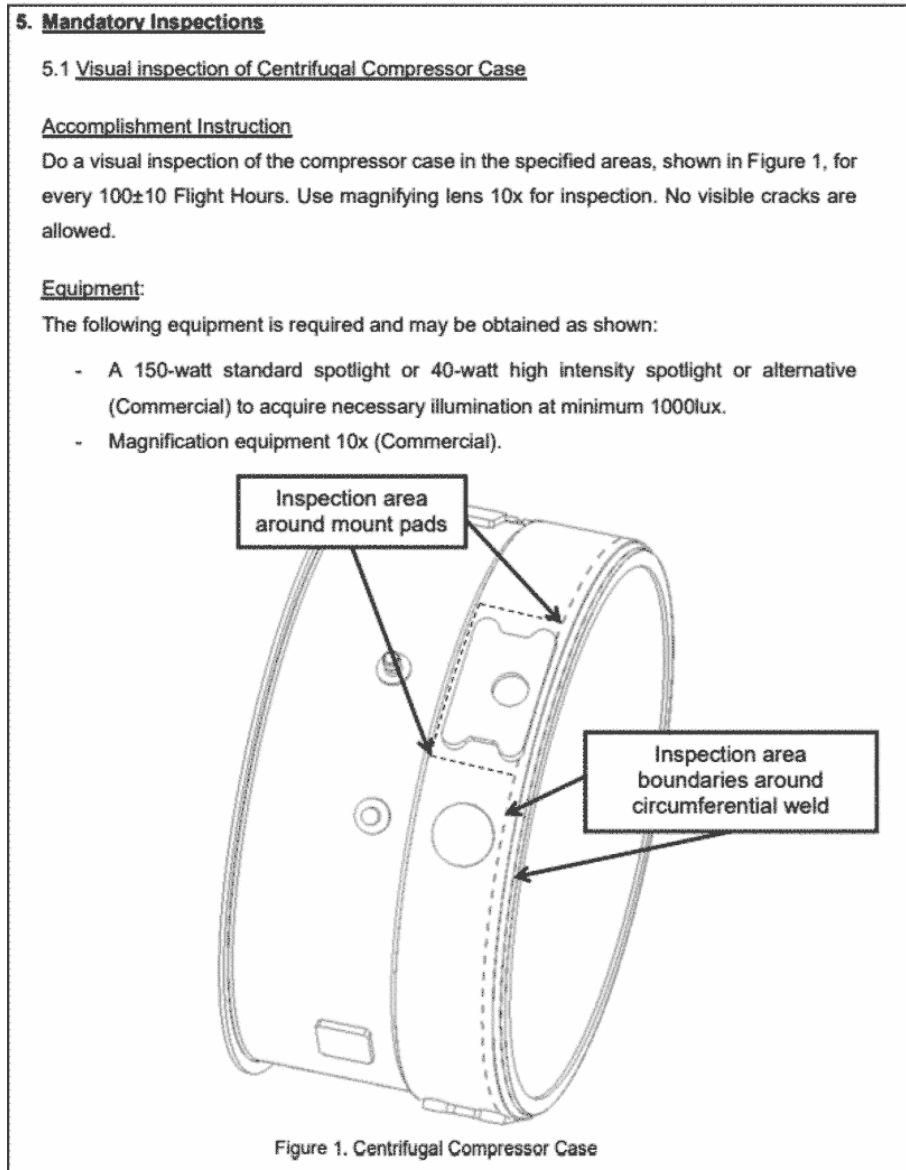
Figure 1 to Paragraph (g)(1) – Visual Inspection of the Centrifugal Compressor Case

This AD was prompted by the manufacturer revising the airworthiness limitations section (ALS) of the existing engine maintenance manual (EMM) to include a visual inspection of the centrifugal compressor case for cracks. The FAA is issuing this AD to prevent failure of the centrifugal compressor case. The unsafe condition, if not addressed, could result in failure of the centrifugal compressor case, engine separation, and loss of the airplane.

(1) Within 90 days after the effective date of this AD, revise the ALS of the existing EMM by incorporating Figure 1 to paragraph (g)(1) of this AD.

(2) After revising the ALS of the existing EMM required by paragraph (g)(1) of this AD, no alternative inspection intervals may be used unless they are approved as provided in paragraph (h) of this AD.

(3) The action required by paragraph (g)(1) of this AD may be performed by the owner/operator (pilot) holding at least a private pilot certificate and must be entered into the aircraft records showing compliance with this AD in accordance with 14 CFR 43.9(a) and 14 CFR 91.417(a)(2)(v). The record must be maintained as required by 14 CFR 91.417, 121.380, or 135.439.
