**FEDERAL AVIATION ADMINISTRATION
AIRWORTHINESS DIRECTIVES**

**SMALL AIRCRAFT, ROTORCRAFT, GLIDERS
BALLOONS, AIRSHIPS, AND UAS**

BIWEEKLY 2024-20

09/23/2024 - 10/06/2024

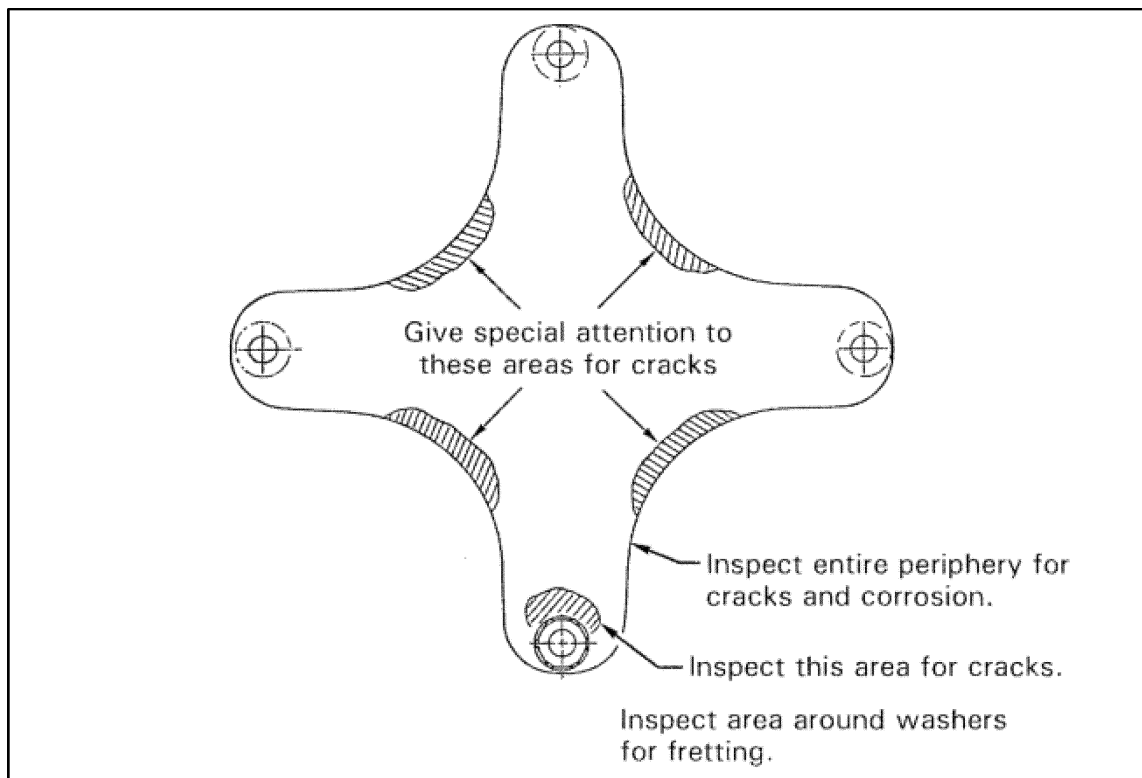
Figure 1 to Paragraph (g)(1)(i)-Flex Plate Inspection

(i) Visually inspect forward flex plate assembly (flex plate) part number (P/N) C947-1 for any loose fasteners, cracks, fretting, corrosion, wear, and to ensure that the washers are bonded to both sides of each flex plate arm, in the areas depicted in Figure 1 to paragraph (g)(1)(i) of this AD. If there is any loose

fastener (can be moved by hand), crack, fretting, corrosion, or wear that consists of the washers not securely bonded to both sides of each flex plate arm, before further flight, remove the flex plate from service and replace with an airworthy flex plate.
