TECHNICAL INFORMATION LETTER

TIL N° T-109-23-001 T-109E-23-001

SUBJECT: Tail rotor pitch link installation procedures update

Helicopters Affected: All A109/AW109 and A119/AW119MKII

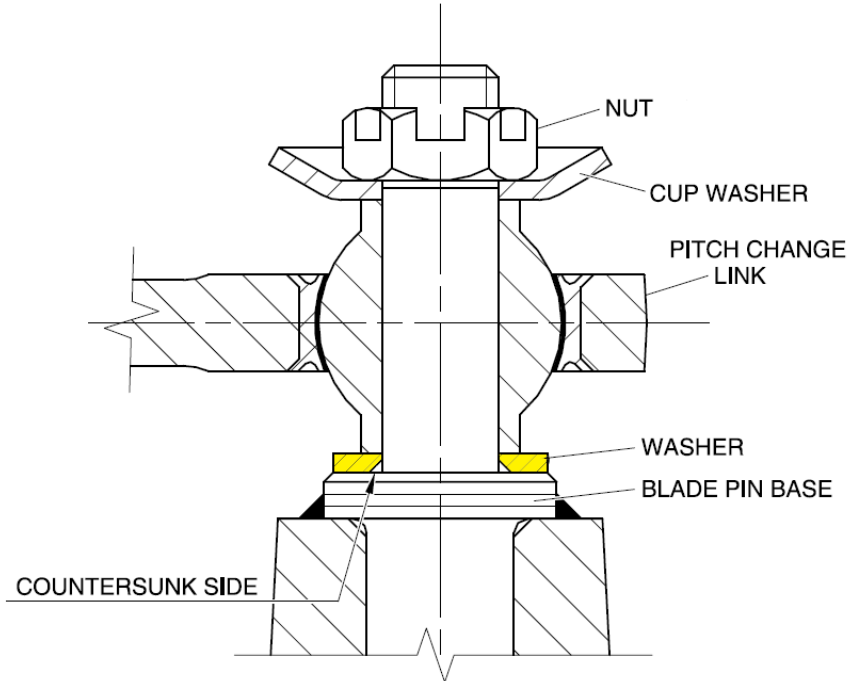
LH has been informed about some cases of scratches all around the root of the tail rotor blade pitch horn PN 709-0160-49-101 during a scheduled inspection of the rotating controls installation. The analysis of the events highlighted that the consequence of the scratches detected is determined by an improper installation of the countersunk washer P/N MS20002C6 of tail rotor pitch link installation.

Countersunk washer installation detail

In addition to the above recommendation, LH will update the content of the procedures listed in Annex A to further underline that the washer P/N MS20002C6 has to be placed with the countersunk side towards the base of the blade pin (Ref. to Annex B picture).
